Review of Redside Dace Habitat Corridor Realignment: Morphology, Sedimentology and Habitat Suitability within Aged Natural Corridor Designs

5th International Conference on Natural Channel Systems

September 26-27, 2016, Niagara Falls, Ontario

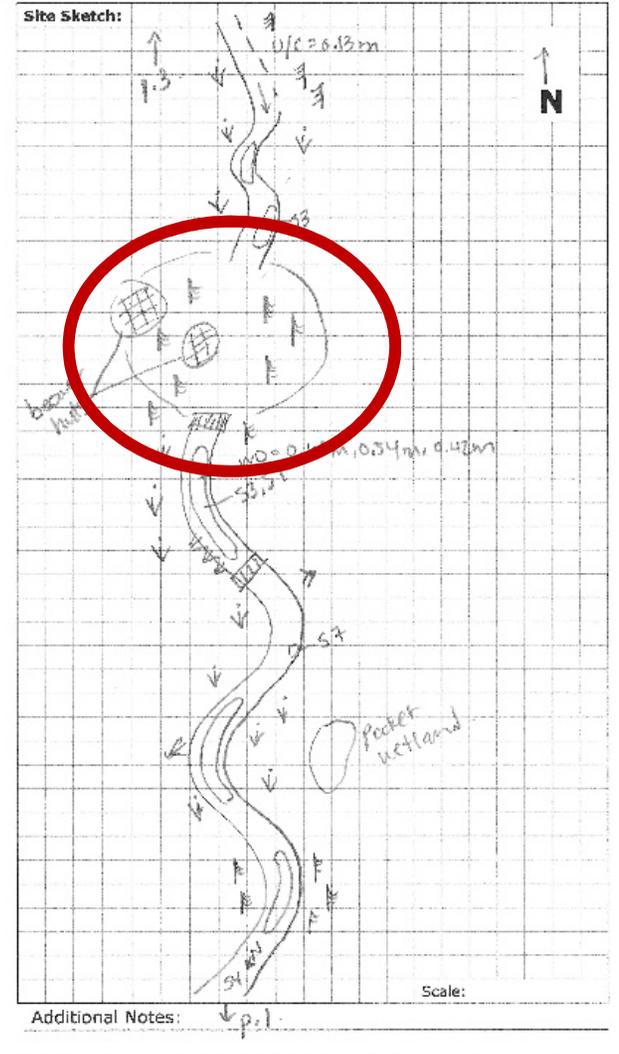
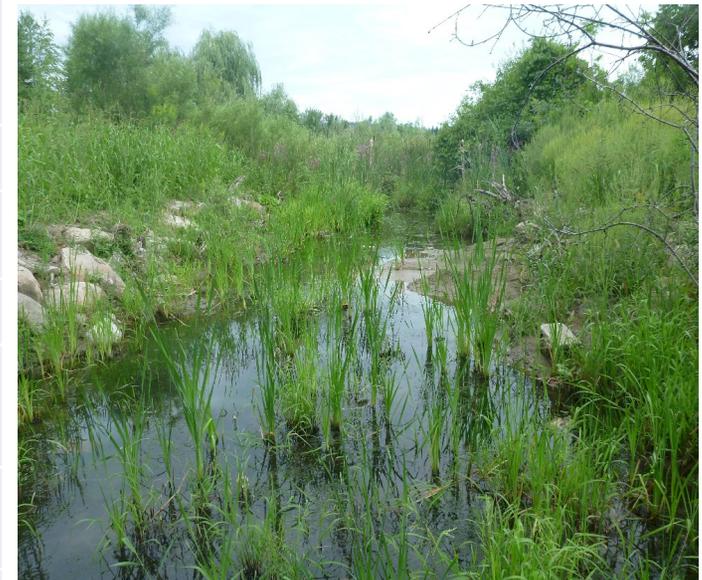
Carruther's Creek, Pickering

Range of Water Depths	0.42m-1m
Range of Velocities	Pool -0.009 m/s - 0.007 m/s
Undercutting	0.08m - 0.40m
Habitat Features	Rooted emergent
Riffle Substrate	Clay/silt, gravel, cobble, rootlets
Pool Substrate	Clay/silt, sand, rootlets
Bank Substrate	Clay/silt, rootlets
Riparian Vegetation	Major localized gaps, Canopy coverage: 60-79% shading
Large obstructions	6 beaver dams (1 breached)

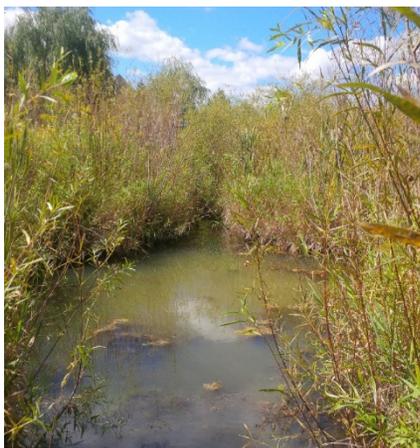
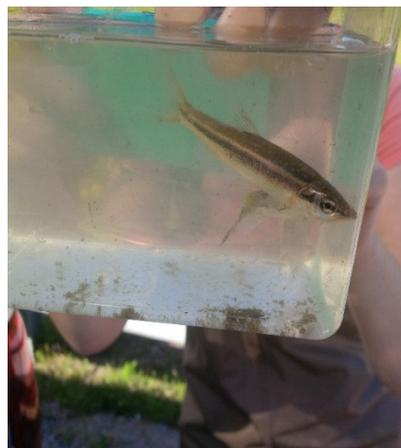
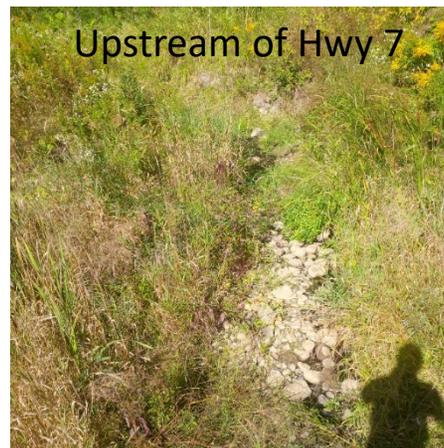
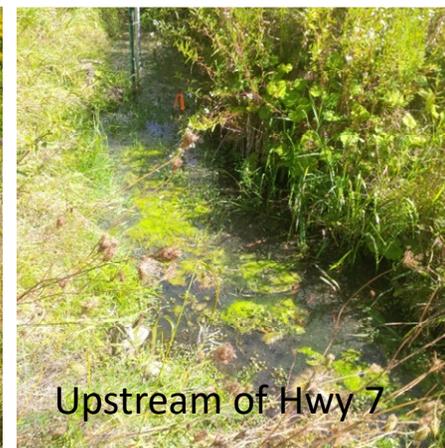
Carruther's Creek, Pickering

- Electrofishing survey completed on September 15, 2016
- Base flow at approximately 2 lpm at time of survey
- Channel maturing with moderate riparian cover
- No riffles, very shallow slope and deep pools present
- Channel dominated with muck and submergent vegetation
- Riffle/pool sequence upstream of Highway 7
- Watercress present in pools
- Seven species of fish collected
- Seven Redside Dace captured during survey reach

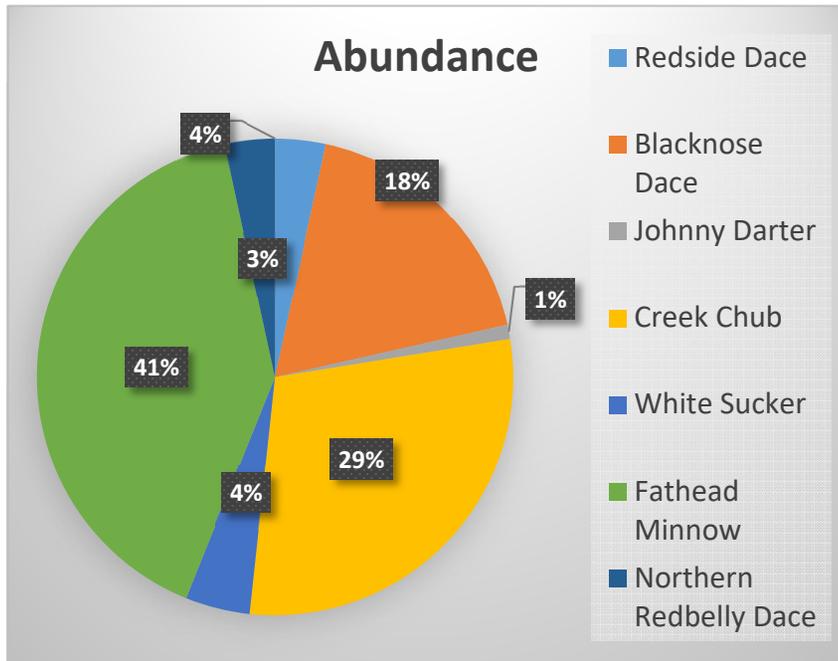
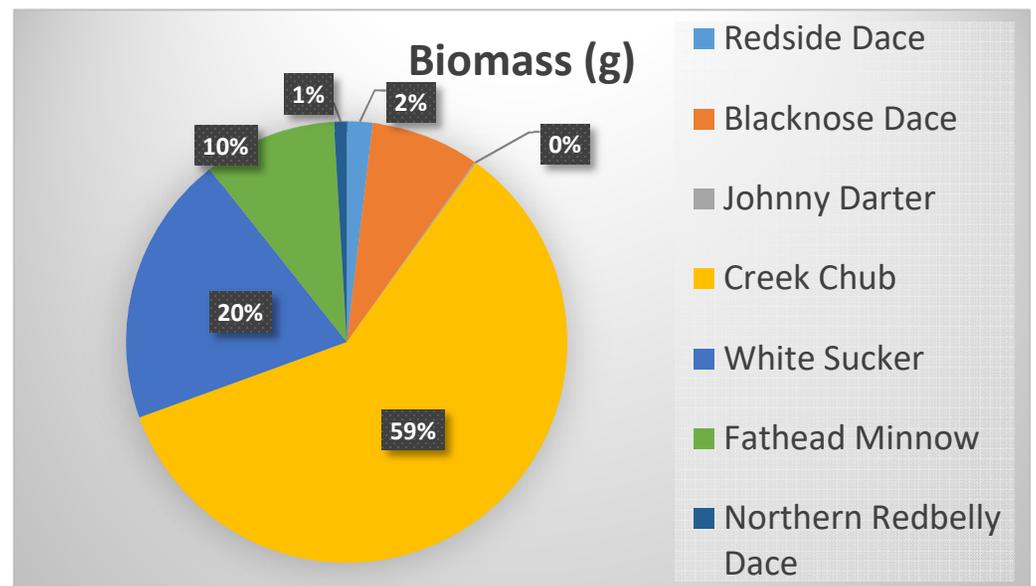
Carruther's Creek, Pickering

- 230 electrofishing seconds
- 30 m reach
- Resident fish community dominated by Creek Chub
- Good pool depth but limited woody cover
- Channel lacks slope and suitable coarse sediment for Redside Dace spawning

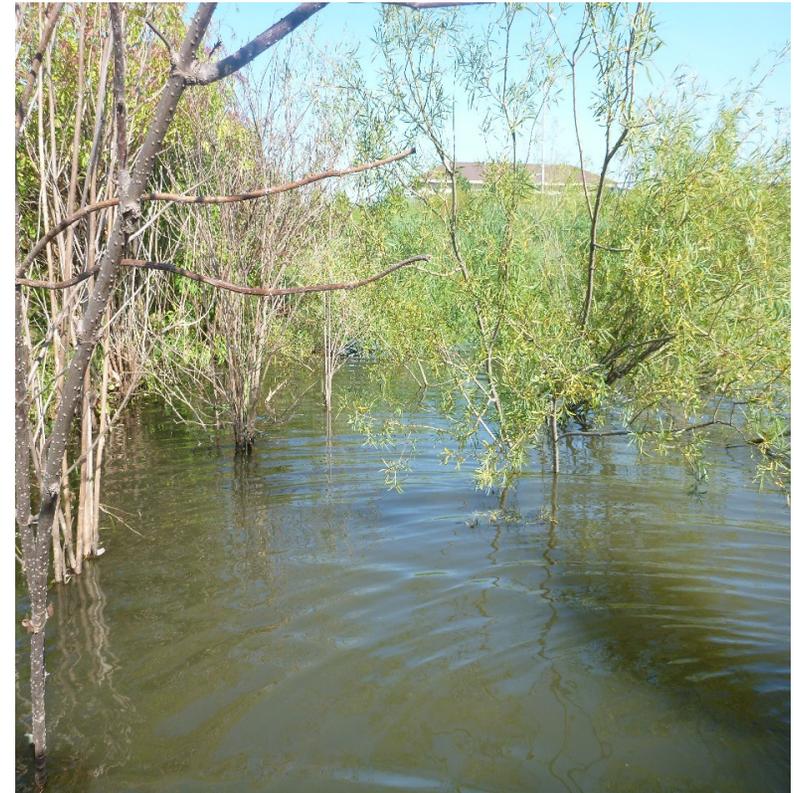
Churchville Creek: Timberbank

Range of Water depth	0.34m - 1.5m
Range of Velocities	Pool
	-0.006 m/s 0.044 m/s
Undercutting	0.15 m
Habitat Features	Rooted emergent/ submergent
Riffle Substrate	Clay/silt, gravel, cobble, rootlets
Pool Substrate	Clay/silt, sand, rootlets
Bank Substrate	Clay/silt, rootlets
Riparian Vegetation	Major localized gaps, Canopy coverage: >80 % shading
Large obstructions	2 Beaver dams (1 was 15m across)
Notes	Large amounts of flooding due to beaver dams

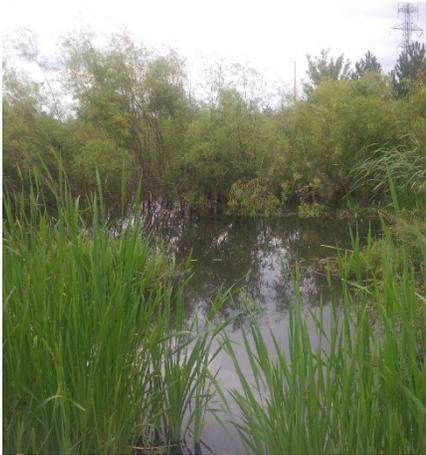
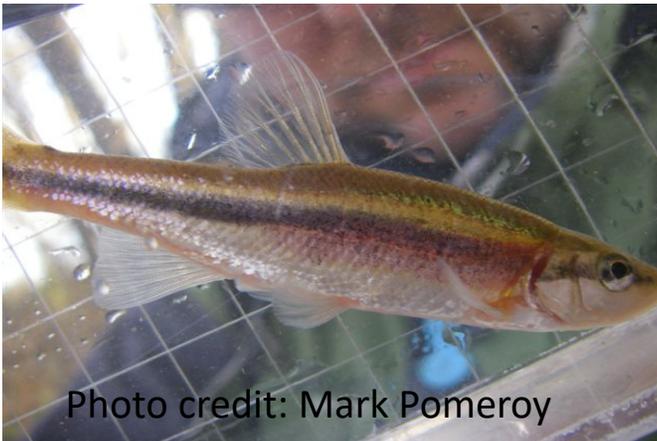
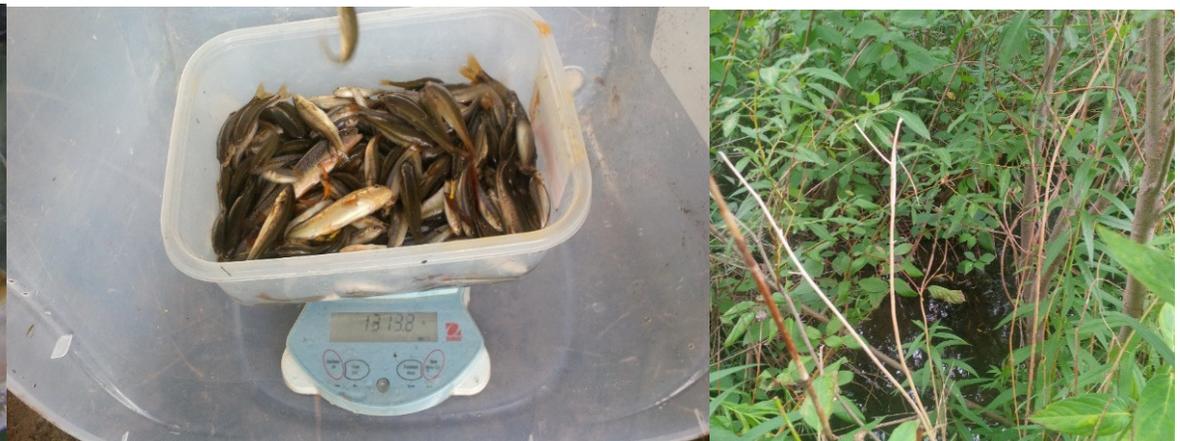
Churchville Creek, Timberbank

- Electrofishing survey completed on August 25, 2016
- Base flow at approximately 200 lpm at time of survey
- Channel maturing with dense riparian cover and dense woody cover in pools
- Riffles composed of cobbles, gravel and finer coarse sediment
- Beaver present with constructed dams
- Four species of fish collected
- Redside Dace captured 2.5 km downstream in 2009 by Stantec

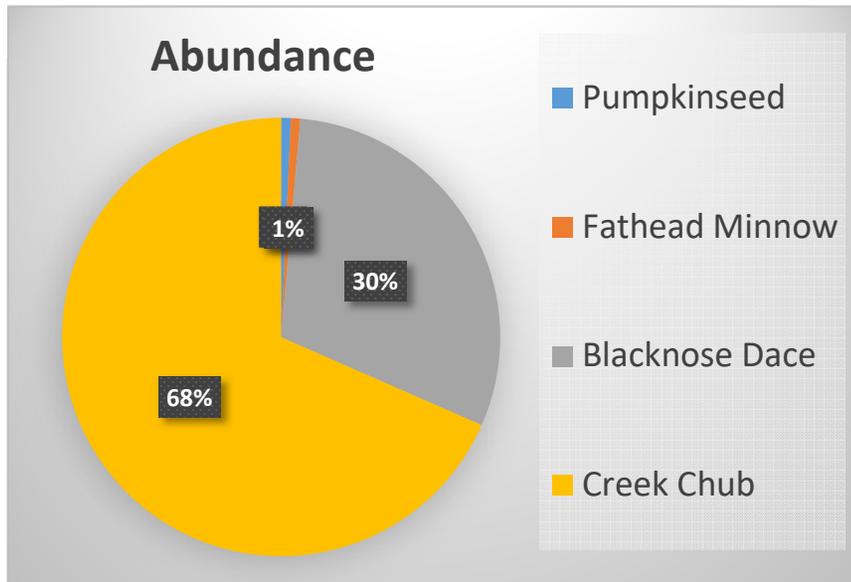
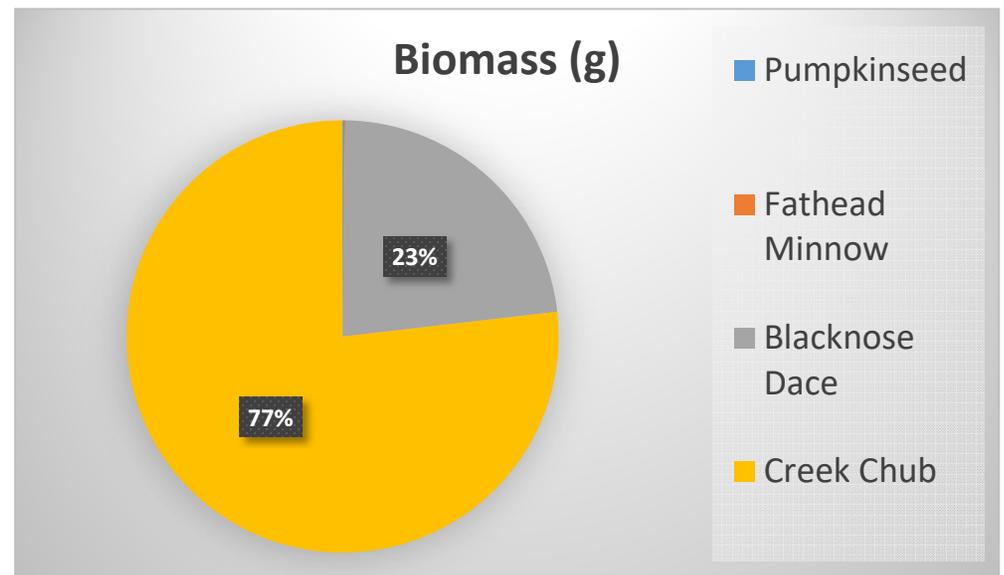
Churchville Creek, Timberbank

- 480 electrofishing seconds
- 80 m reach
- Resident fish community dominated by Creek Chub
- Channel provides suitable habitat for all life stages of Redside Dace

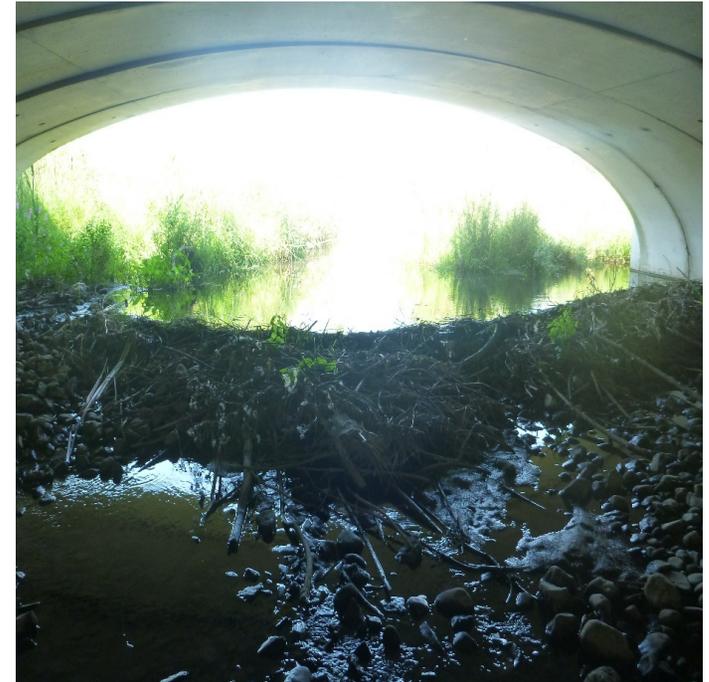
Morningside Creek, Scarborough

Range of Water depth	0.55m- 1.10m
Range of Velocities	Riffle -0.009 m/s - 0.385 m/s
Undercutting	0.05m- 0.30m
Habitat Features	Rooted submergent
Riffle Substrate	Gravel, Cobble
Pool Substrate	Sand, gravel, parent
Bank Substrate	Clay/silt
Riparian Vegetation	Major localized gaps, Canopy coverage: <50 % shading
Large obstructions	Large amounts of flooding due to 5 Beaver dams
Notes	Flooded since 2013, fish observed

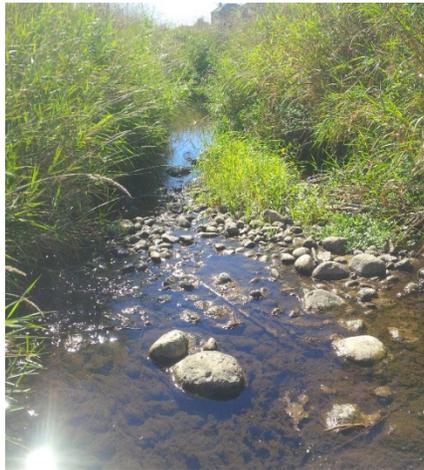
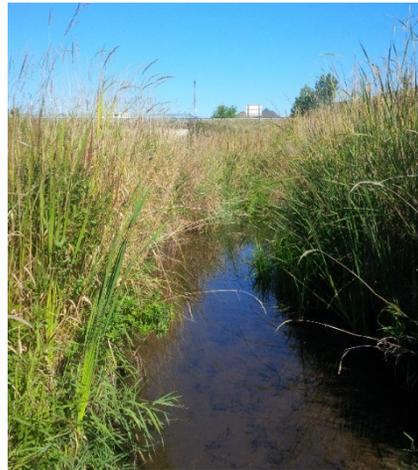
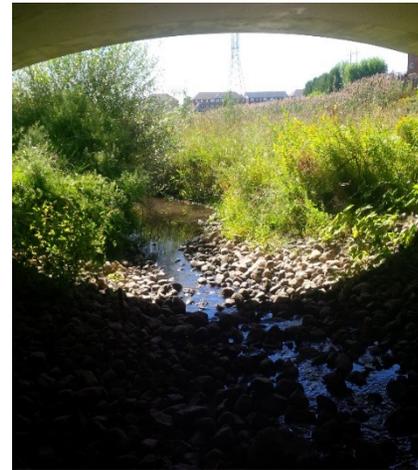
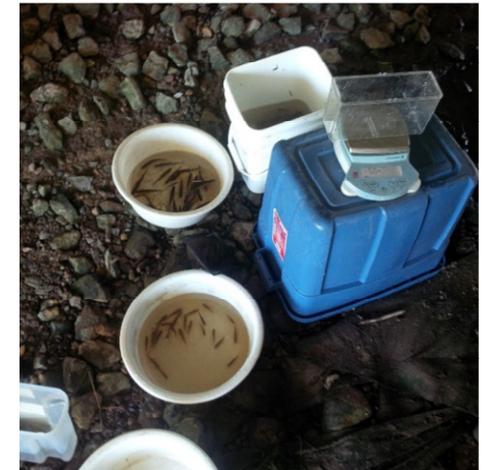
Morningside Tributary, Rouge River

- Electrofishing survey completed on September 15, 2016
- Base flow at approximately 20 lpm at time of survey
- Channel maturing with moderate riparian cover
- Riffles composed of cobbles and gravel
- Beaver present with constructed dams
- Nine species of fish collected
- Four Redside Dace captured during survey

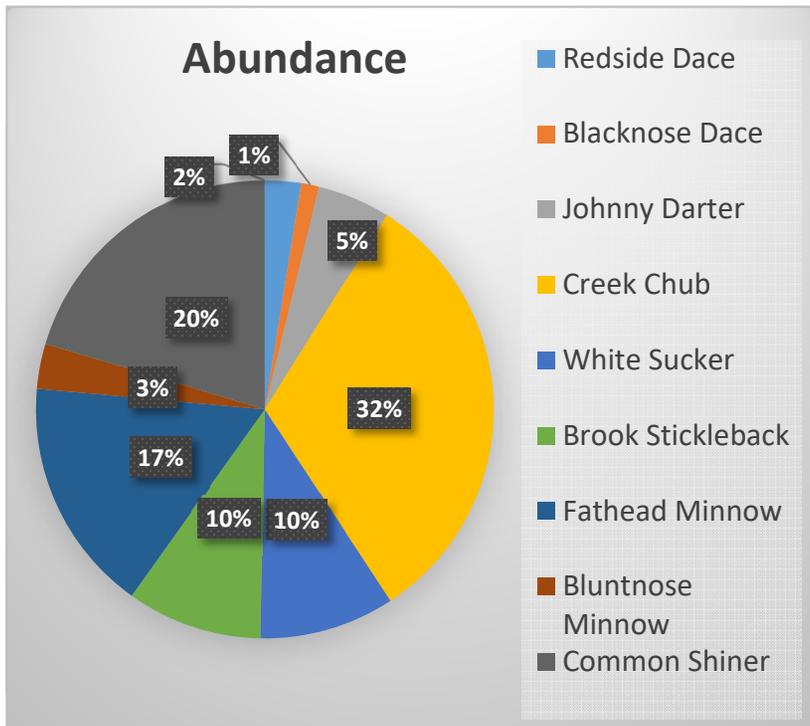
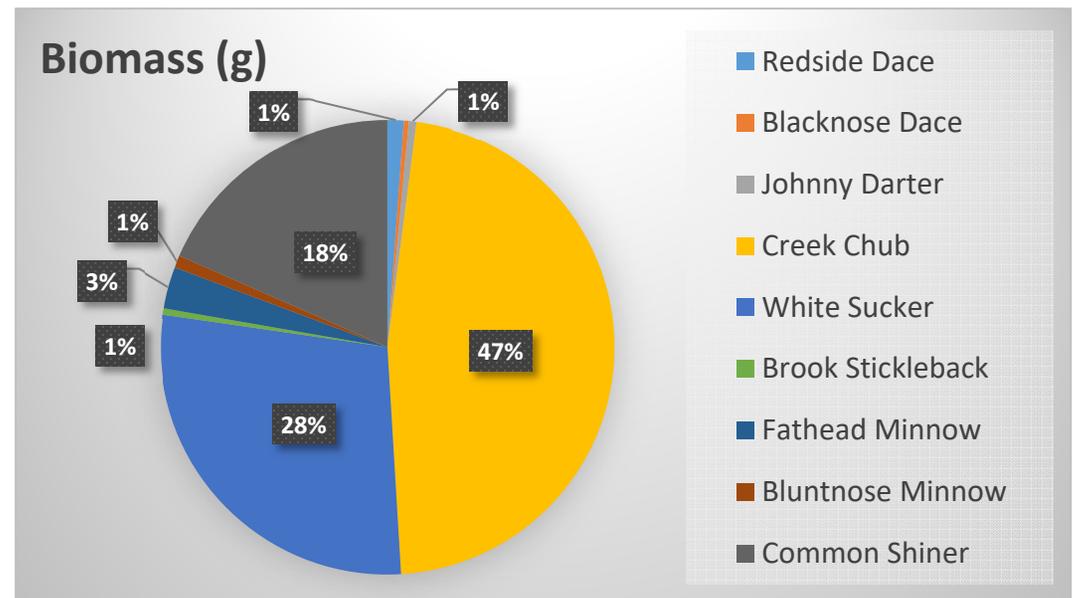
Morningside Tributary, Rouge River

- 305 electrofishing seconds
- 30 m reach
- Resident fish community dominated by Creek Chub
- Channel lacks large woody debris in pools
- Plastic mesh in channel from original erosion blankets
- Culvert substrate oversized and limiting fish passage

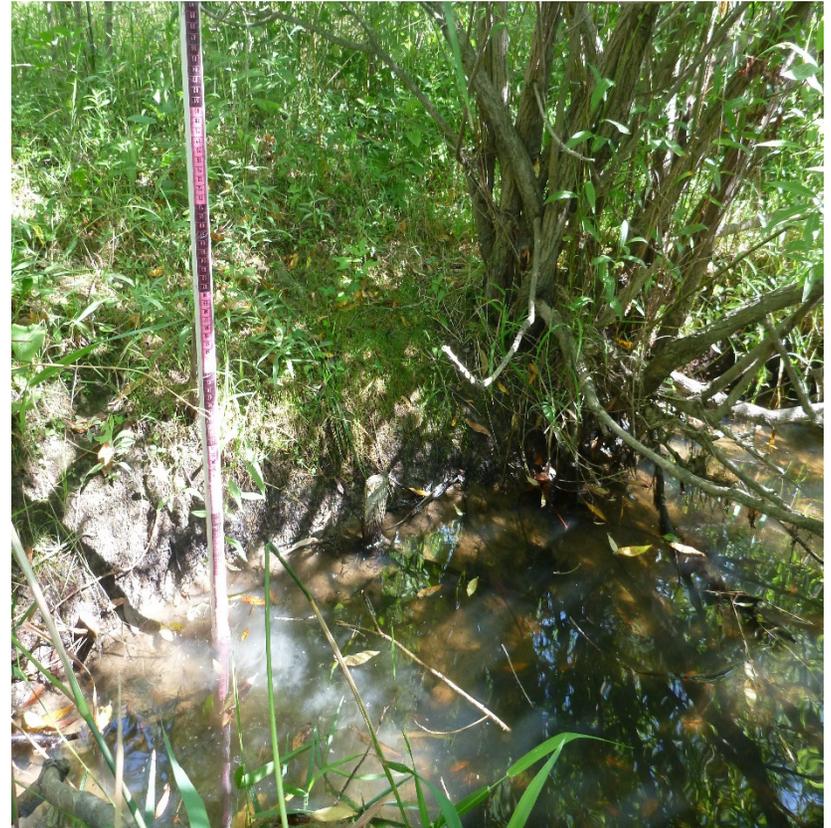
Fletcher's Creek, Brampton

Range of Water depth	0.55m- 1.10m
Range of Velocities	Pool -0.006 m/s - 0.044 m/s
Undercutting	0
Habitat Features	Rooted emergent
Riffle Substrate	Cobble
Pool Substrate	Clay/silt
Bank Substrate	Clay/silt
Riparian Vegetation	Major localized gaps, Canopy coverage: <50 % shading
Large obstructions	No beaver dams
Notes	Standing water, no flow

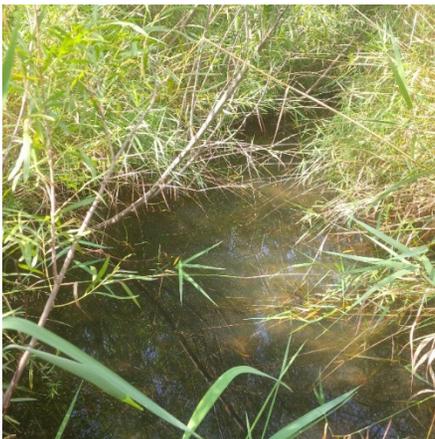
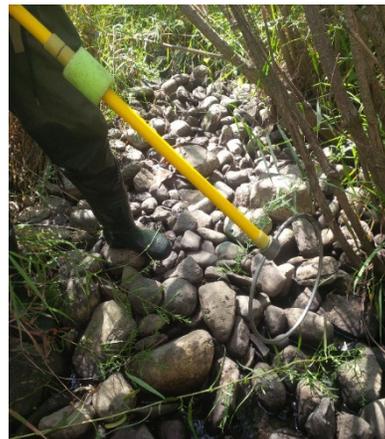
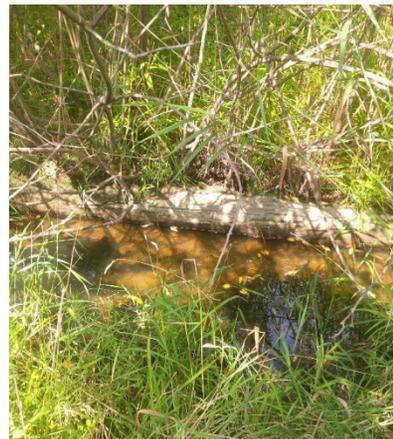
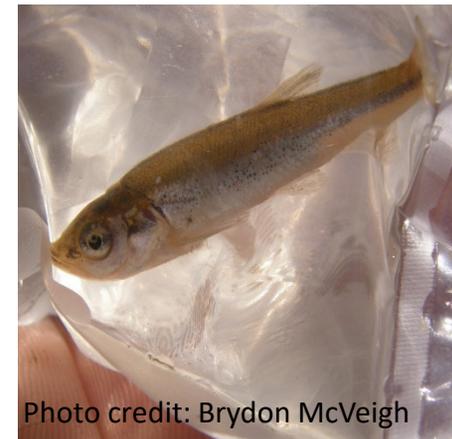
Fletcher's Creek, Credit River

- Electrofishing survey completed on August 25, 2016
- Base flow at approximately 40 lpm at time of survey
- Channel maturing with dense riparian cover with some large woody cover in pools
- Riffles composed of cobbles
- Channel dominated with muck
- Beaver present with constructed dams
- Six species of fish collected
- YOY Redside Dace captured in same survey reach in 2011 by Credit Valley Conservation

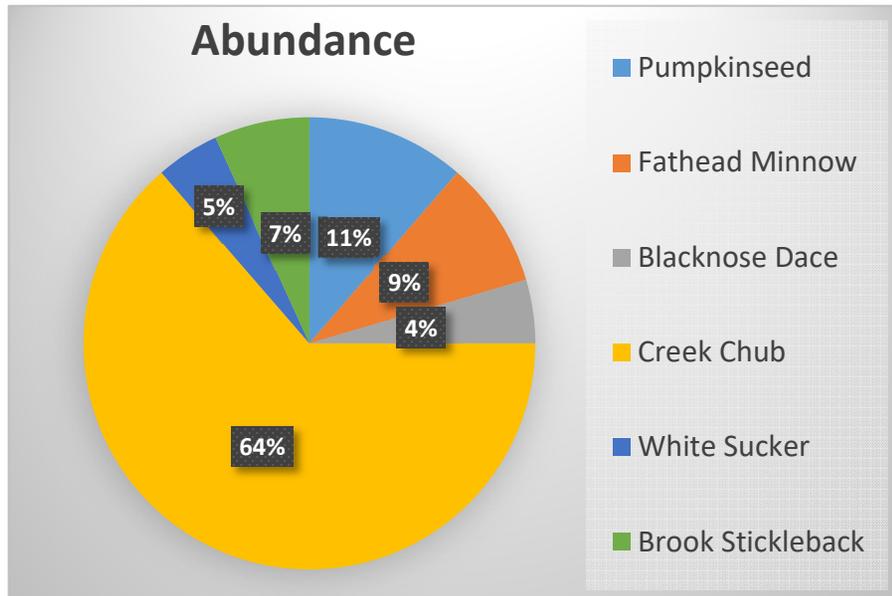
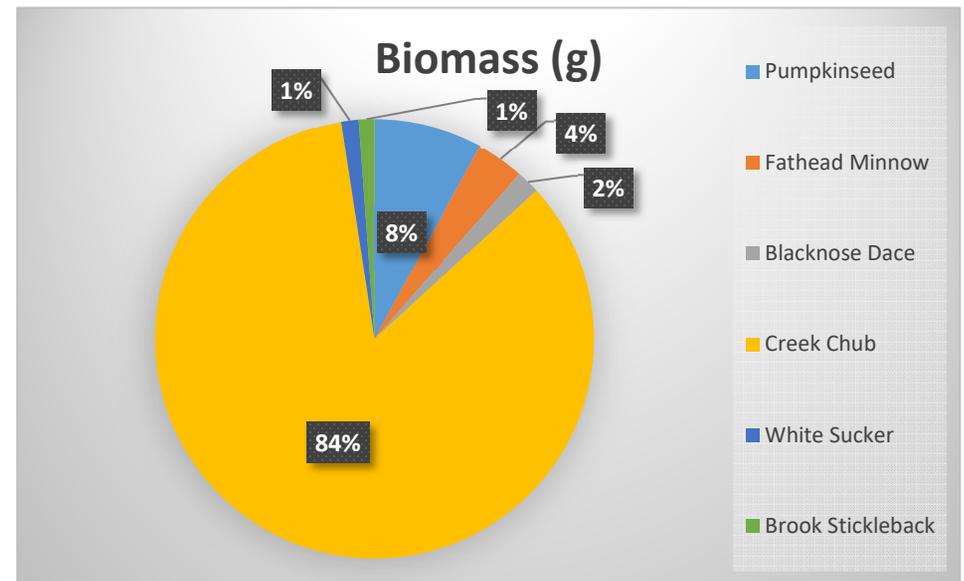
West Fletcher's Creek, Credit River

- 466 electrofishing seconds
- 100 m reach
- Resident fish community dominated by Creek Chub
- Channel lacks suitable coarse sediment for Redside Dace spawning

- Issue with oversized riffle substrates at Fletchers' illustrating that designers and agency reviewers need to be cautious in balancing erosion/instability concerns with the finer substrate needs of riffle spawning species
