Integrating Biological Design Criteria into Channel Rehabilitation Projects

Marc Gaboury

NATURAL CHANNEL SYSTEMS
5th International Conference
September 26 & 27, 2016
Niagara Falls, Ontario

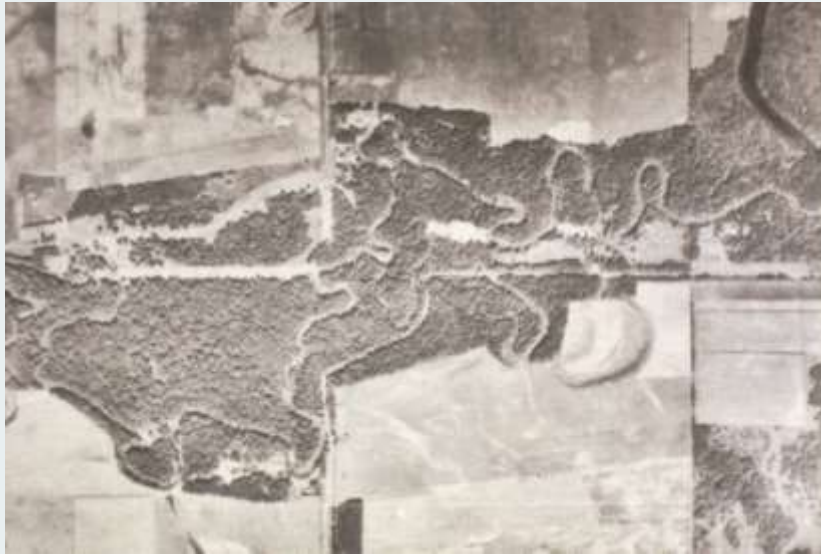
Wilson River Channelization

- ▶ 25 km of channel lost or 31% of 1949 length

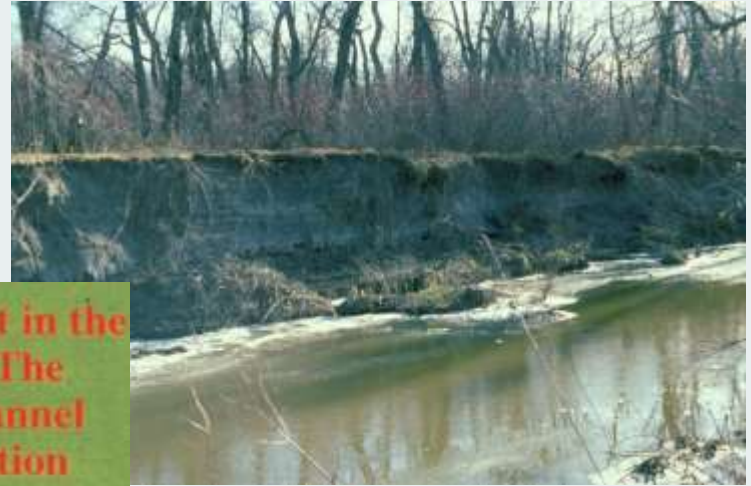
Channelization 1949-1986

Since 1949 some 41 miles of stream length has been lost in the Dauphin Lake Basin due to channel straightening. The resulting gradient increase has caused erosion of channel banks and beds, thereby increasing the overall siltation contribution to Dauphin Lake.

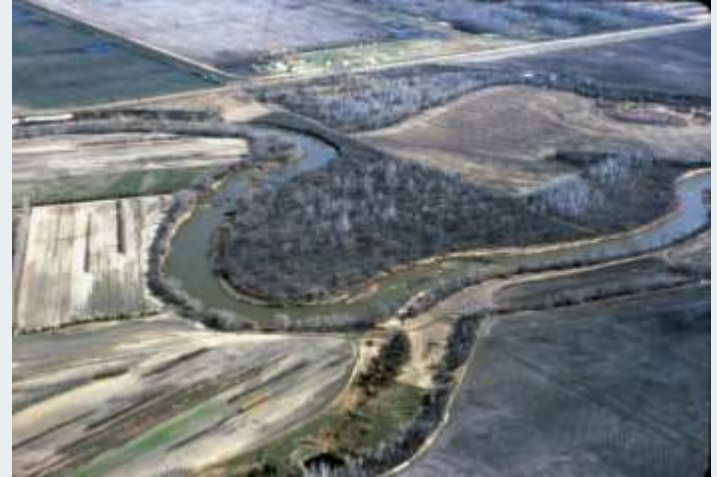
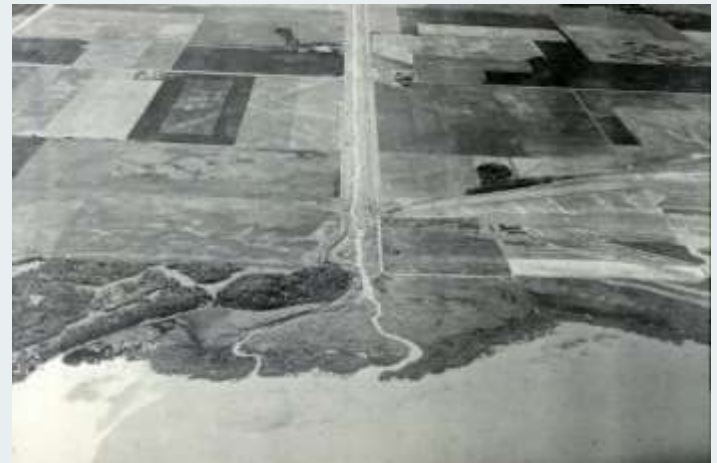
- Loss of channel meanders – pools & riffles used for walleye spawning and incubation
- Channel degradation (~1 m from 1950 to 1982) & high sedimentation affecting egg incubation success & early fry survival

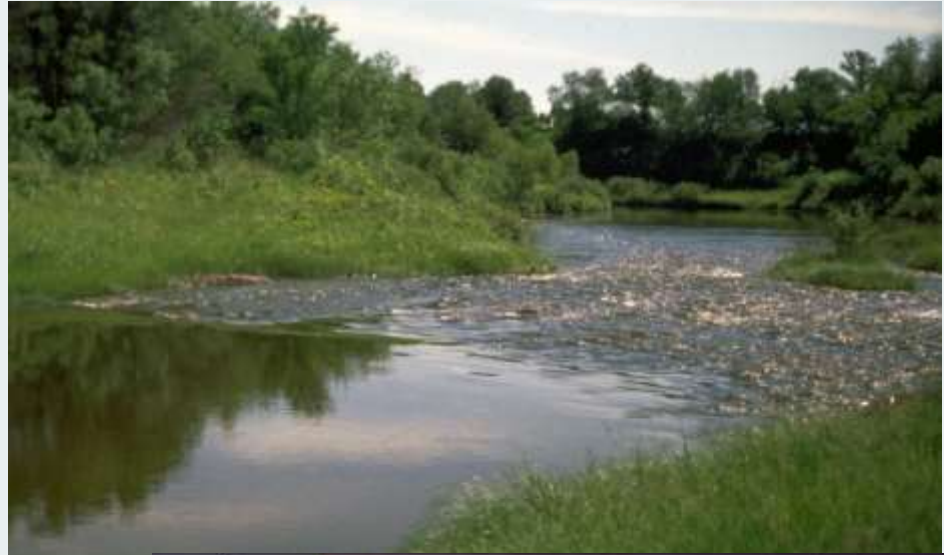
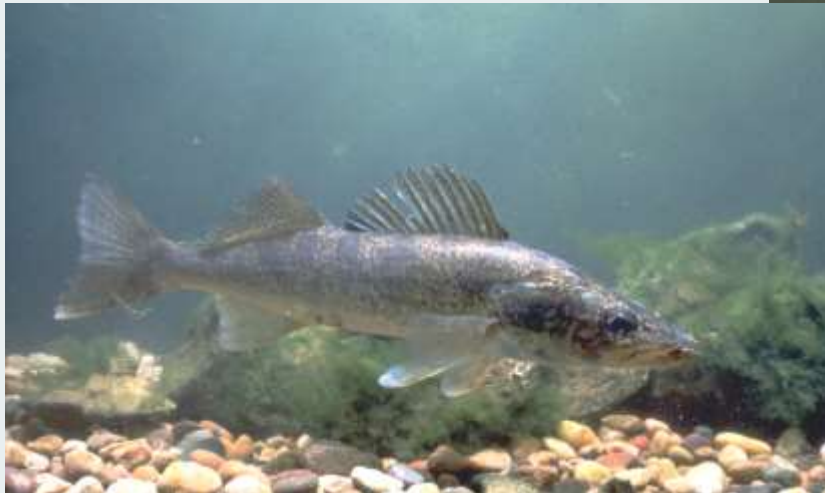
Natural Walleye Spawning Area

- Reference reach topo survey of natural riffle
- Assessment to determine walleye spawning behaviour

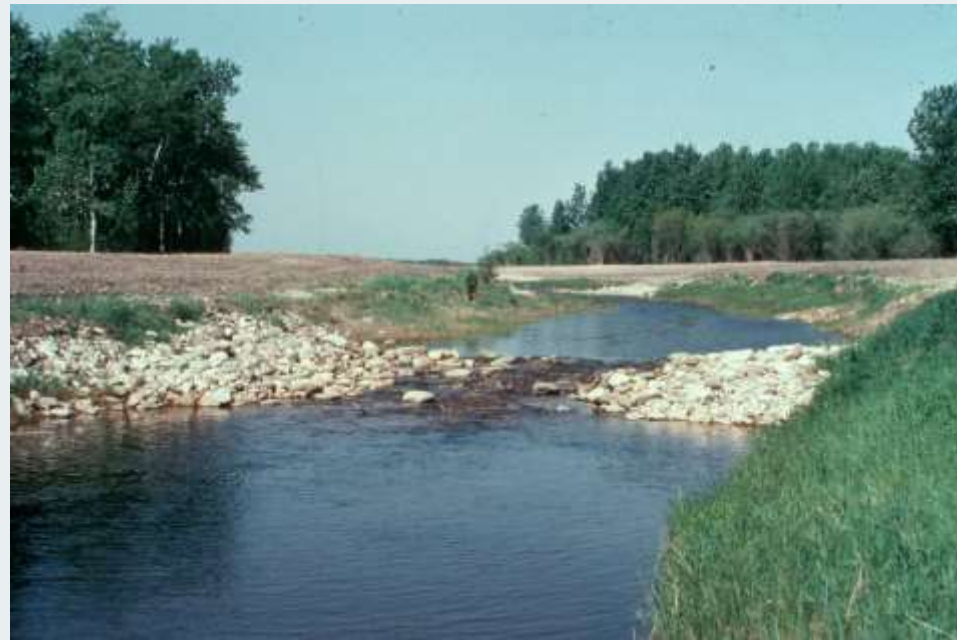
Riffle Design Considerations

Biological – Spawning, Rearing & Migration

- ❖ Emergent boulders on downstream face to capture & hold fertilized eggs
- ❖ Backwatering to reduce streambed erosion & sediment transport
- ❖ V-notched riffle to ensure adequate migration & incubation flows

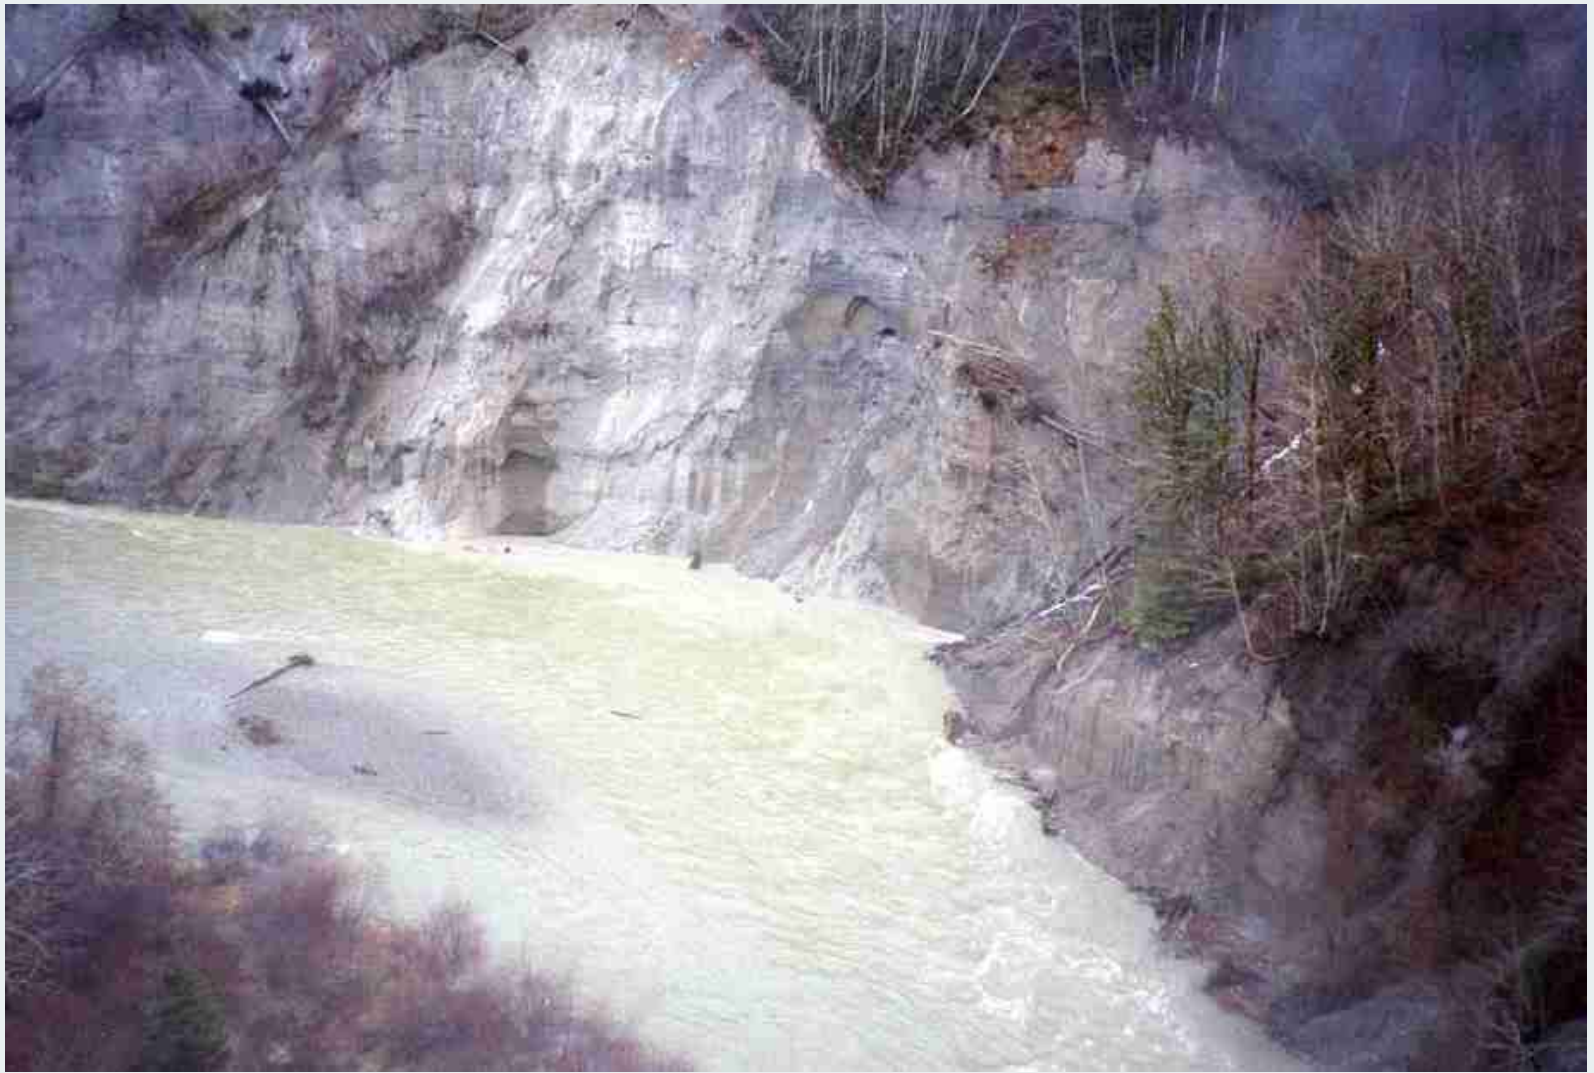
Stoltz Bluff is a deposit of glacial sediment
(50 m high by 800 m long)

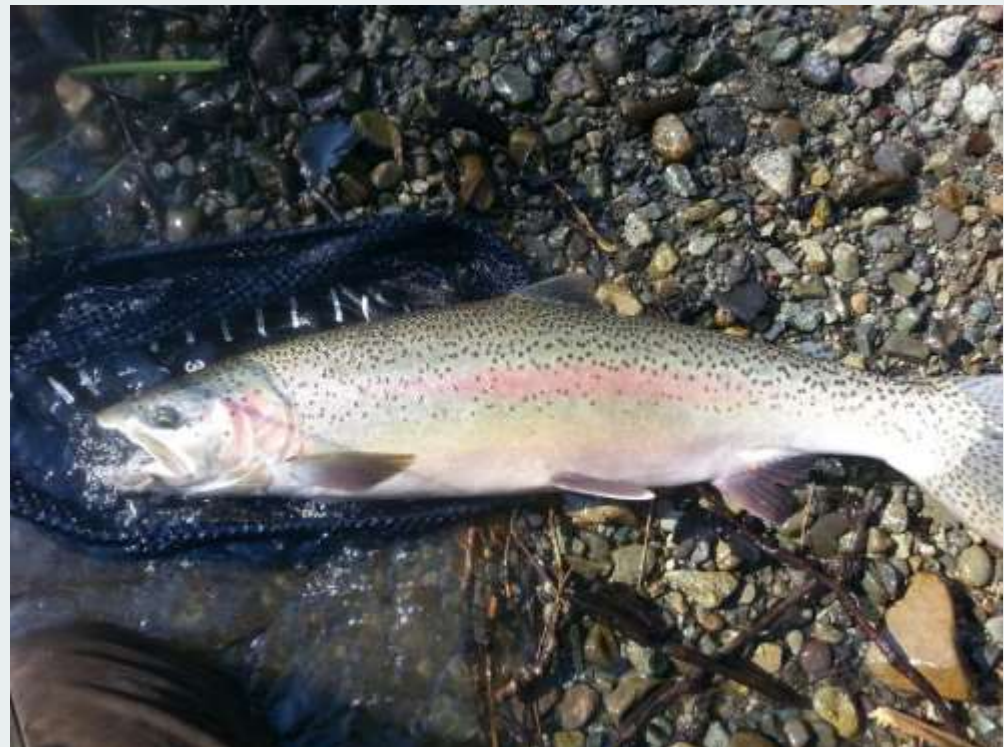
Biological Impacts

- “Paving effect” on stream substrates downstream of bluff
- Reduced salmon egg-fry survivals compared to upper river controls
- Sand infilling natural & enhanced side-channels
- Higher TSS/turbidity below Stoltz during winter months

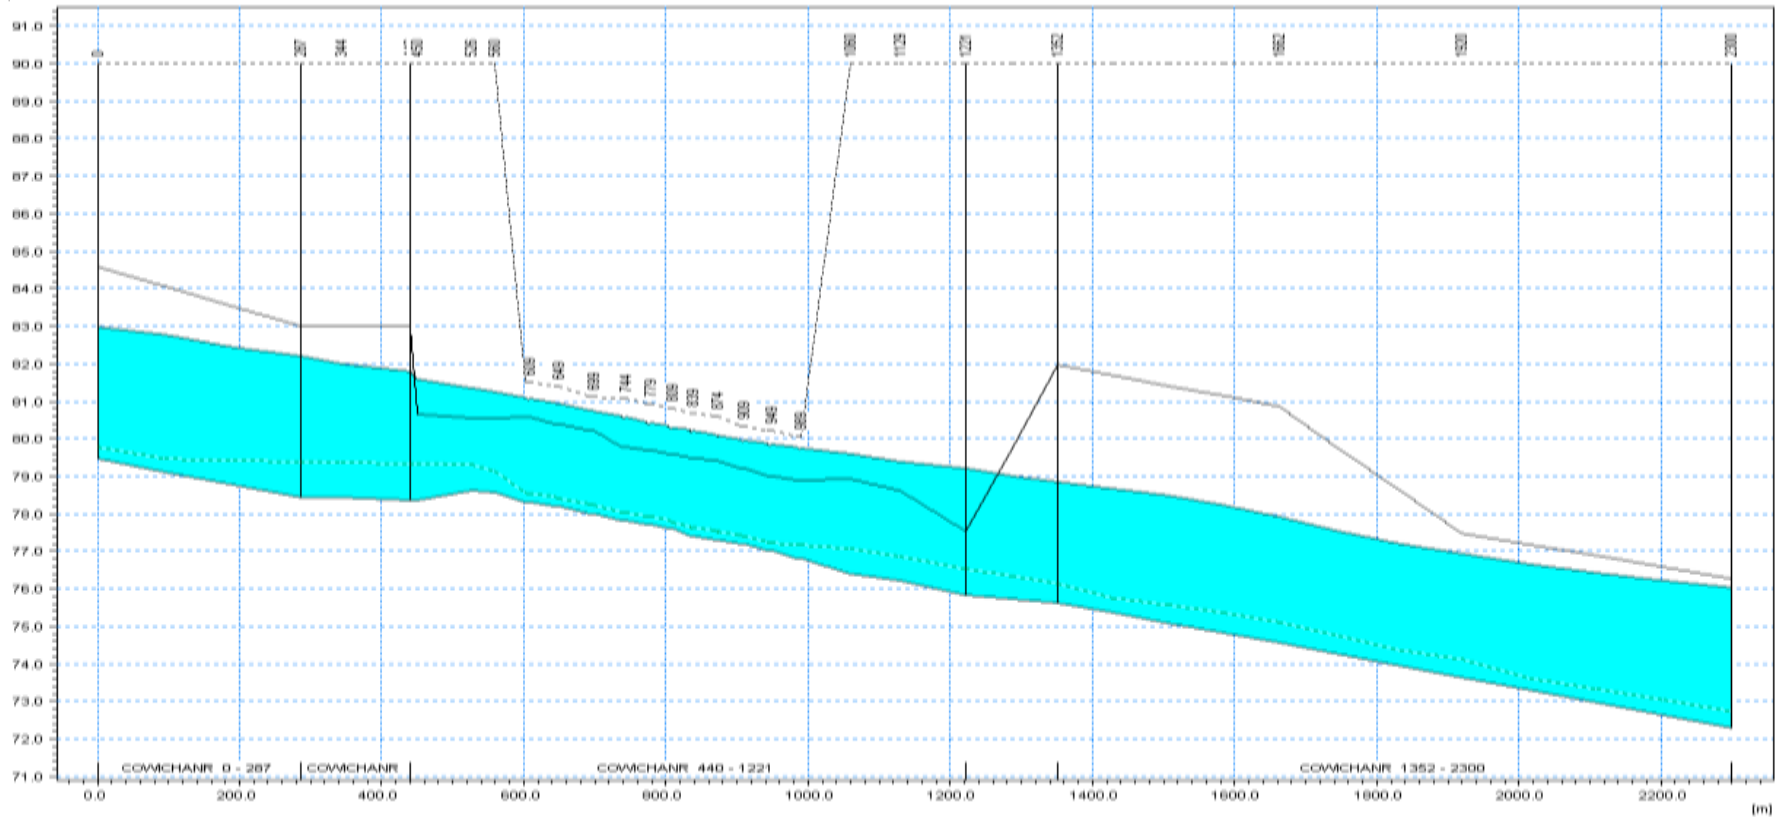
Hydraulic Modeling - 200-year Flood, Post-construction

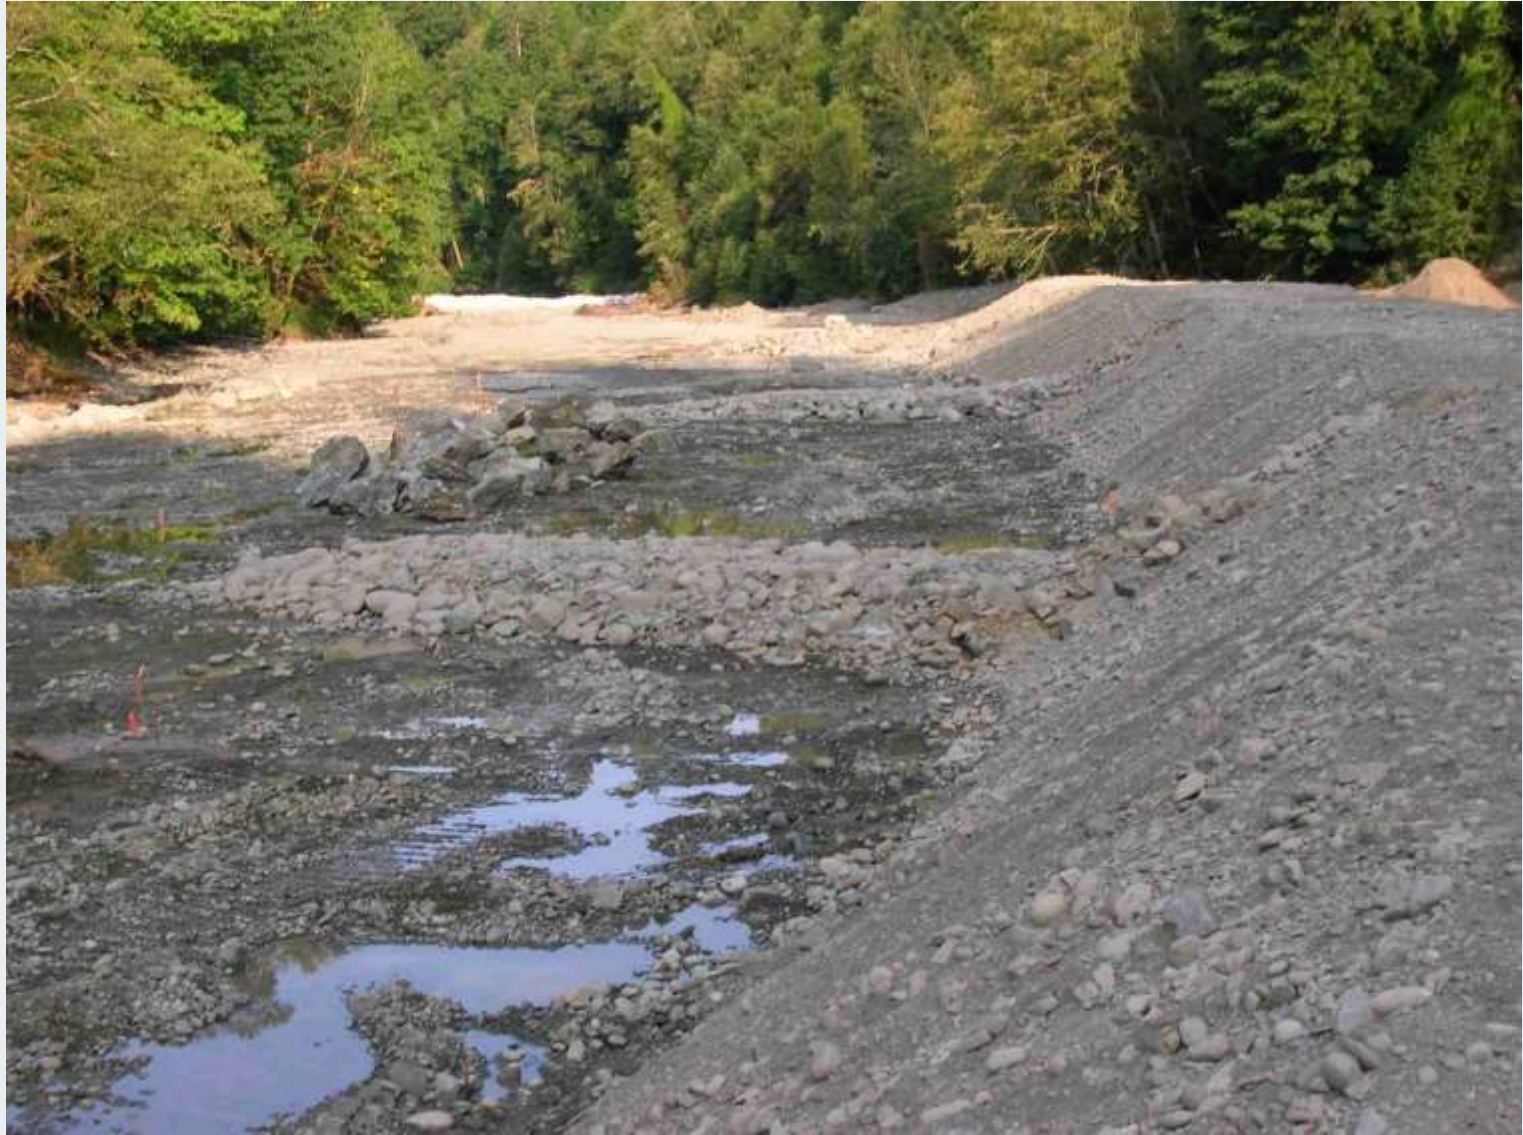
Finished Bendway Weirs

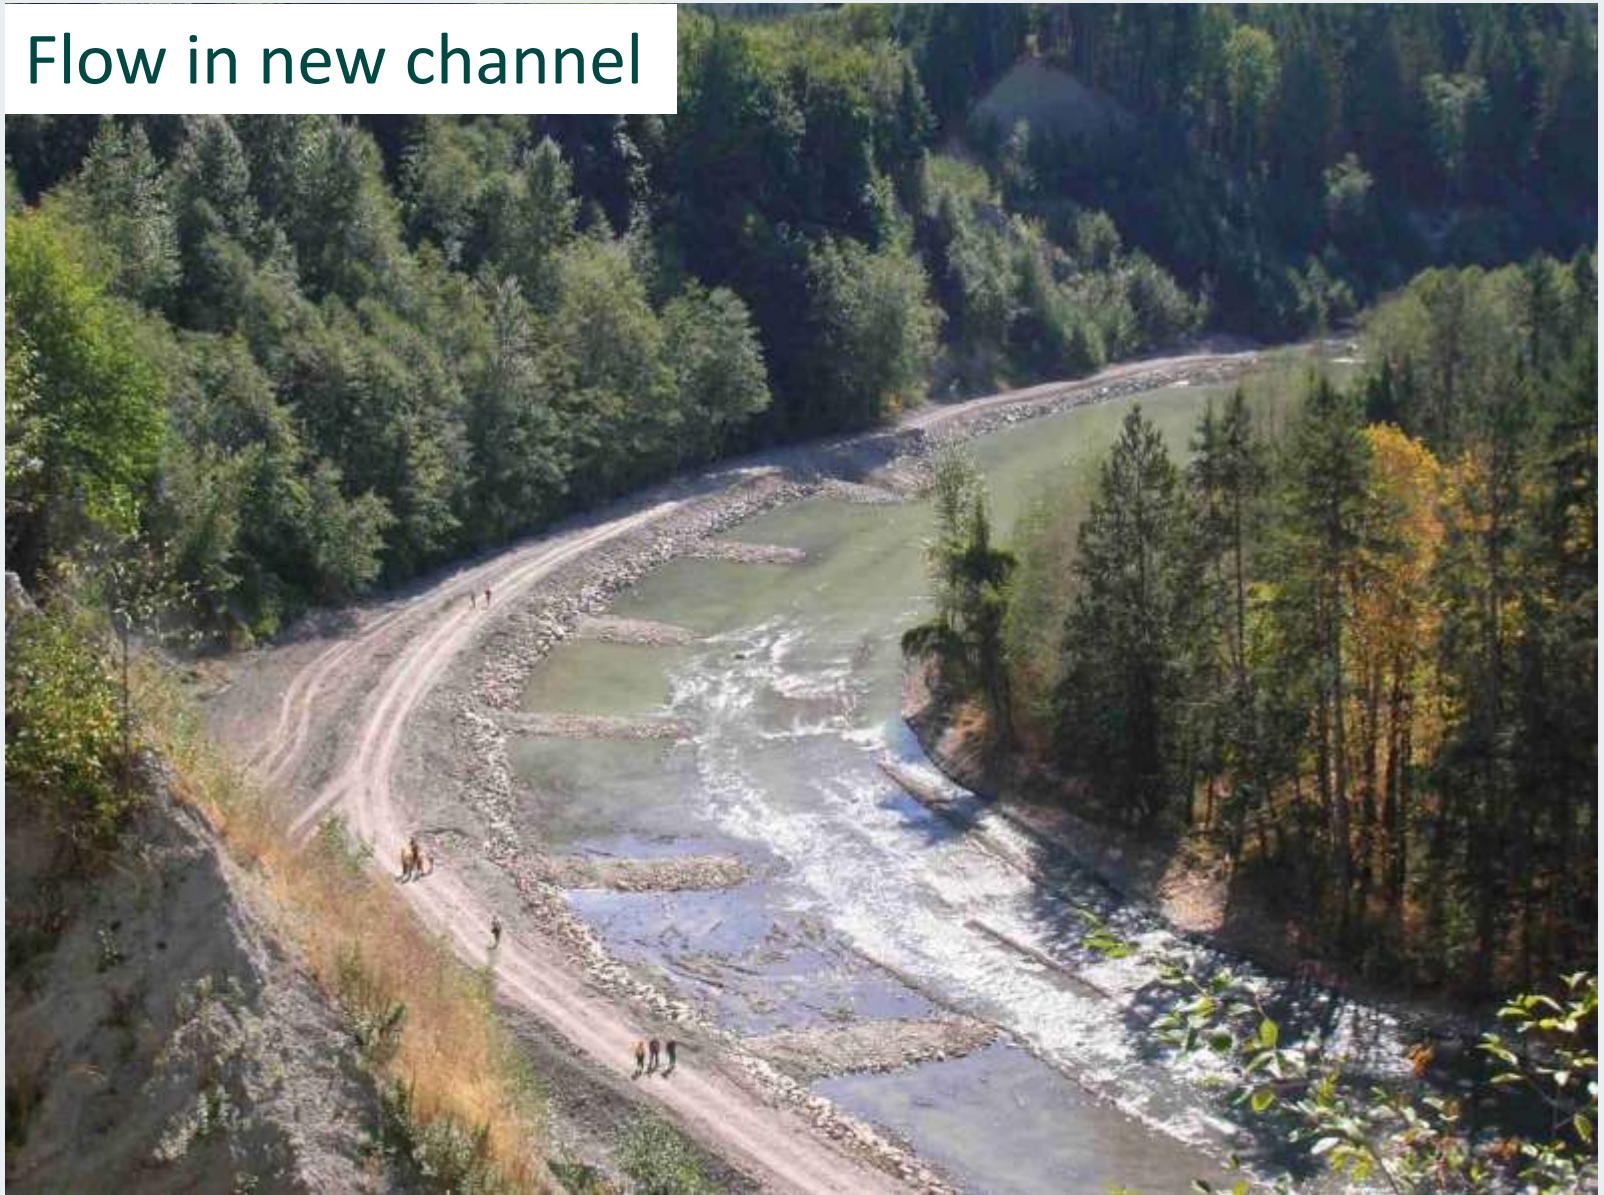
Stabilization Project Completed

Flow in new channel

Monitoring in 2010-2012 found contributions from Stoltz Bluff were reduced from $\sim 15,000$ - $22,000$ tonnes/yr to $\sim 1,000$ tonnes/yr

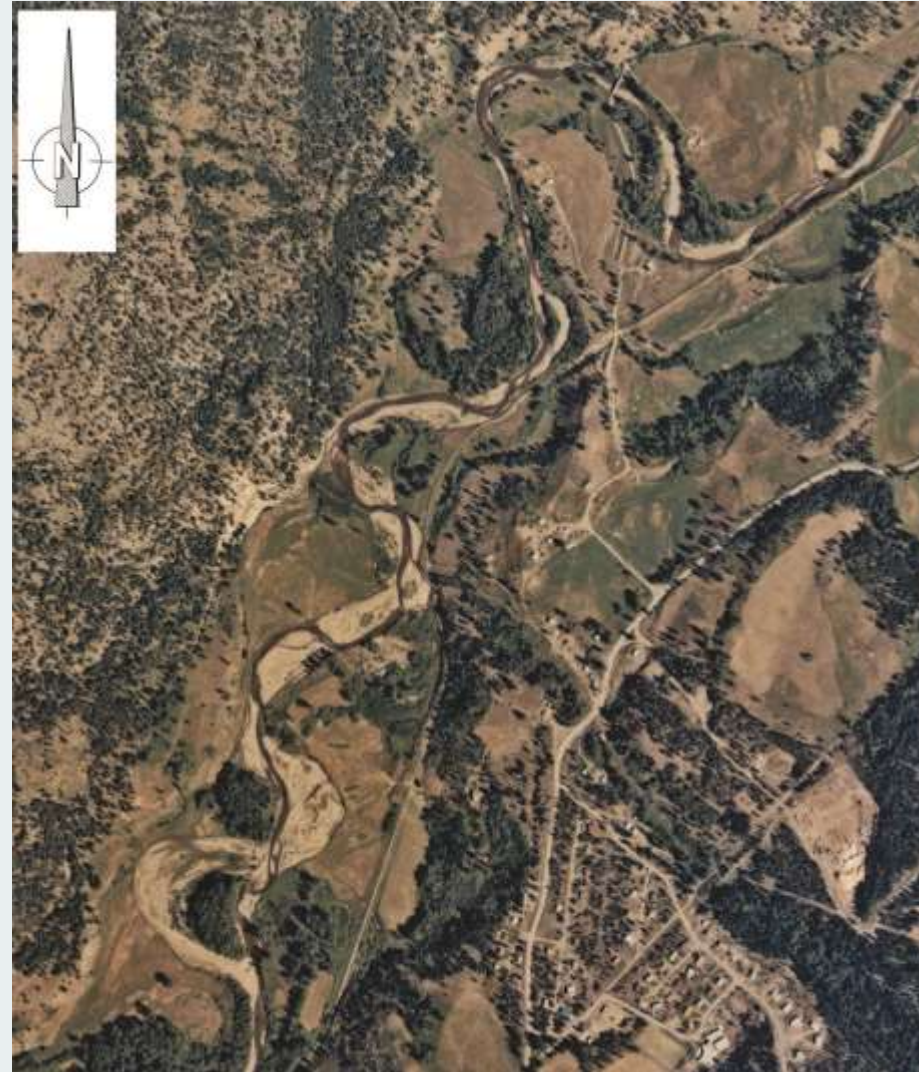
Riparian Loss Affecting Channel Morphology and Aquatic Habitats

- Riparian trees and shrubs eliminated
- Accelerated bank erosion rates
- Increased sediment transport contributing to aggradation, braiding, overwidening, pool in-filling & sedimentation of spawning gravels, decreased diversity of mesohabitats
- Lack of LWD recruitment

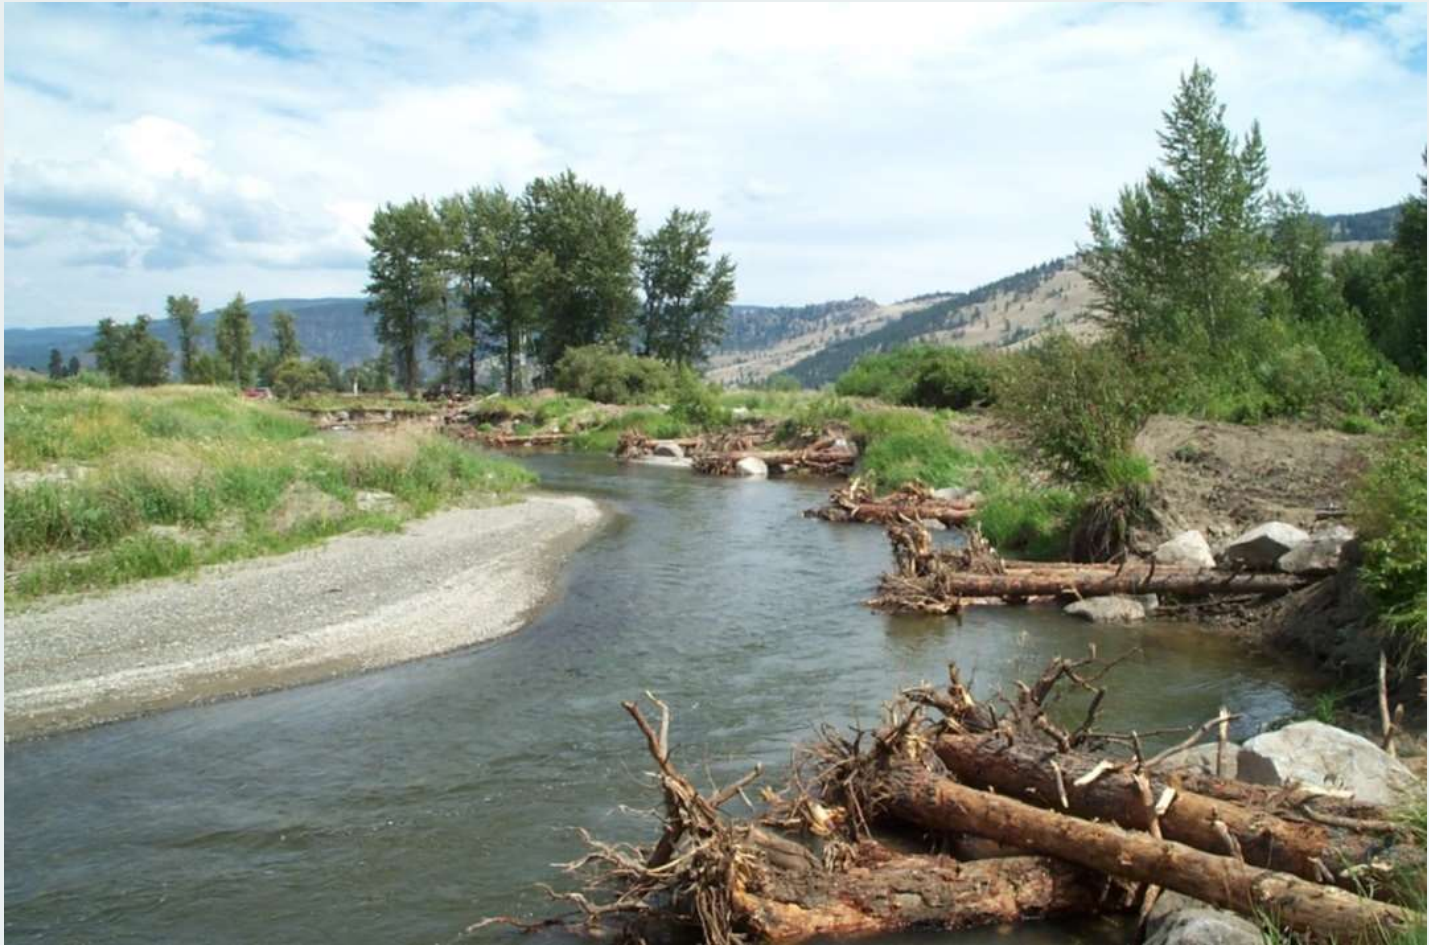
Series of Deflectors Along Bank

LWD structure spacing of ~ 4 times projection length offers some bank protection

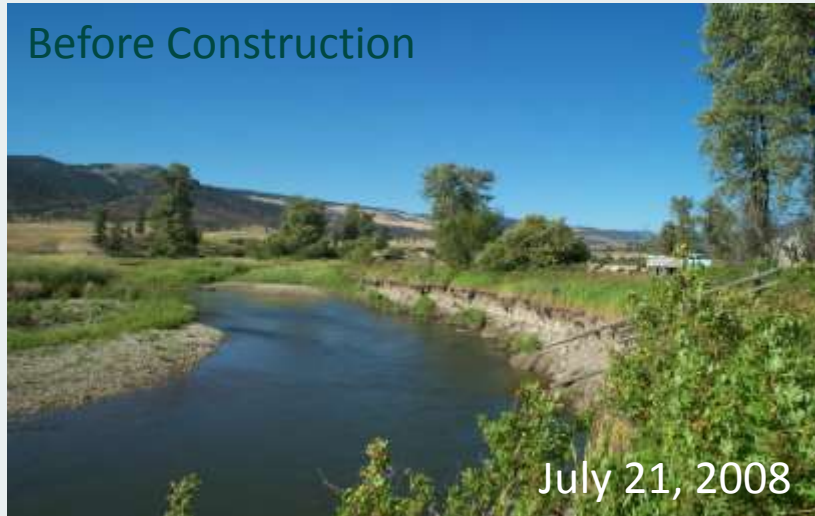
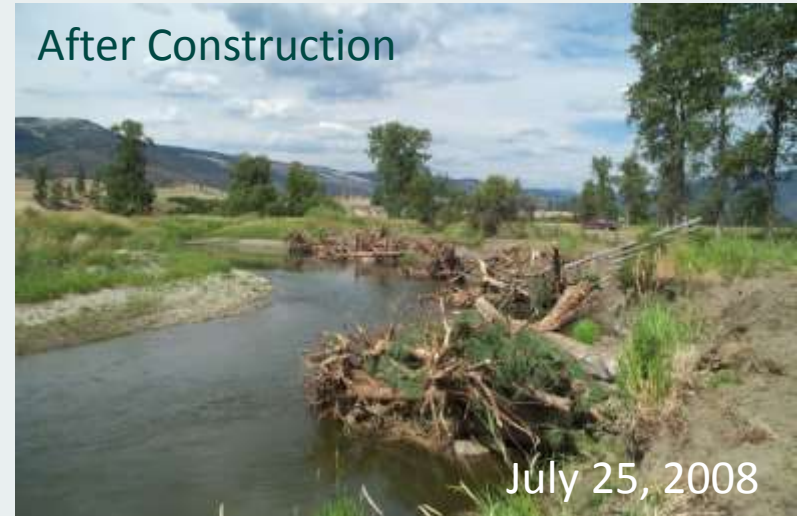
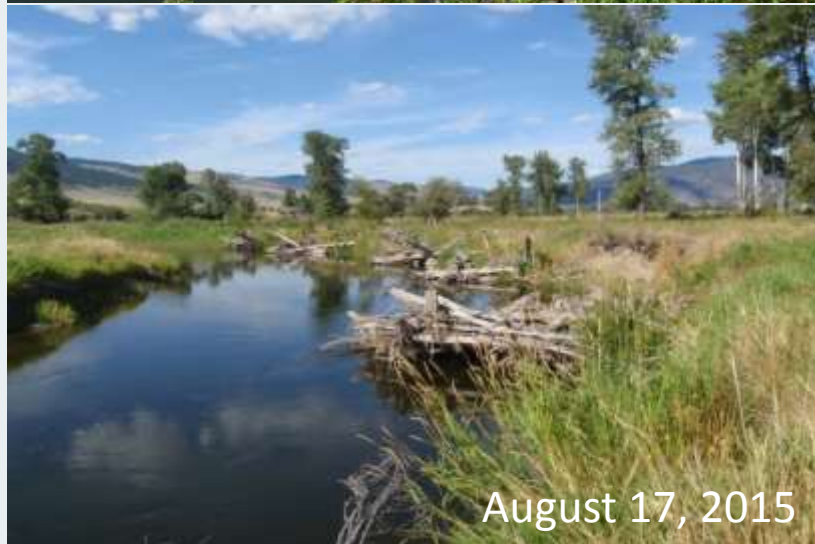
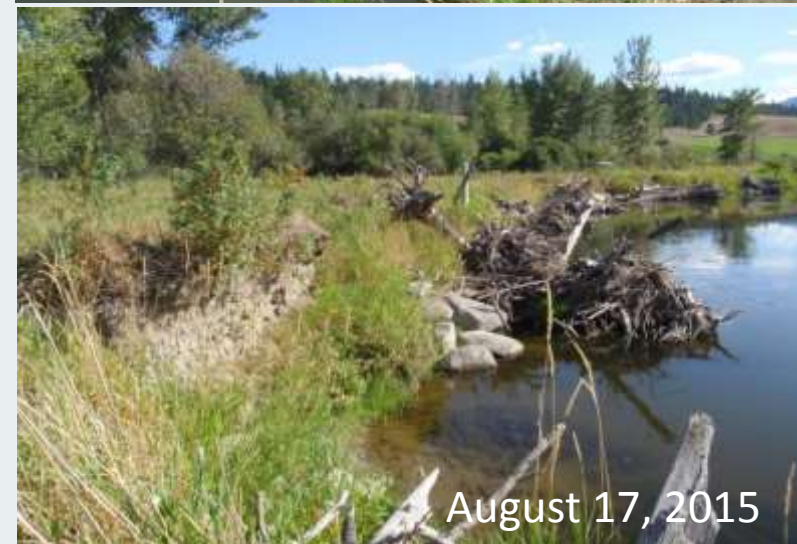
LWD Structures - Nicola River

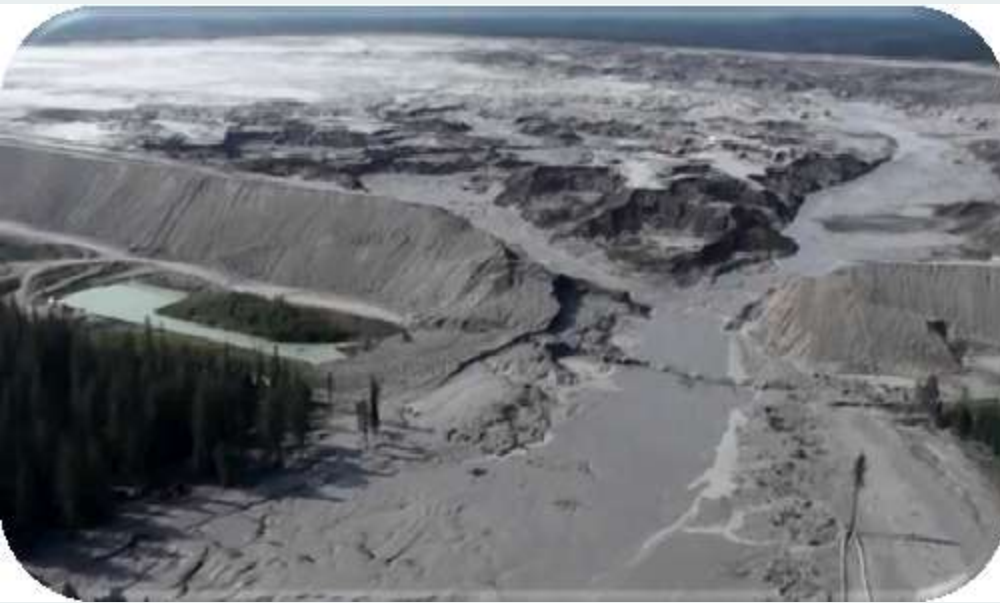
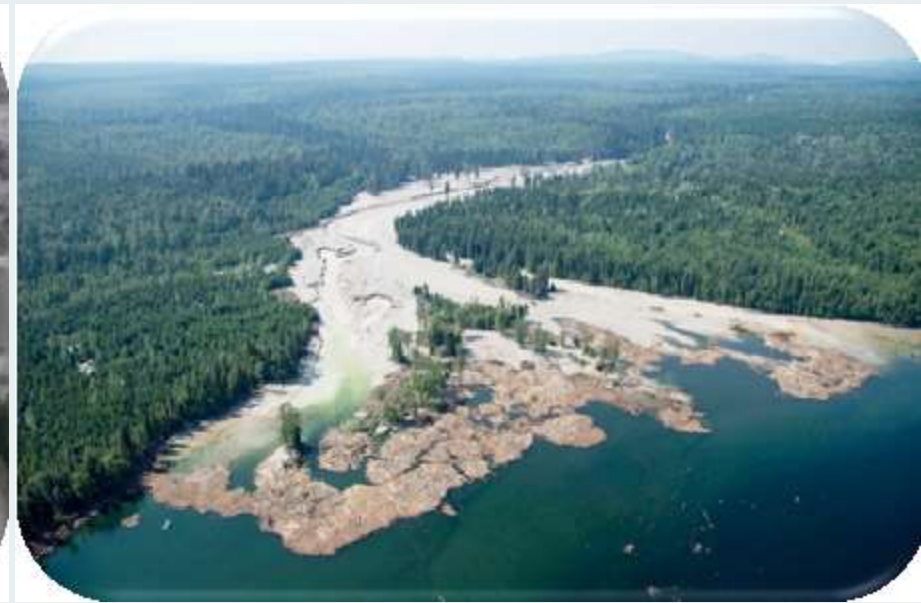
Current Challenges: Tailings Dam Breach Impacts Creek Corridor

- Flood wave from breach scoured the creek channel changing its planform and proportions of riffle, pool and glide habitats
- All of the riparian vegetation was removed

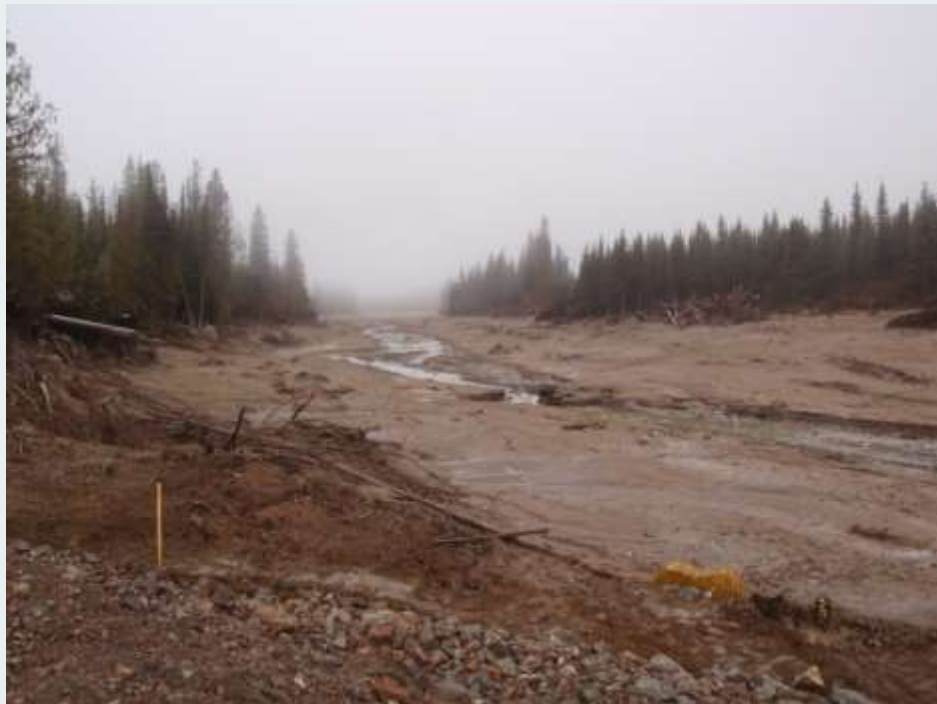
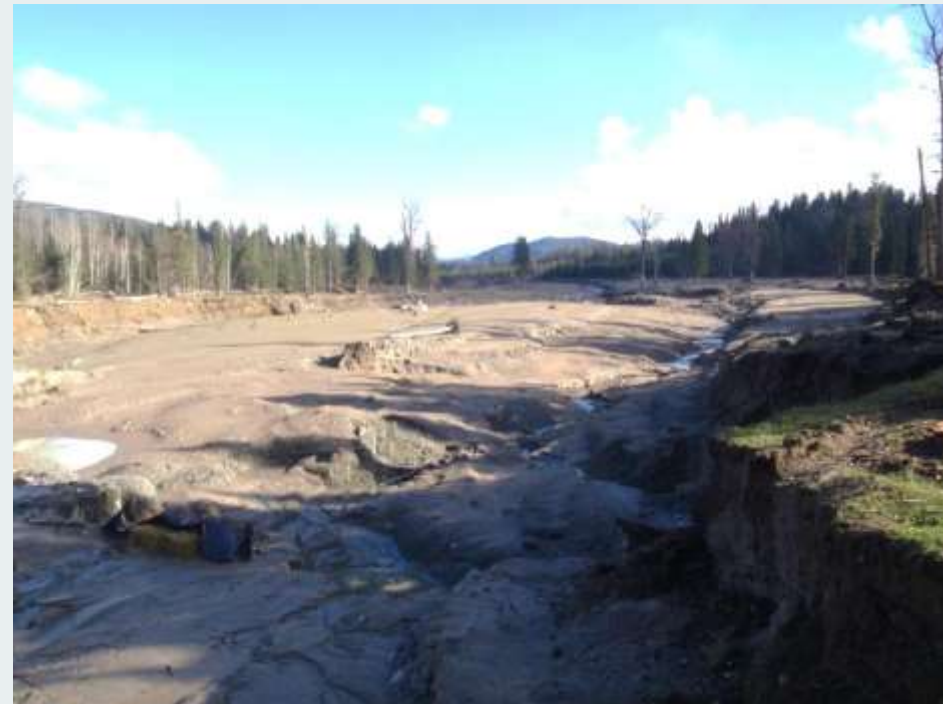
Channel & Riparian Impacts

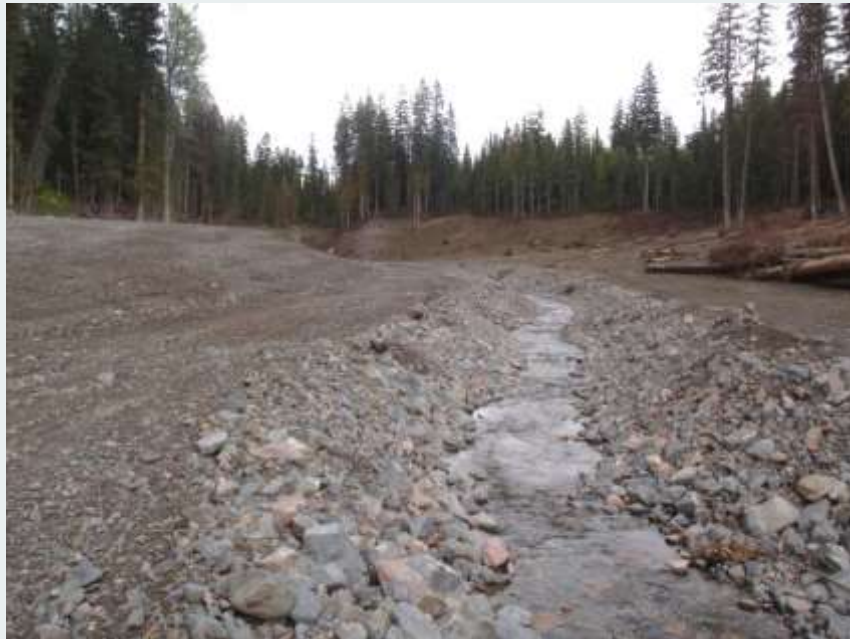
Rehabilitation Design Fundamentals

- Channel Planform & Streambed Profile to establish Riffle-Pool-Glide proportions
- Instream cover - design and siting of structures in appropriate mesohabitats

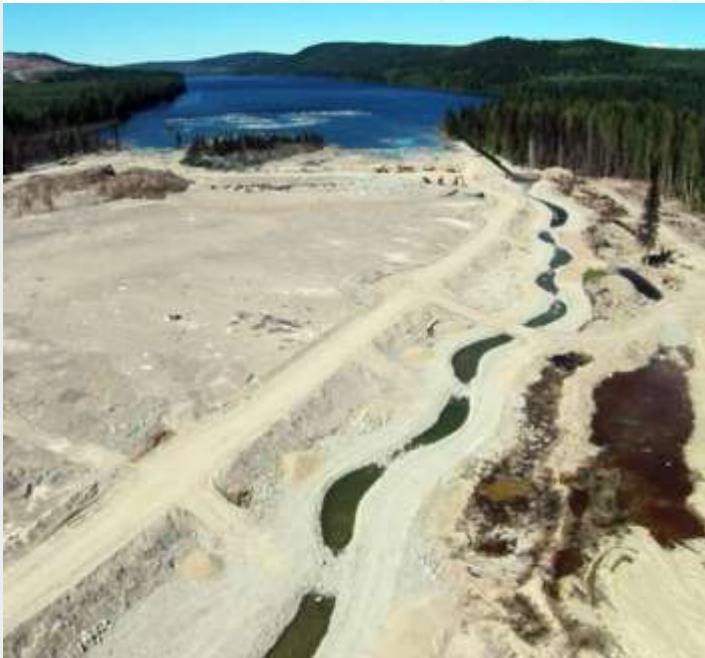
Riffle Siting

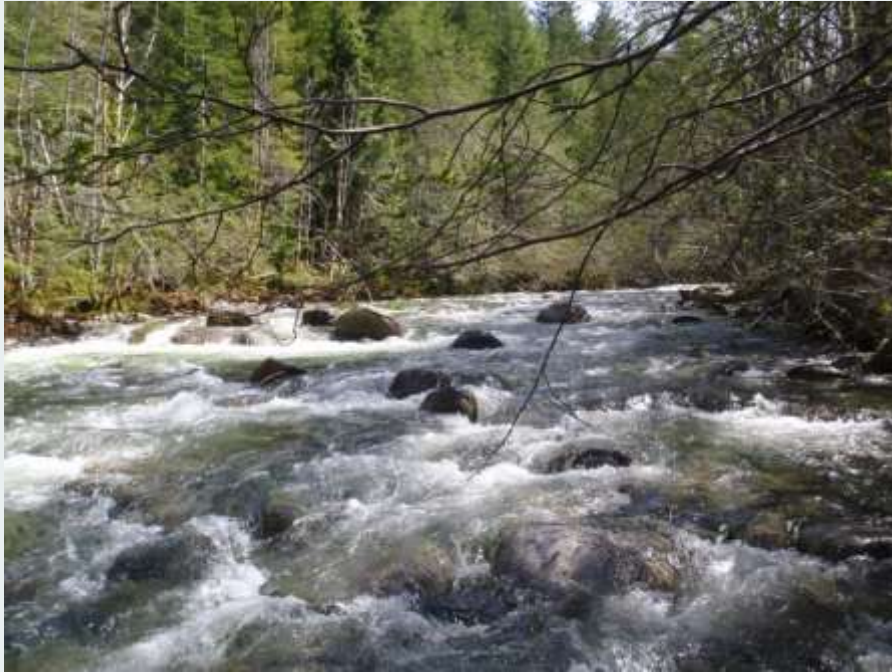
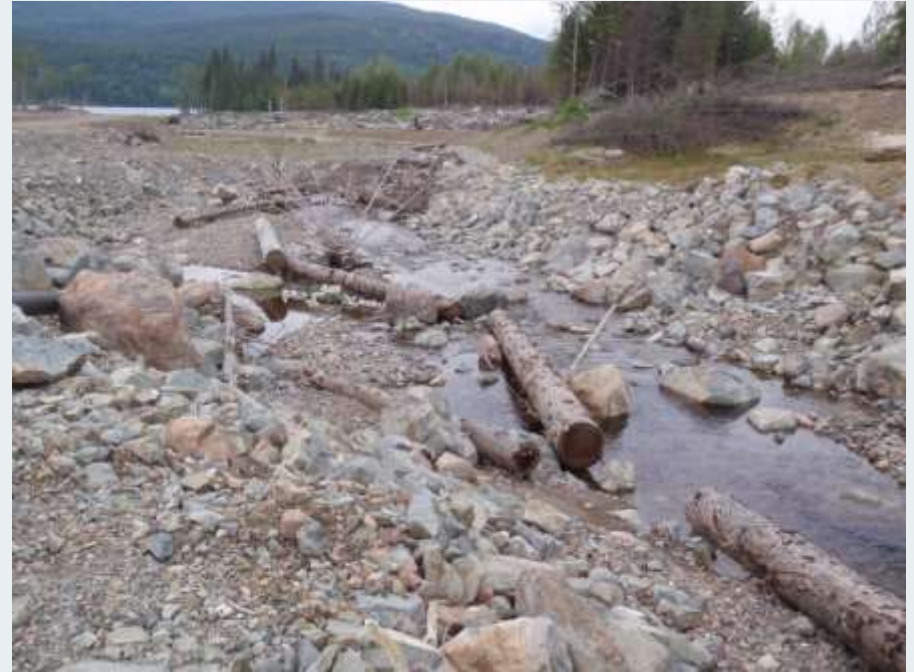
Rehabilitation Design Fundamentals

- Instream cover - design and siting of structures in appropriate mesohabitats

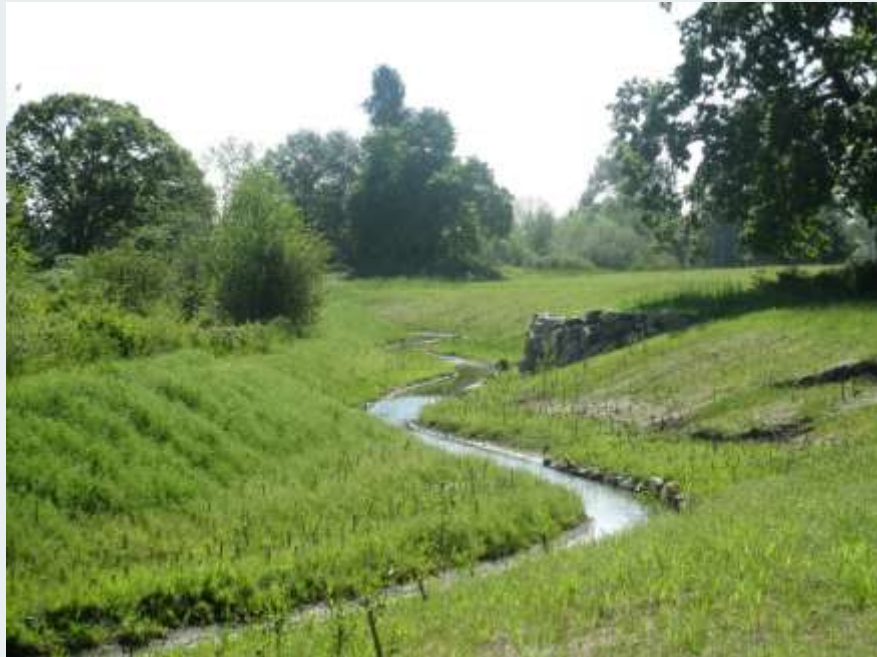
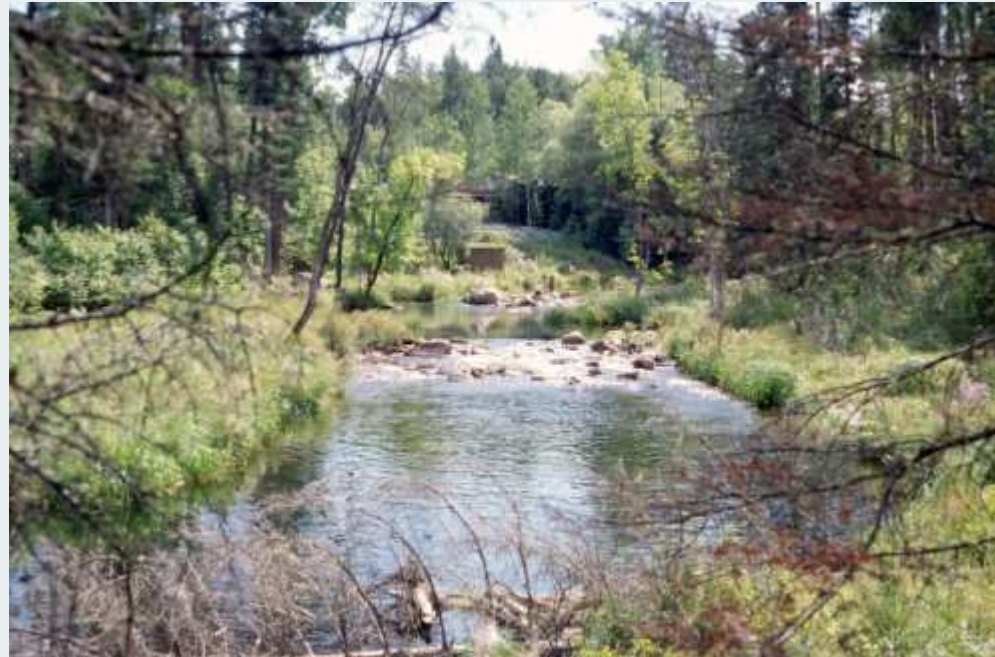
- Channel & Floodplain connectivity & flood capacities
- Substrate sizing to ensure stability during floods

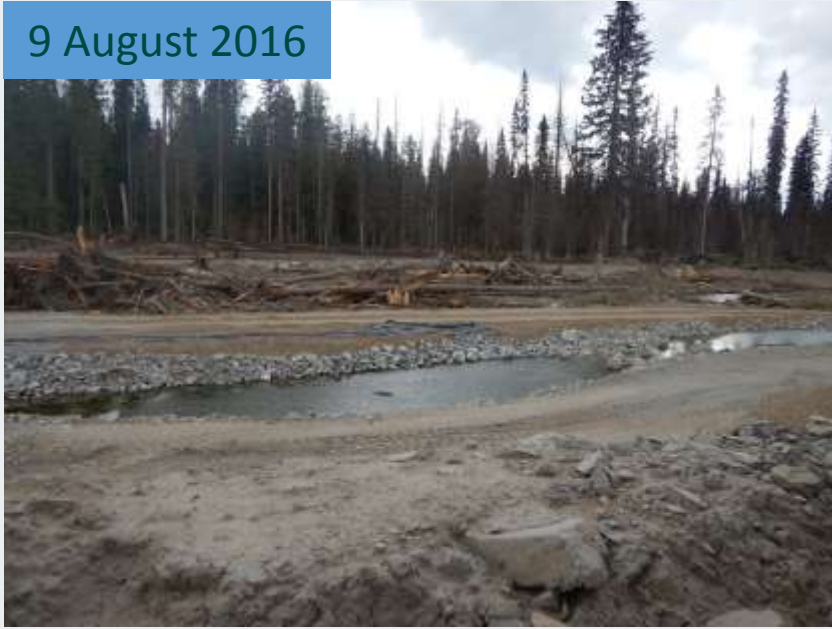
9 August 2016

Stages of Creek Rehabilitation
