# Evaluating the Effectiveness of Stream Rehabilitation Projects: Lessons Learned From 10 Years of Monitoring

Dean Young  
Toronto and Region Conservation Authority  
Sustainable Technologies Evaluation Program

Natural Channels 2016  
Niagara Fall, ON  
September 26, 2016

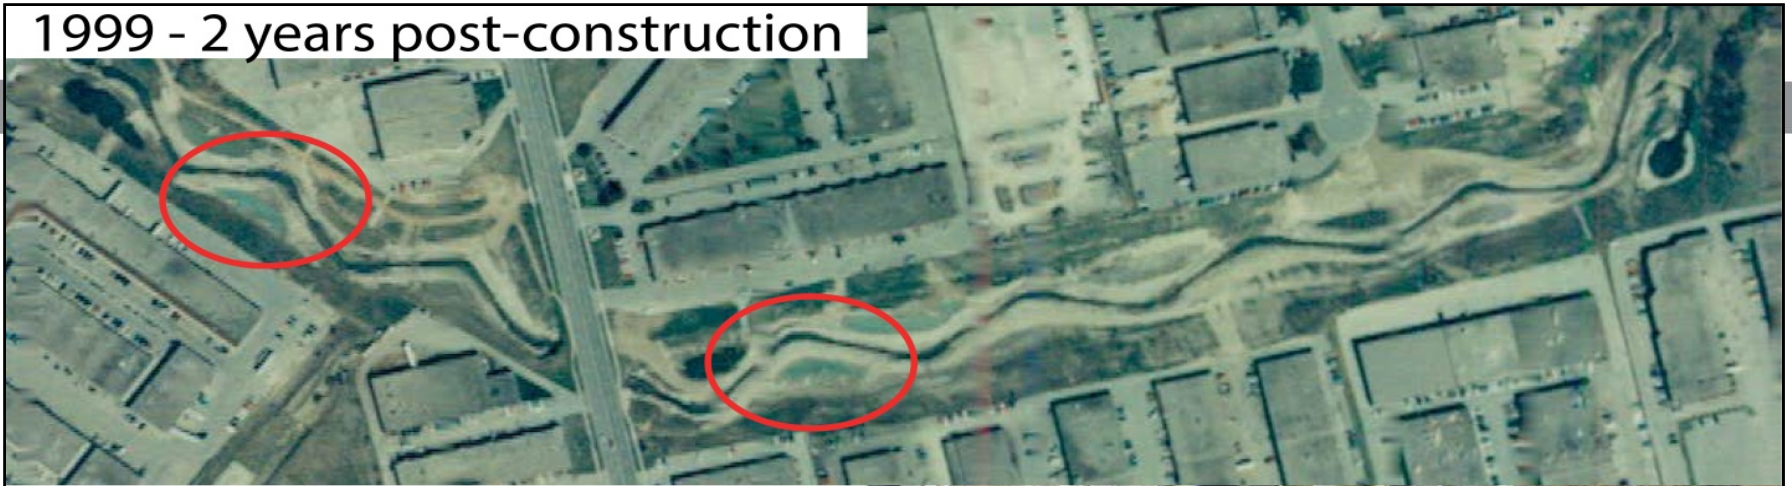
1999 - 2 years post-construction

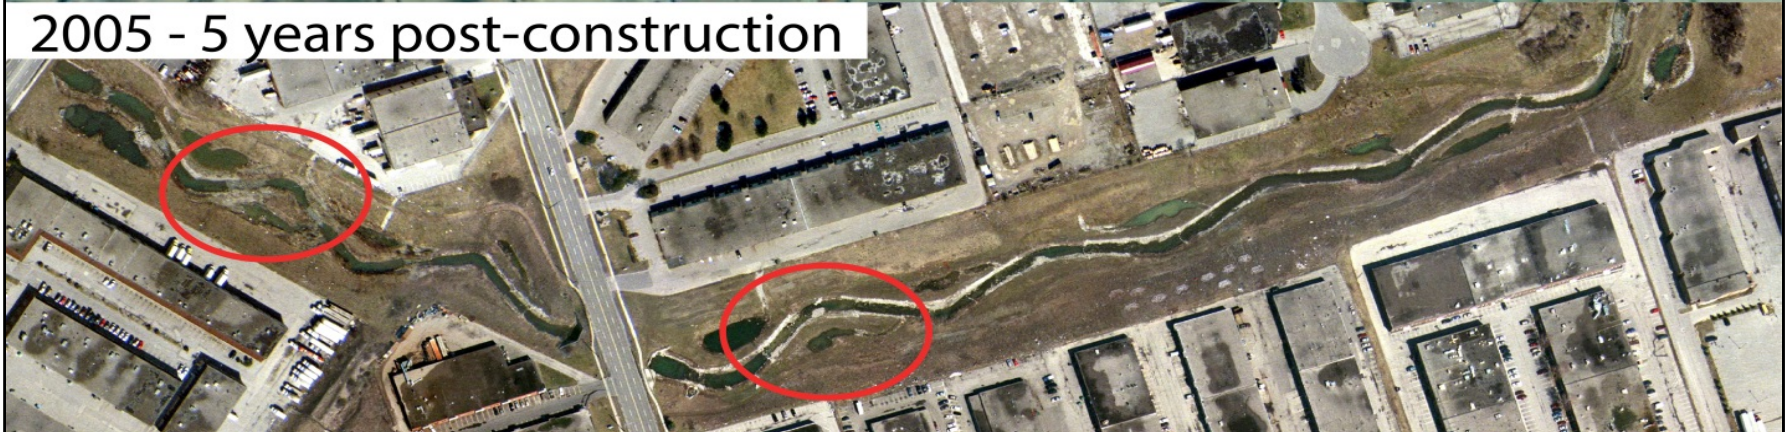
2005 - 5 years post-construction

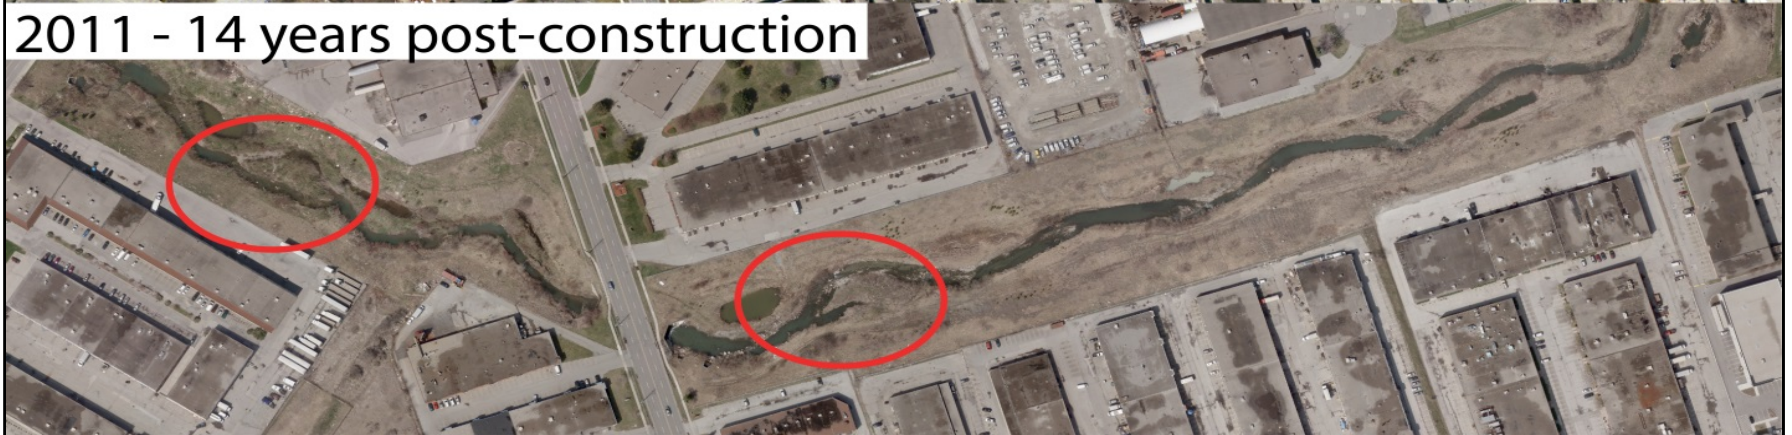
2011 - 14 years post-construction

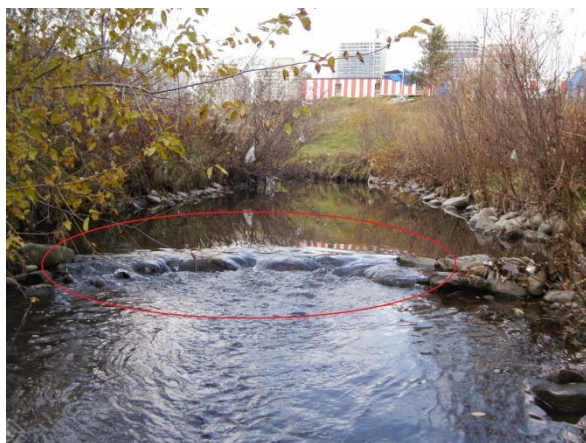
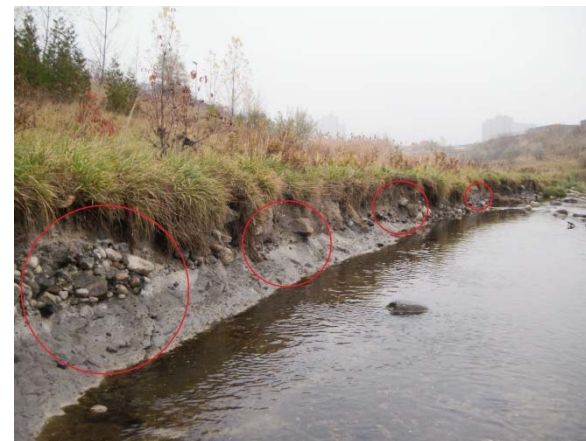
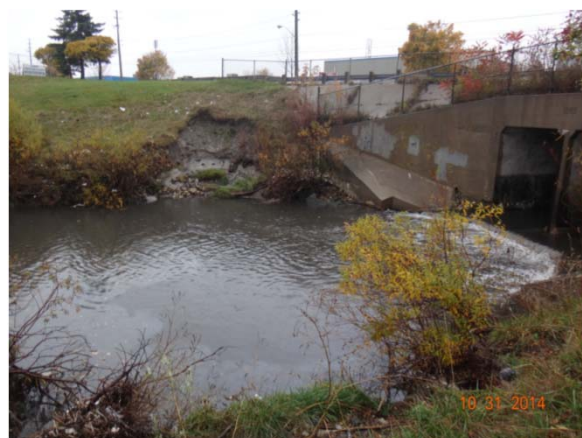
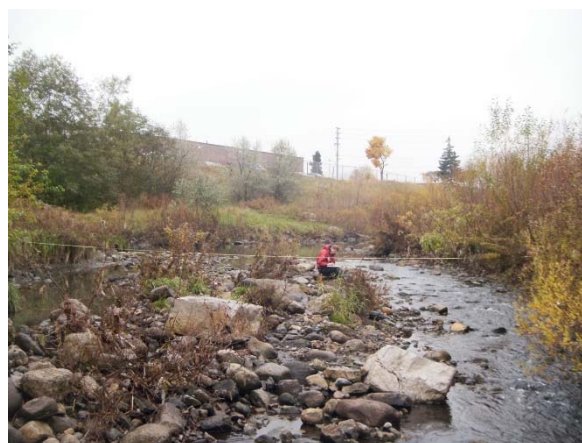
# Photographic surveys

# NCD 5 – Highland Creek, Toronto

| Site | SWM Controls | Age* | Channel State (RGA) | Active Processes | Substrate - Temporal |
|---|---|---|---|---|---|
| NCD 5 | No | 14 | In Adjustment;<br>Entrenchment | Widening; Degradation & Aggradation | Similar |

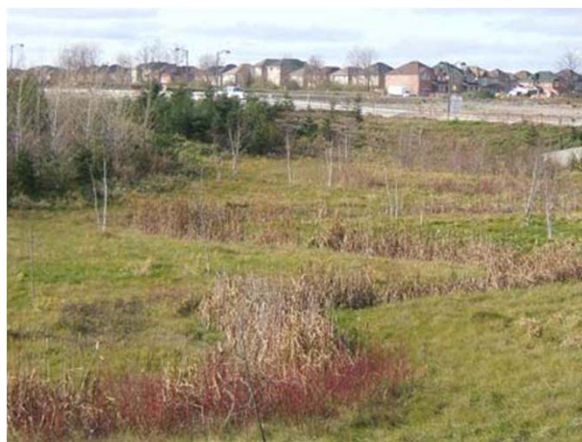
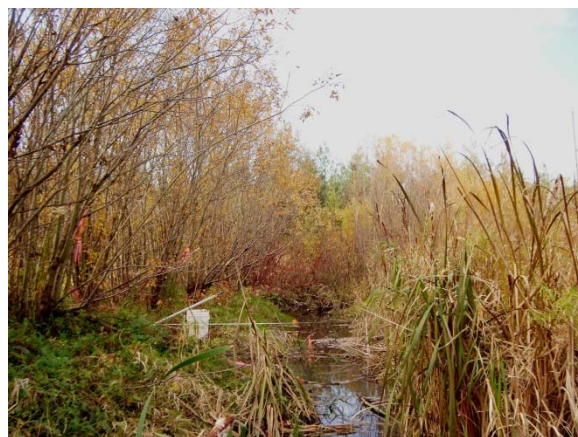
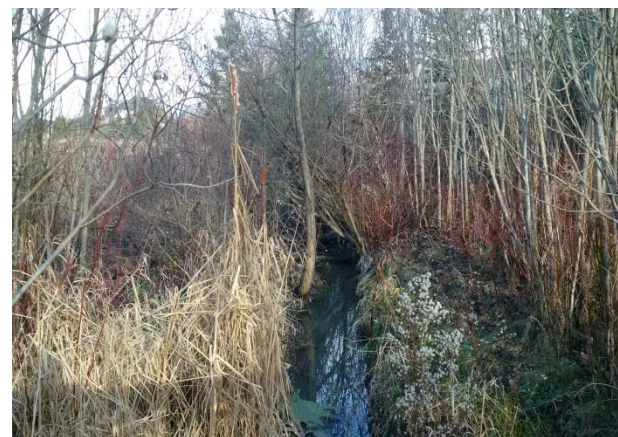
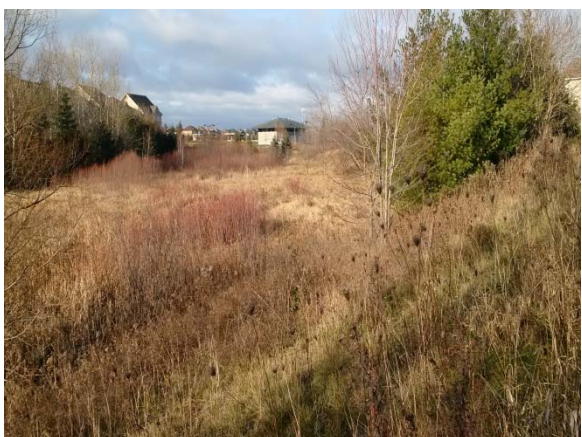
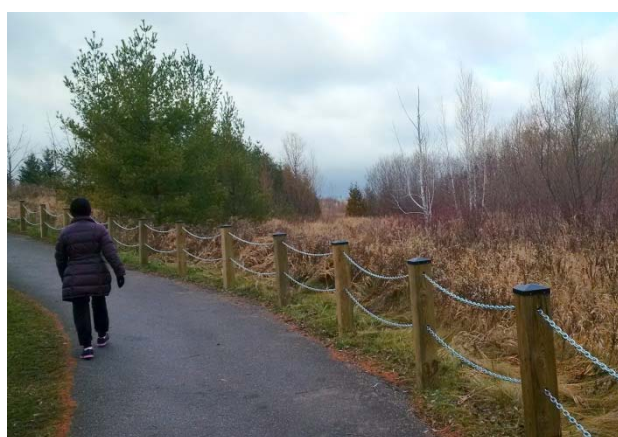
## Photographic surveys

| Site | SWM Controls | Age* | Channel State (RGA) | Active Processes | Substrate - Temporal |
|---|---|---|---|---|---|
| NCD 13 | Part | 11 | In Transition;<br>Entrenchment | Widening; Degradation | Coarser |
| NCD 20 | No | 10 | In Transition;<br>Entrenchment | Widening; Degradation | Coarser |

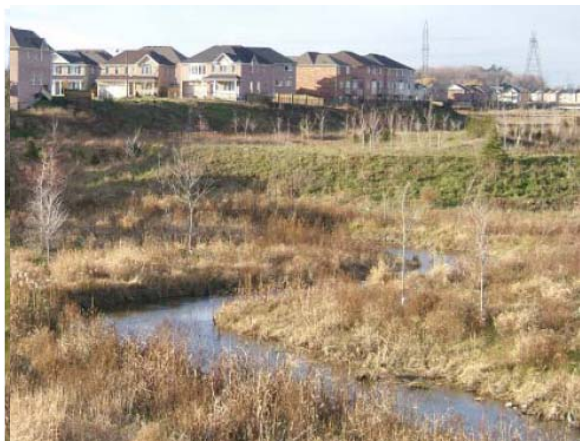
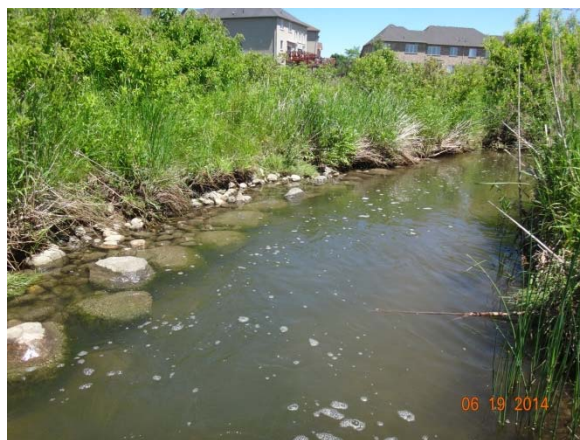
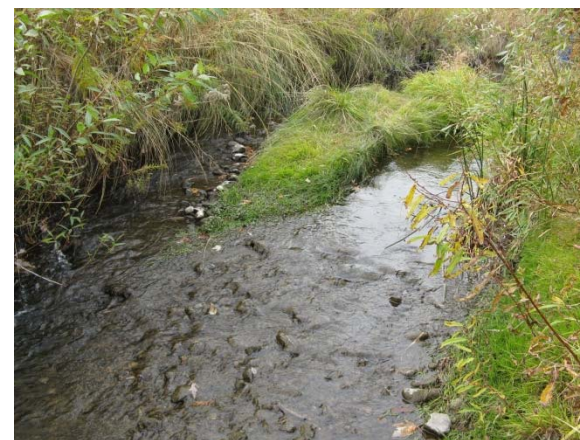
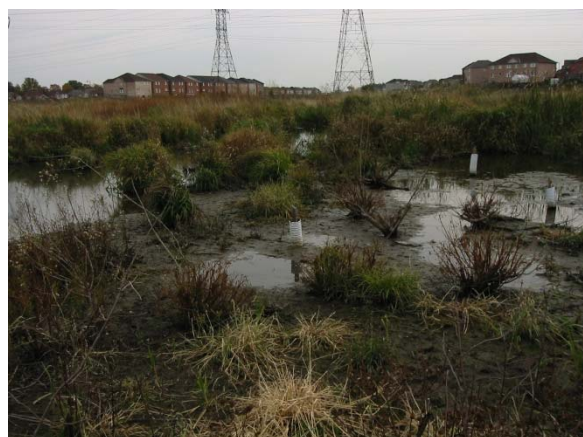
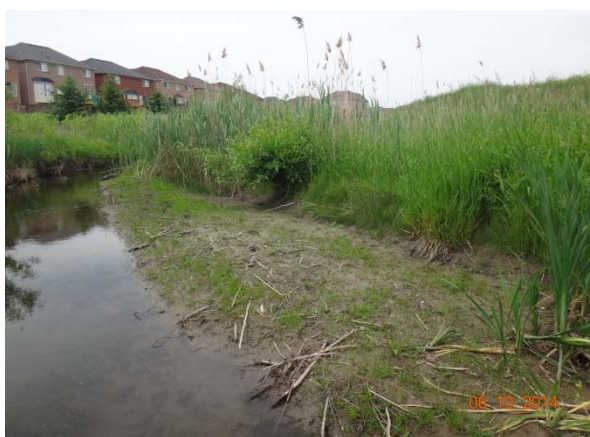
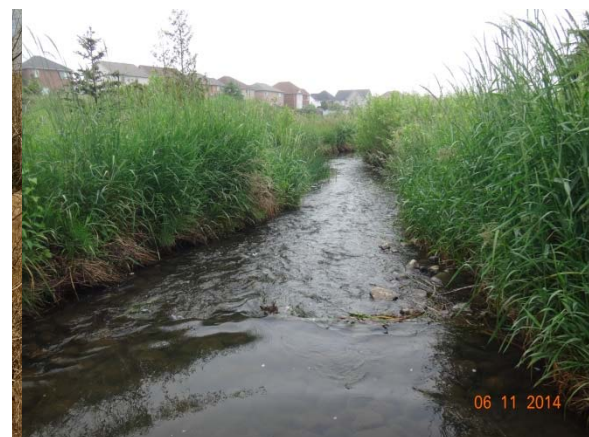
## Photographic surveys

| Site | SWM Controls | Age* | Channel State (RGA) | Active Processes | Substrate - Temporal |
|---|---|---|---|---|---|
| NCD 21 | No | 10 | In Adjustment;<br>Entrenched | Widening; Degradation | Similar |
| NCD 30 | No | 8 | In Transition;<br>Entrenchment | Widening; Degradation & Aggradation | Finer |

- All (4) channels with no SWM quantity & quality controls upstream were found to be still in transition & entrenched, or in adjustment 10 to 15 years post-construction;
- Bank failures more common where herbs & grasses are the only vegetation cover types;
  - Supplemental bank treatments/plantings to establish deeply rooting shrubs & trees in problem areas;
- All (5) channels with catchments serviced by SWM quantity & quality controls were found to be in-regime or in-transition but not entrenched 10 to 15 years post-construction;
