# **Avonhead Creek Daylighting Project: characterizing flow for natural channel design**

Natural Channel Design Conference

September 27, 2016

By Karen Chisholme and Jayeeta Barua

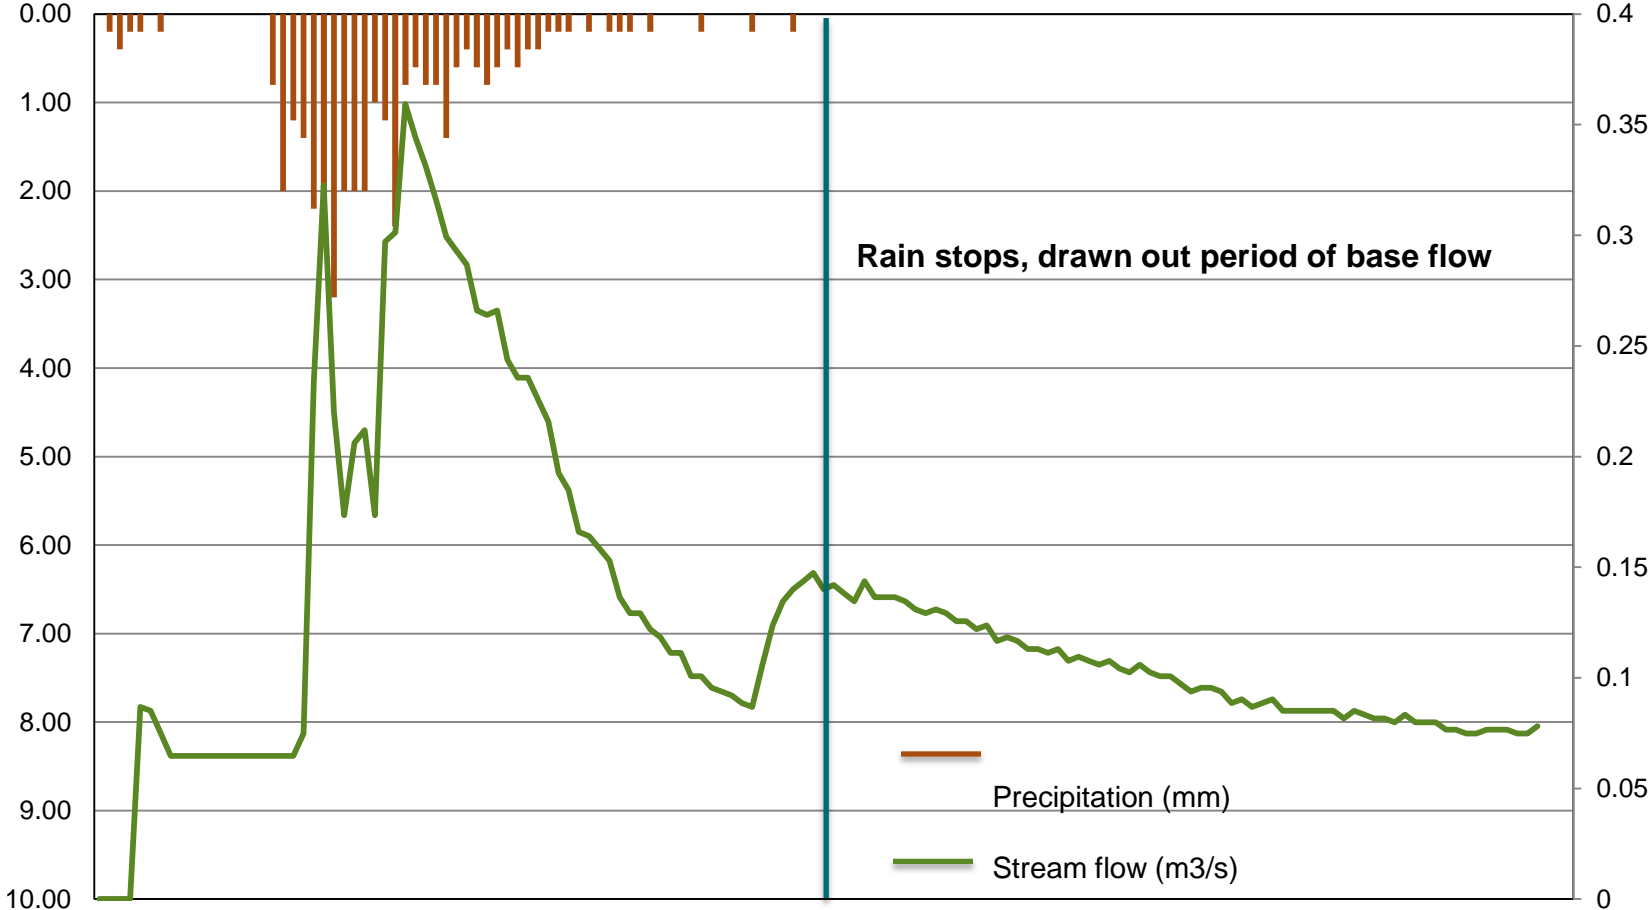
## Sept 29th Event

# Flow Observation

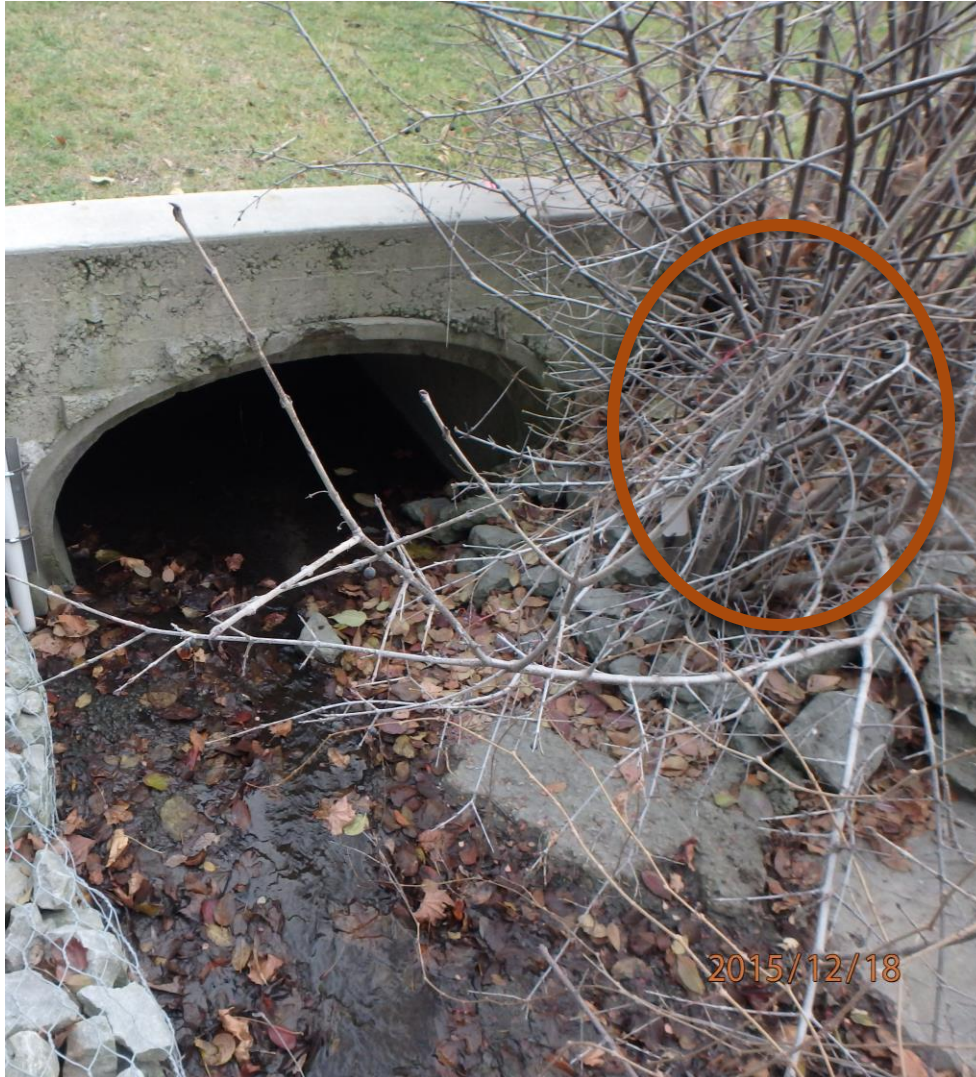
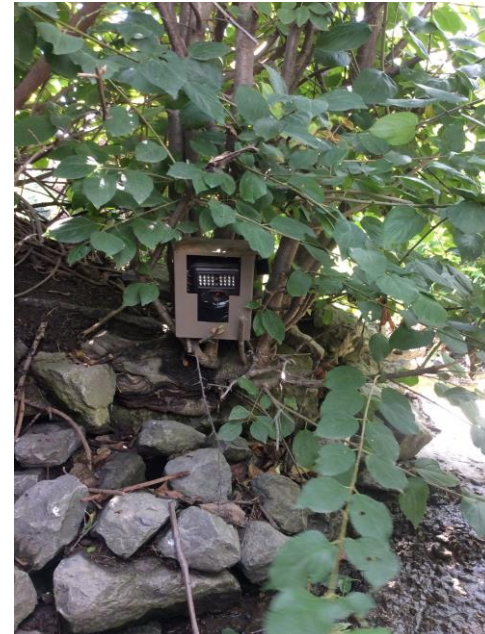
- Camera installed captures images every 5 minutes
- Ground-truth monitoring data and utilized for QA/QC

- Traditional flood models can over estimate discharge for lower return period flows (in this case 3 times higher)
- Robust monitoring programs can shed insight into the complex hydrology/hydraulics of urban creeks
- Time lapse photography can be helpful in verifying the monitored data
- Continuous stream flow records can be utilized to perform flow frequency analysis to estimate design flow

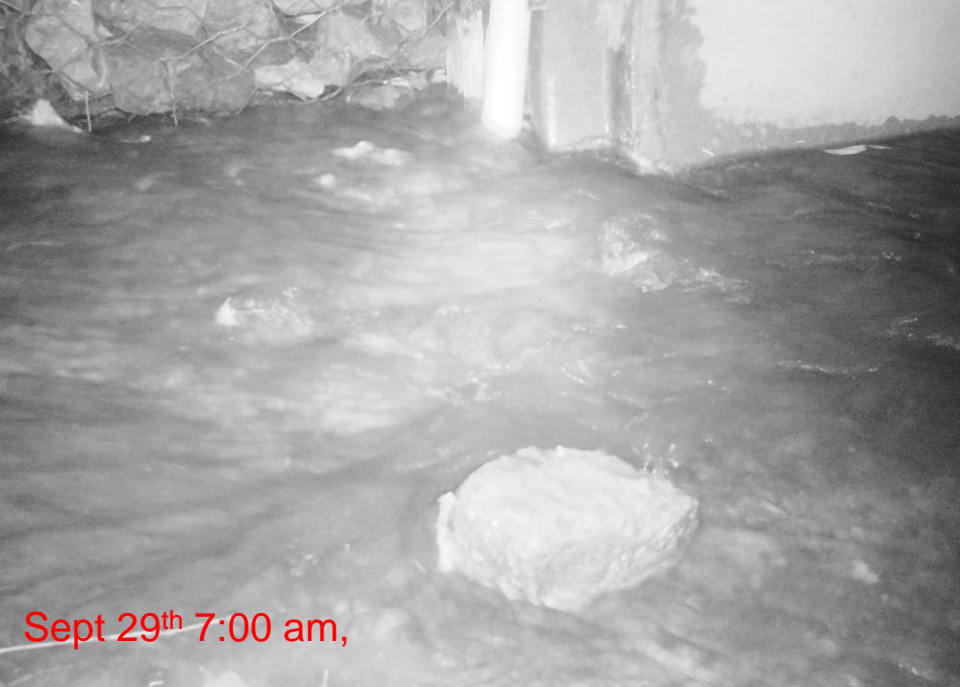
Sept 29<sup>th</sup> 7:00 am,

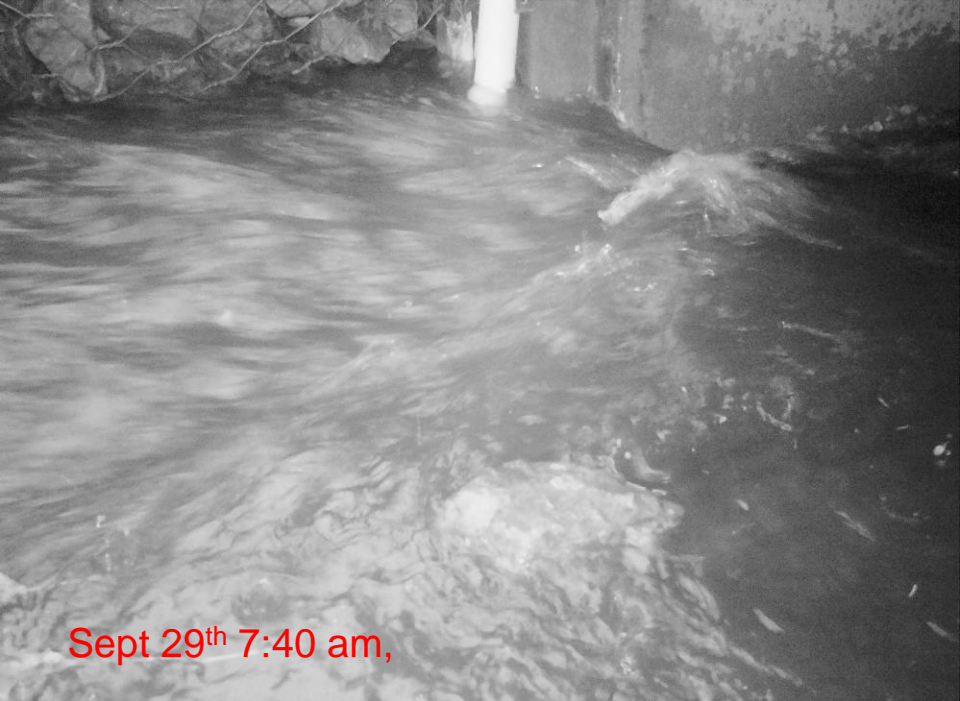
Sept 29<sup>th</sup> 7:40 am,

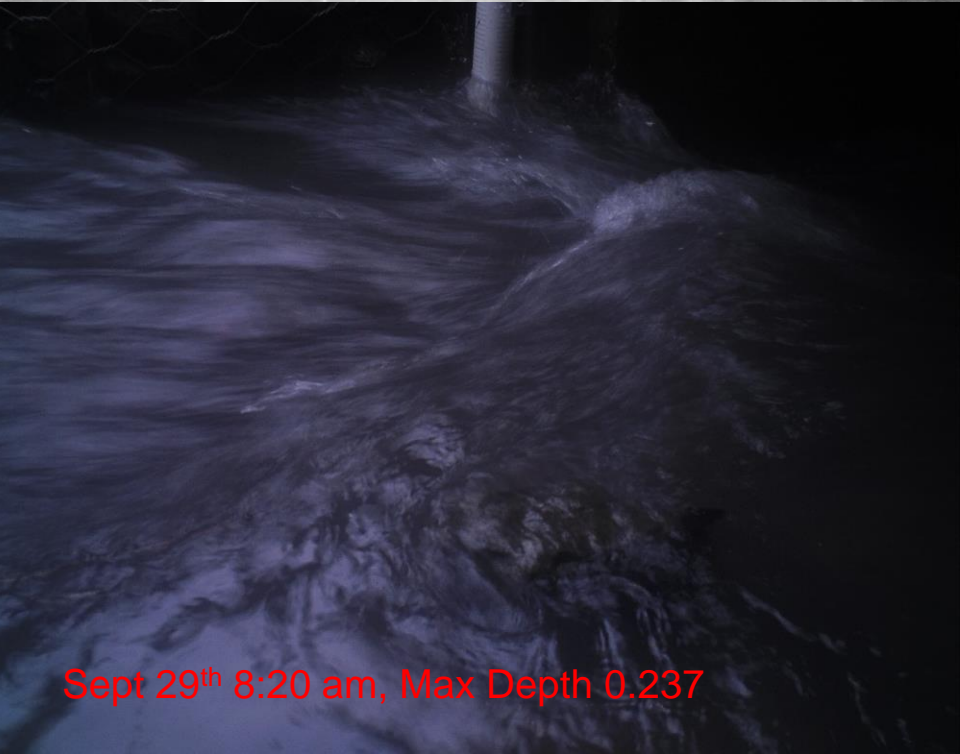
Sept 29<sup>th</sup> 8:20 am, Max Depth 0.237

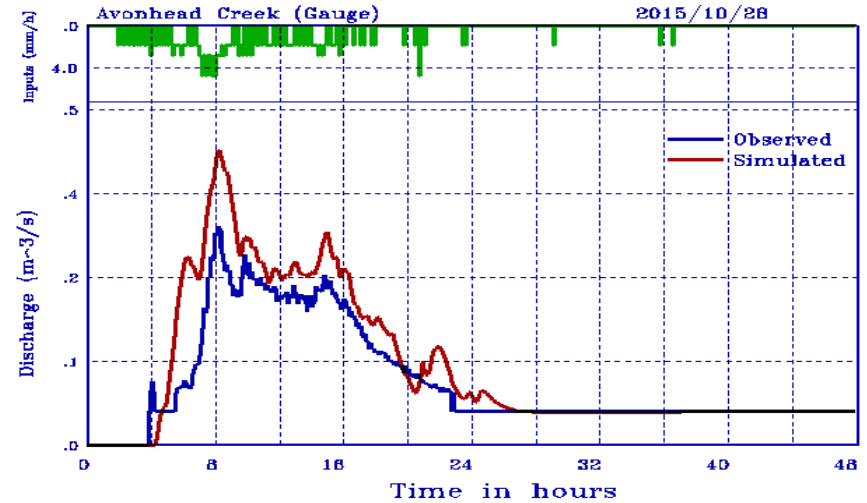
- Utilize the stream flow data available to calibrate a watershed model for Avonhead Creek in GAWSER
- Run simulations with long term data (60 years of rainfall data)

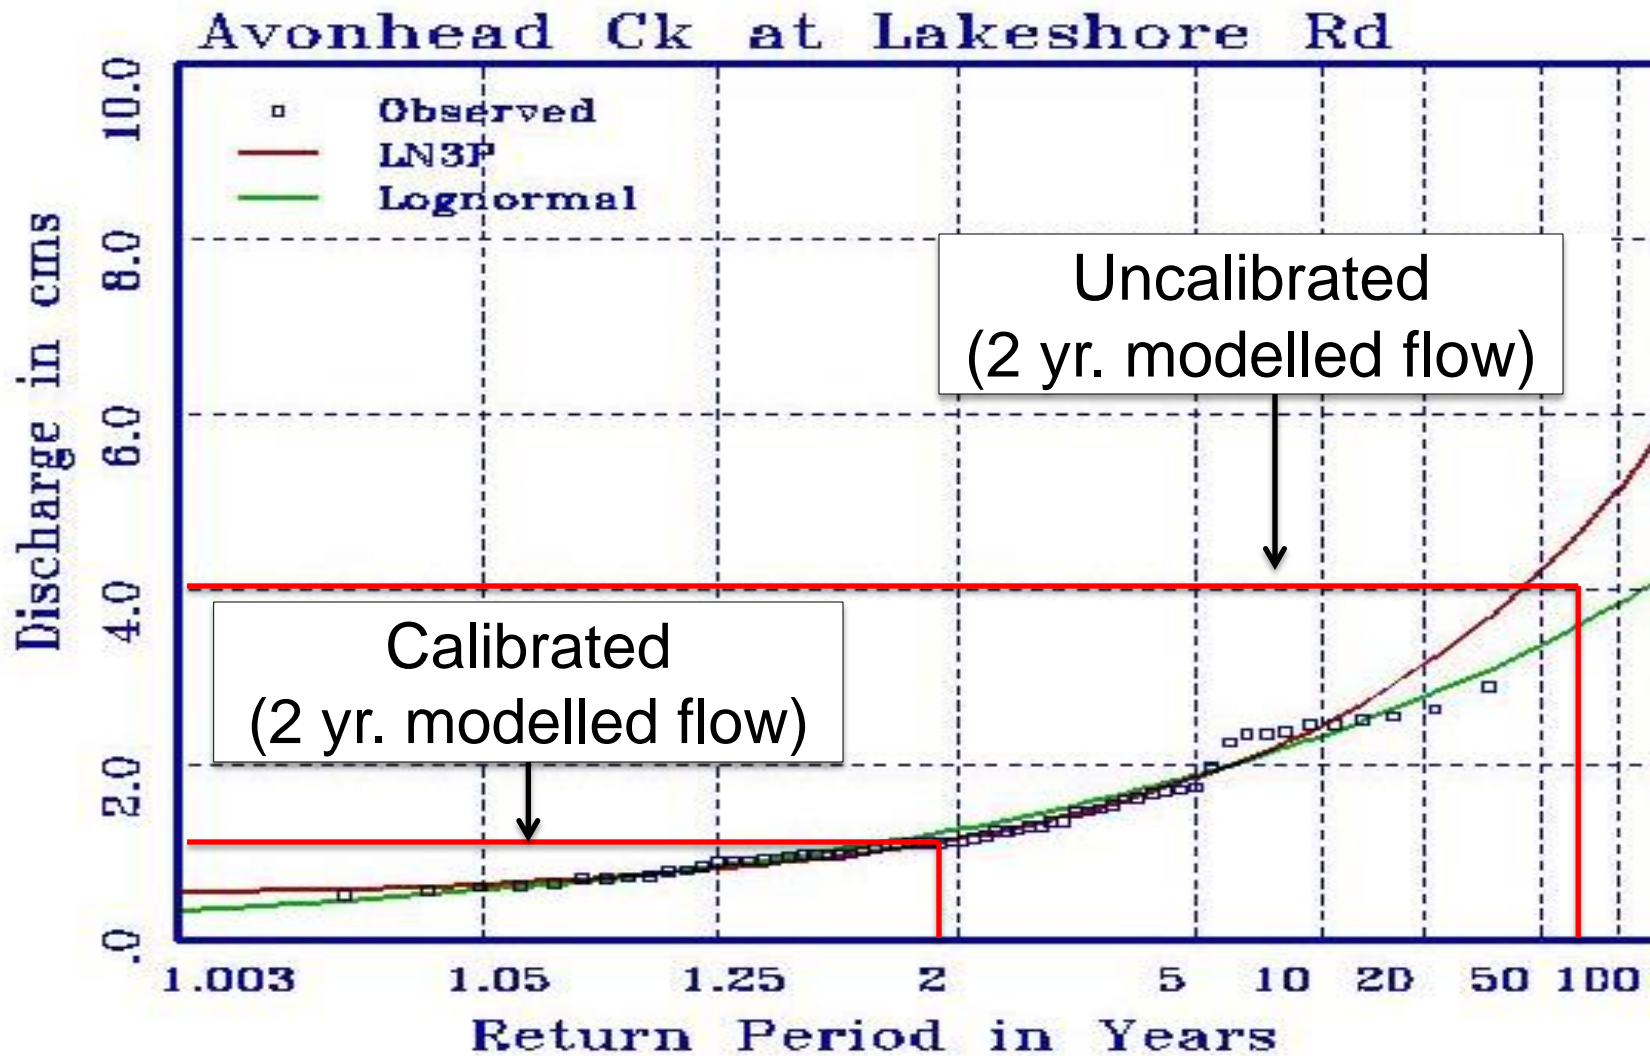
# Flow Frequency Analysis

Return period	Existing Uncalibrated Model (m <sup>3</sup> /s)	Calibrated Model with monitoring data (m <sup>3</sup> /s)
1.005 yr.	-	0.36
1.05 yr.	-	0.55
1.25 yr.	-	0.82
60 % of 2 yr. <i>(design flow)</i>	2.4	0.75
2 yr.	4.0	1.2
5 yr.	6.7	1.8
10 yr.	9.5	2.3
50 – 100 yr.	12- 15	~ 4.0

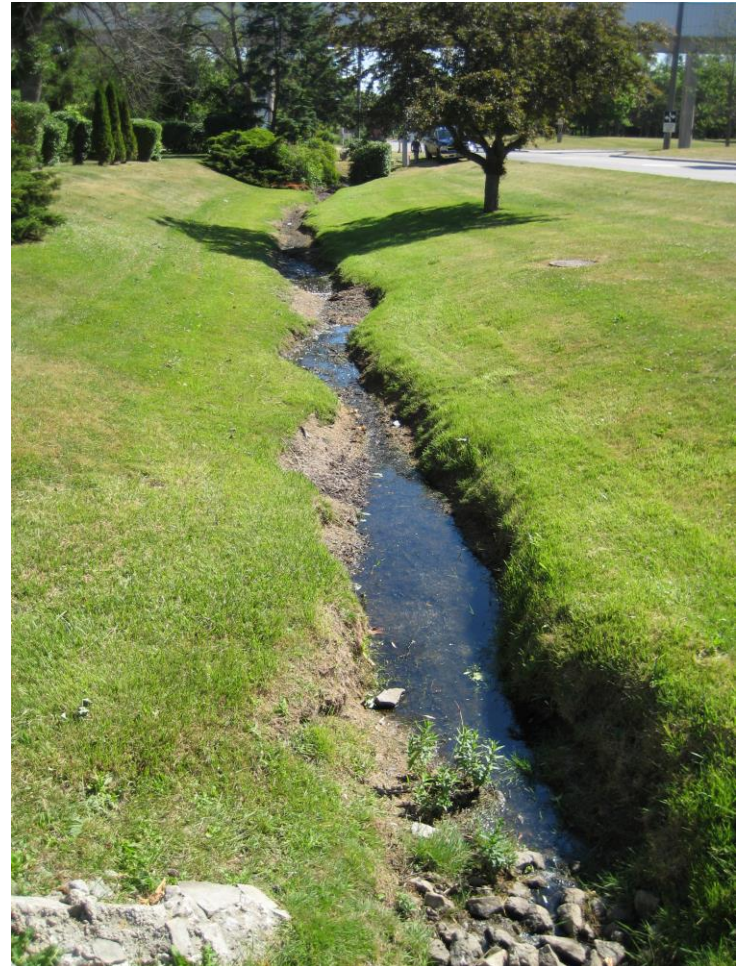
- Survey data for upstream reach
- Visual observations of erosion indicative of flows experienced (measured)
- Manning's equation and Flowmaster used to estimate discharge
  - $Q = 0.50 \text{ m}^3/\text{s}$
