# Examining Slope Instability on a Small Bank Slope Along the Schoharie Creek in New York State

Authors: Dr. Jaclyn Cockburn, Matthew  
Vetta M.Sc, Dr. John Garver

Natural Channels Conference 2018

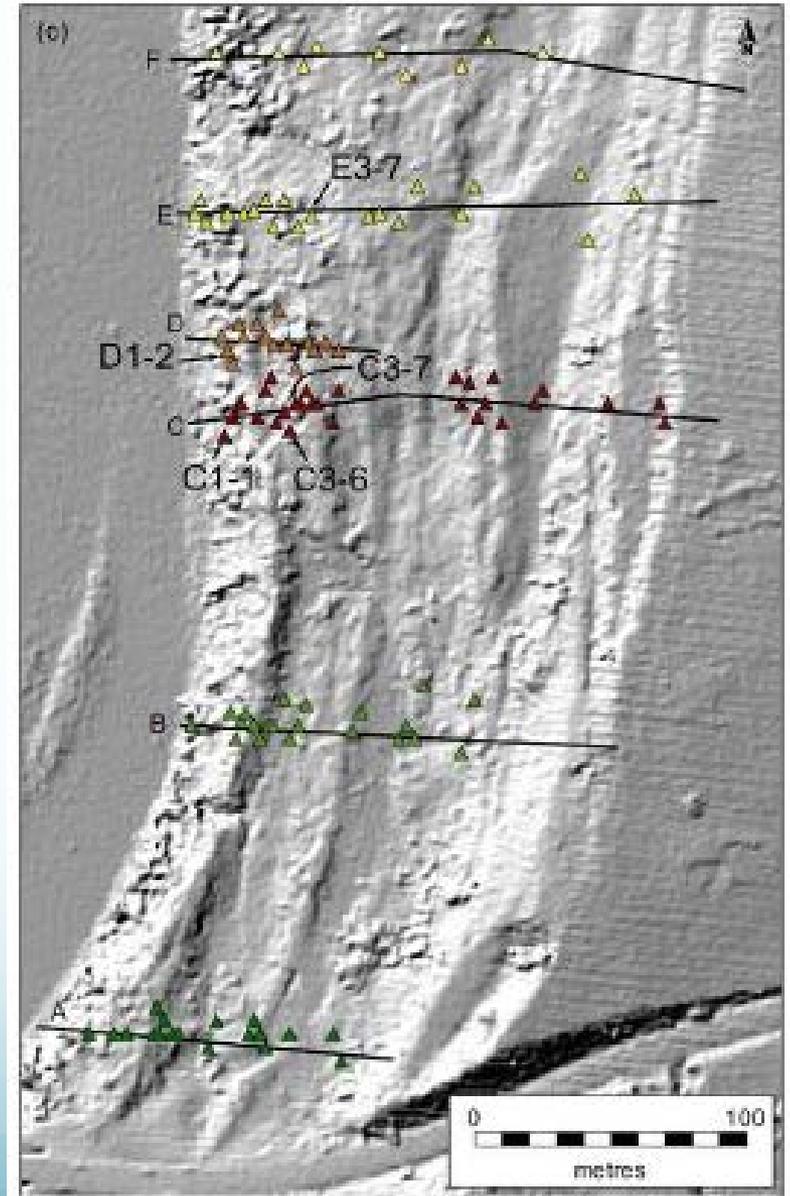
# Sampling Strategy

- Trees were sampled within 10m from either the north or south of each transect line
  - 2-3 trees per slope unit, most sampled was 8
- Fix to sample the largest trees possible

Oldest tree → 1731  
(Transect C)

Youngest tree → 1976  
(Transect B)

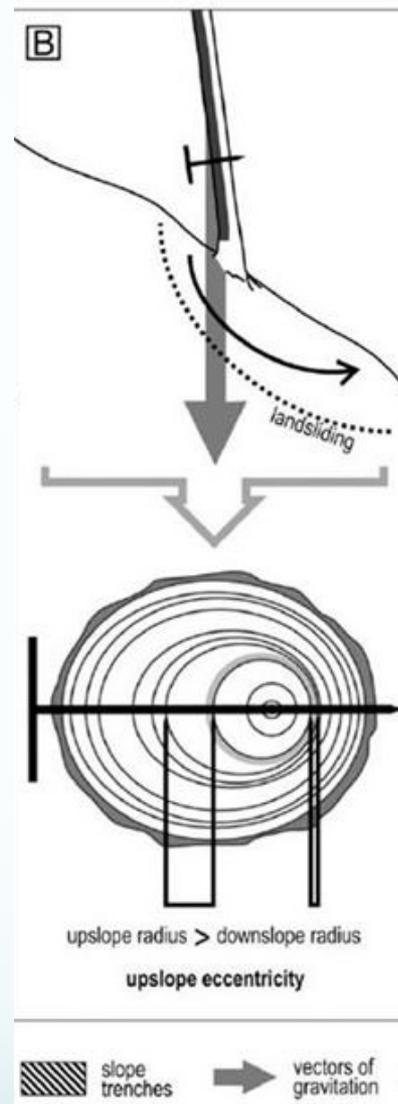
(Wistuba *et al.*, 2013; Figure 4)

# Tree Ring Growth Anomalies

- Two growth anomalies identified:
  - Growth eccentricity
  - Reaction wood
- Catalogued the absence/presence of reaction wood

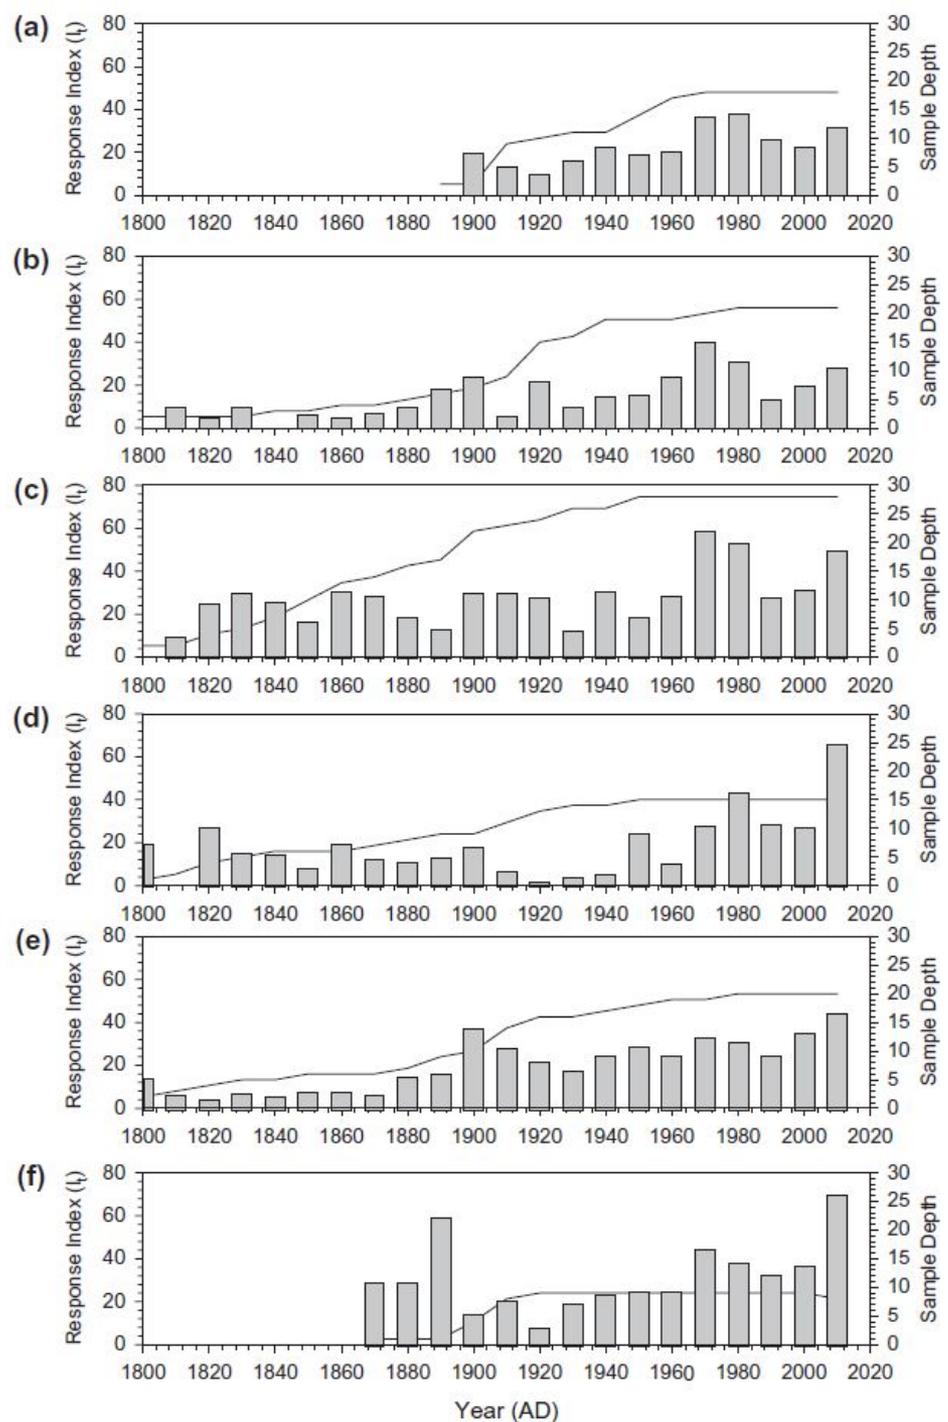
# Assessing Frequency Patterns

- Frequency records indicate a greater occurrence in instability from 1969 to present
- Response to stress is synchronous both across the entire study site and within each transect during different periods

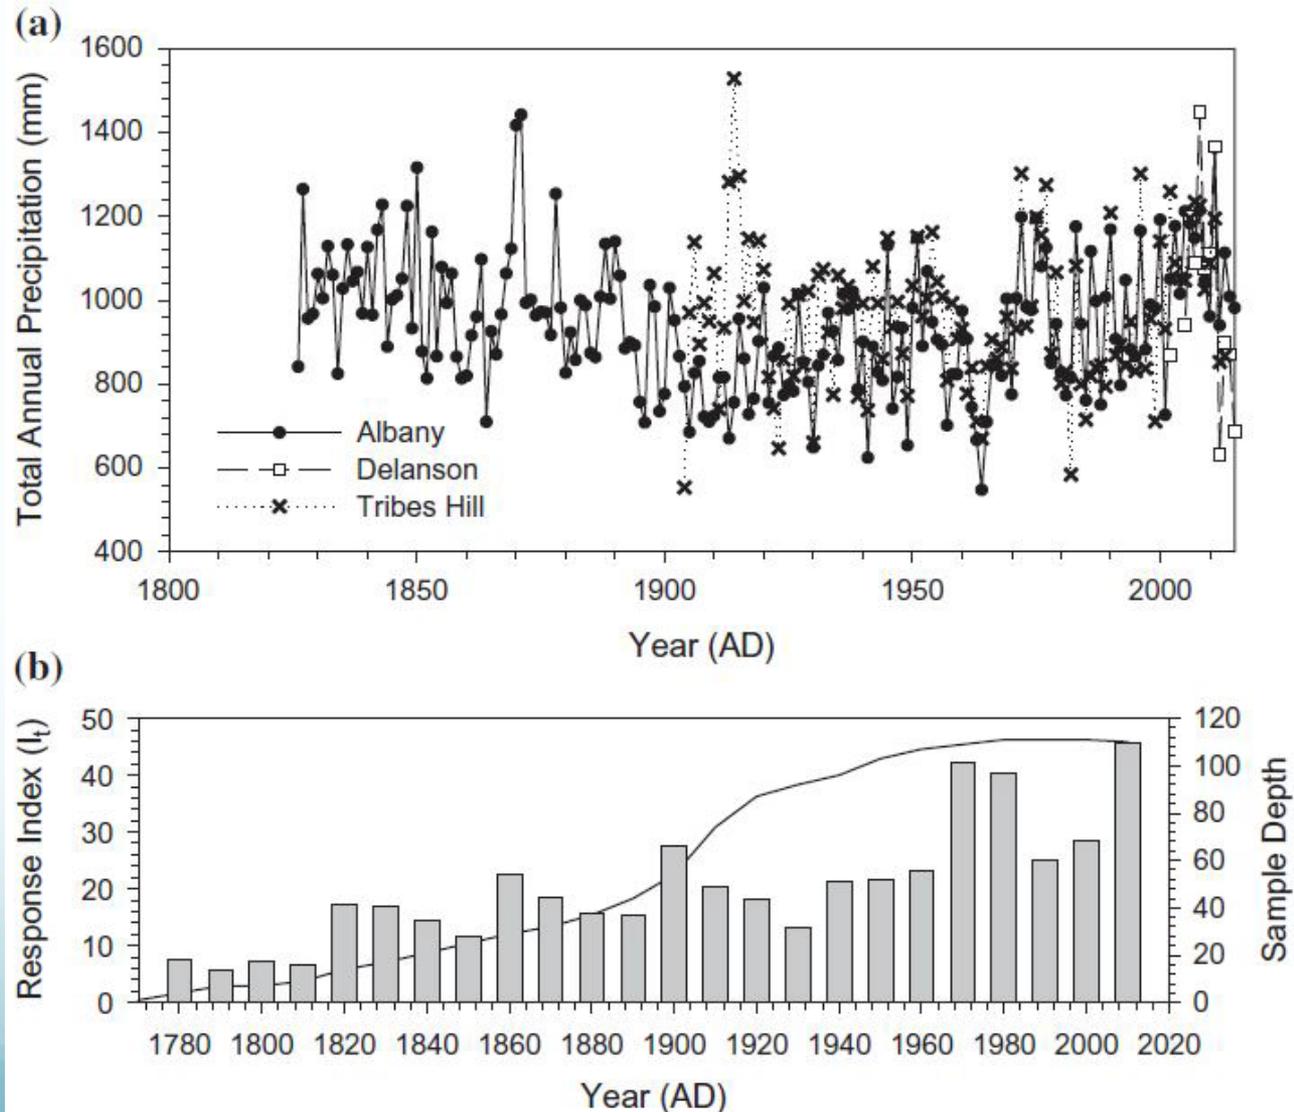
# Linking Slope Instability with Precipitation

- Statistically significant positive trend (using a Mann-Kendall test) was found for the response index for 1960s to present.
- 1960s coincides with the end of a regional drought and the beginning of a significant wet period in the 1970s.

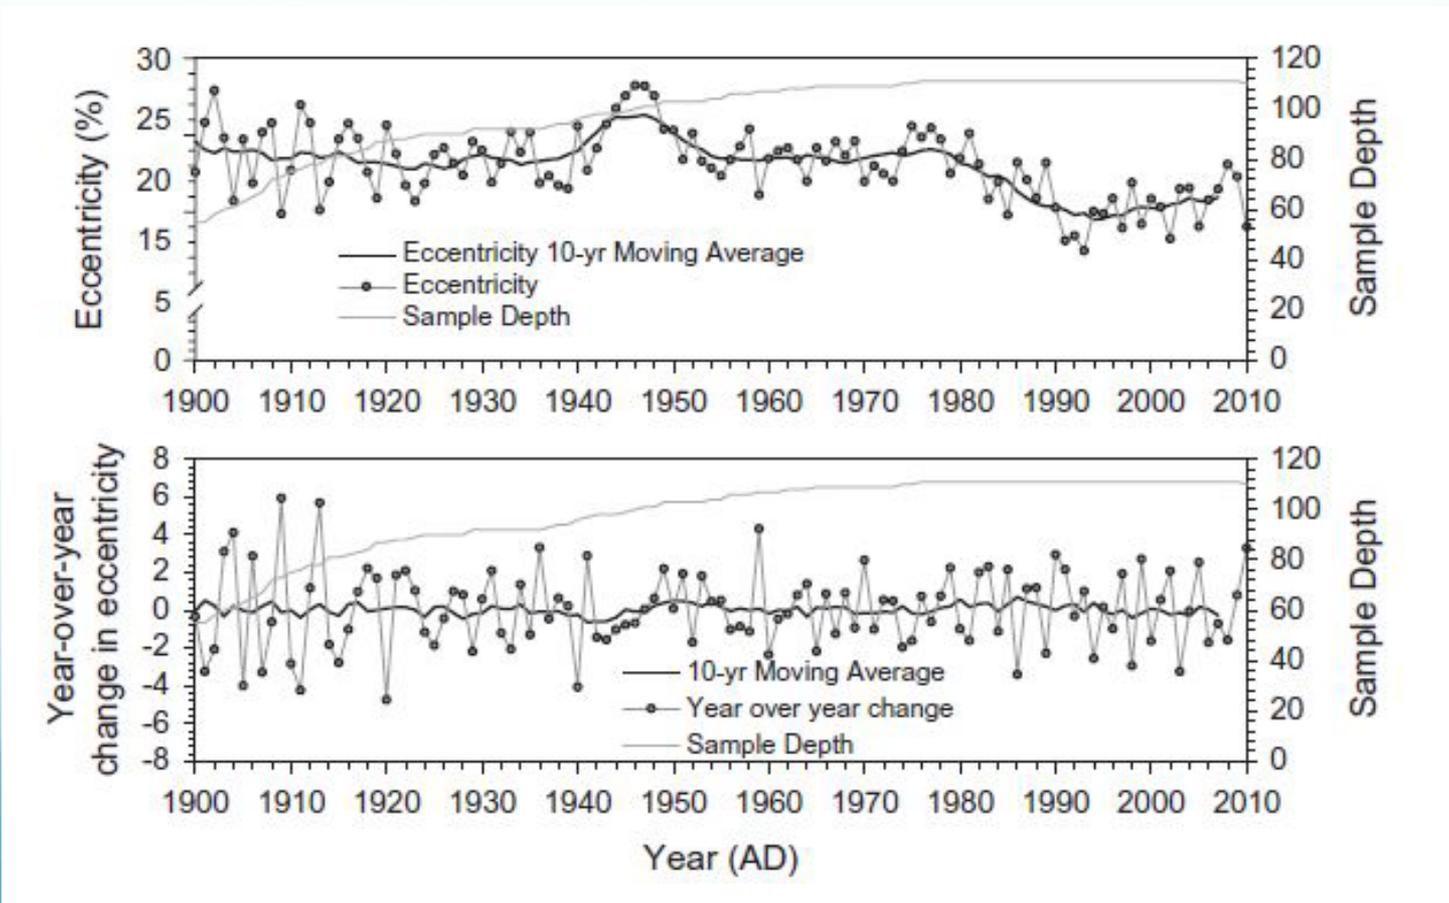
# Assessing Patterns in Magnitude

- Average eccentric growth over the entire site does not correlate with temporal trends observed in response index

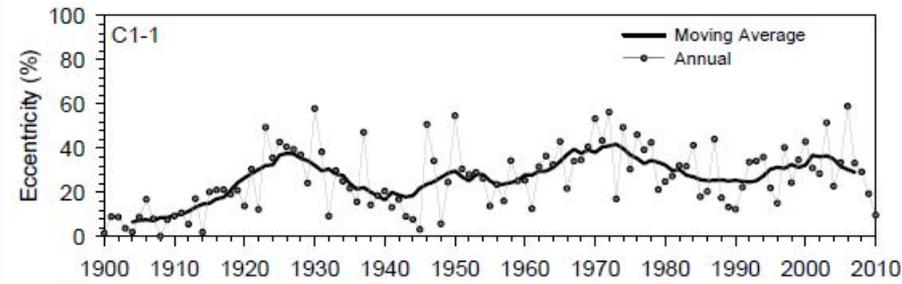
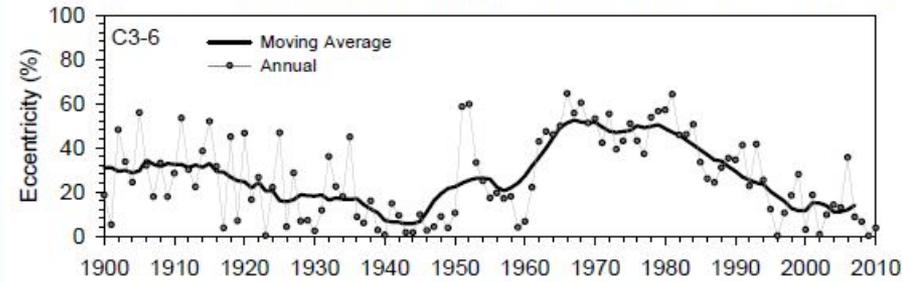
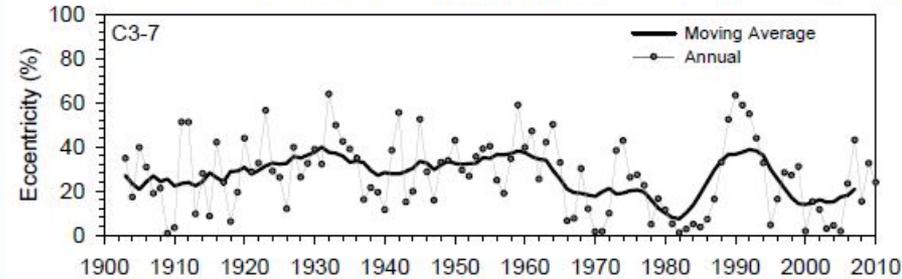
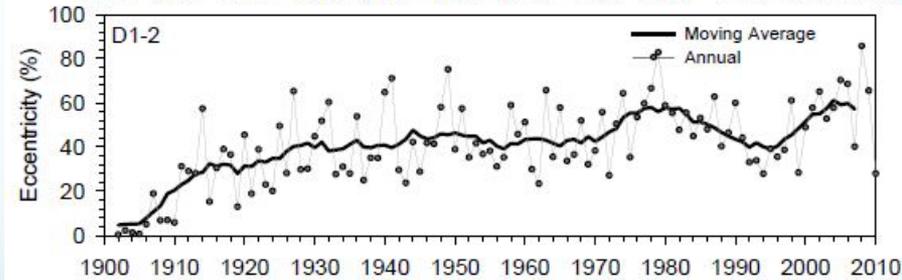
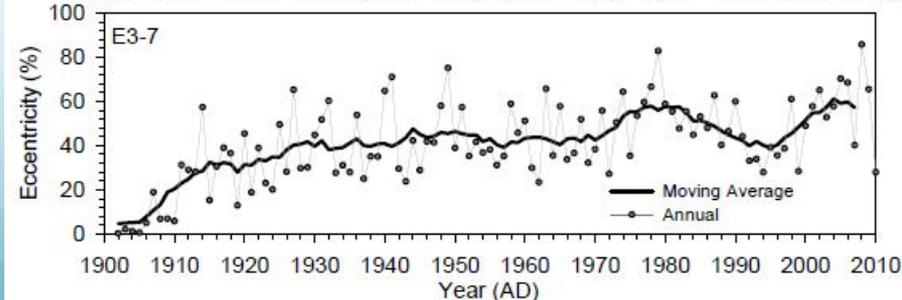
# Assessing Patterns in Magnitude

- Localized instability was evident in the distribution of highly variable eccentricity records for individual trees

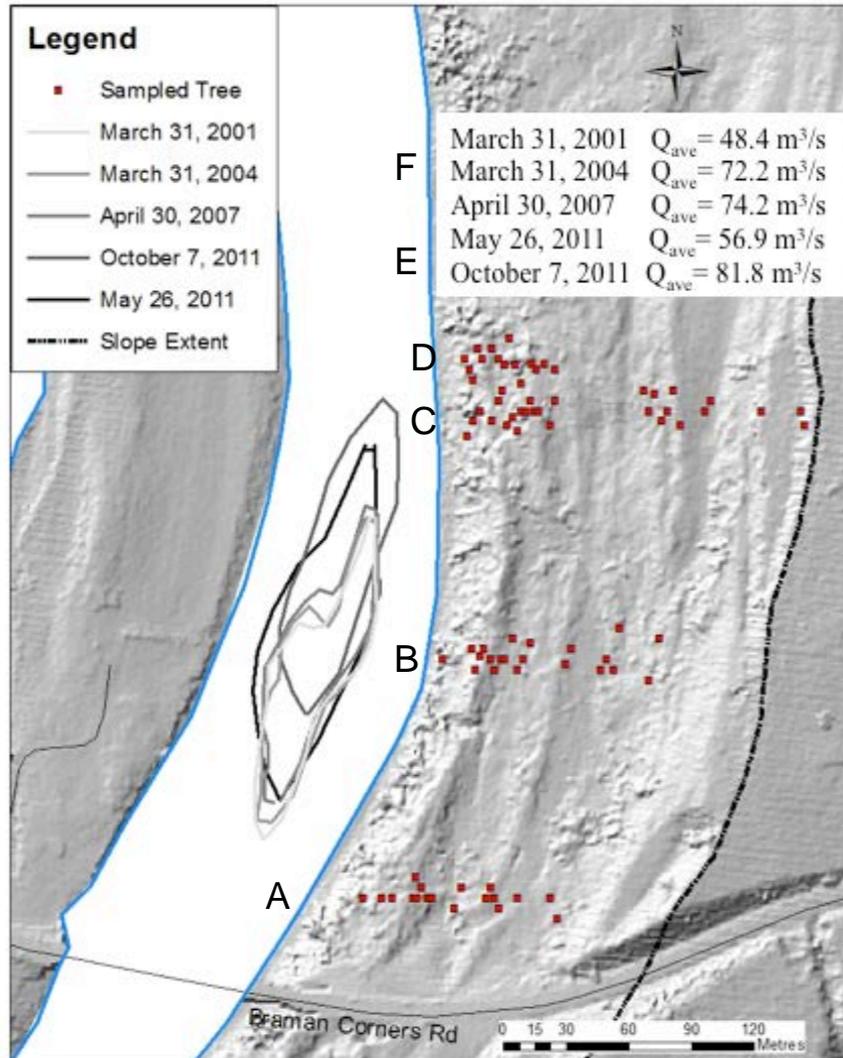
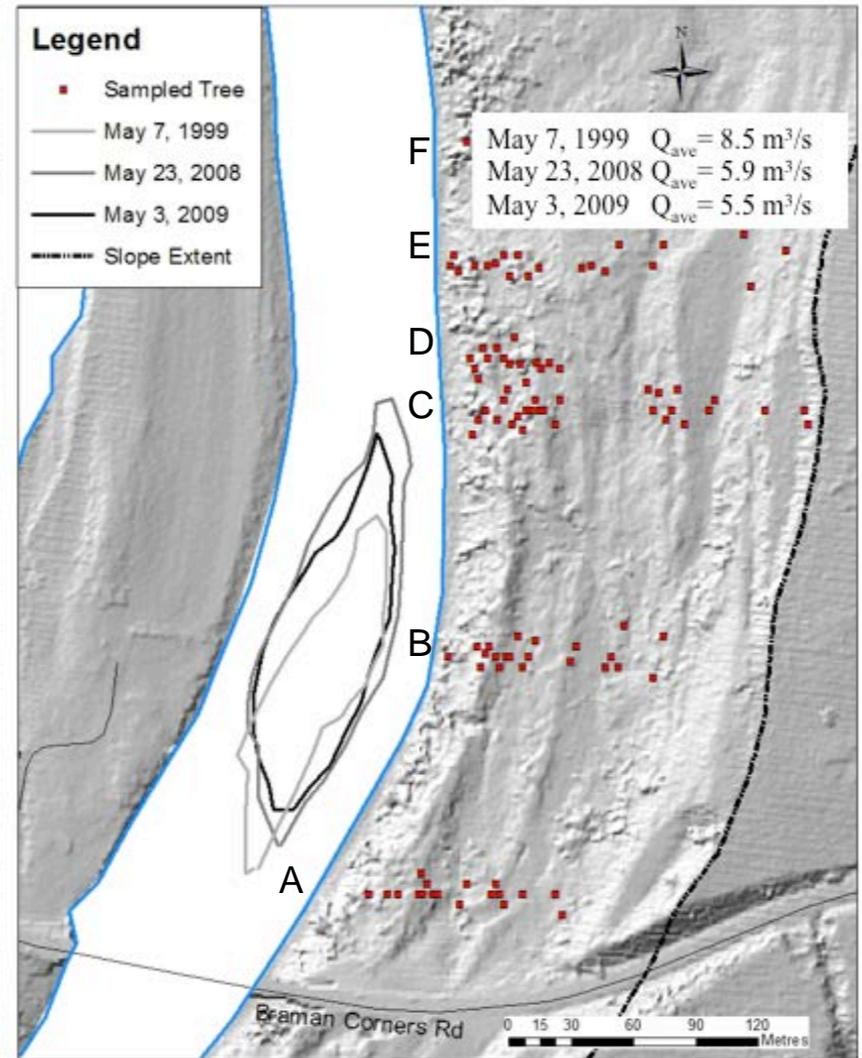
# Medial Bar Mapping

High Flow Conditions

Low Flow Conditions

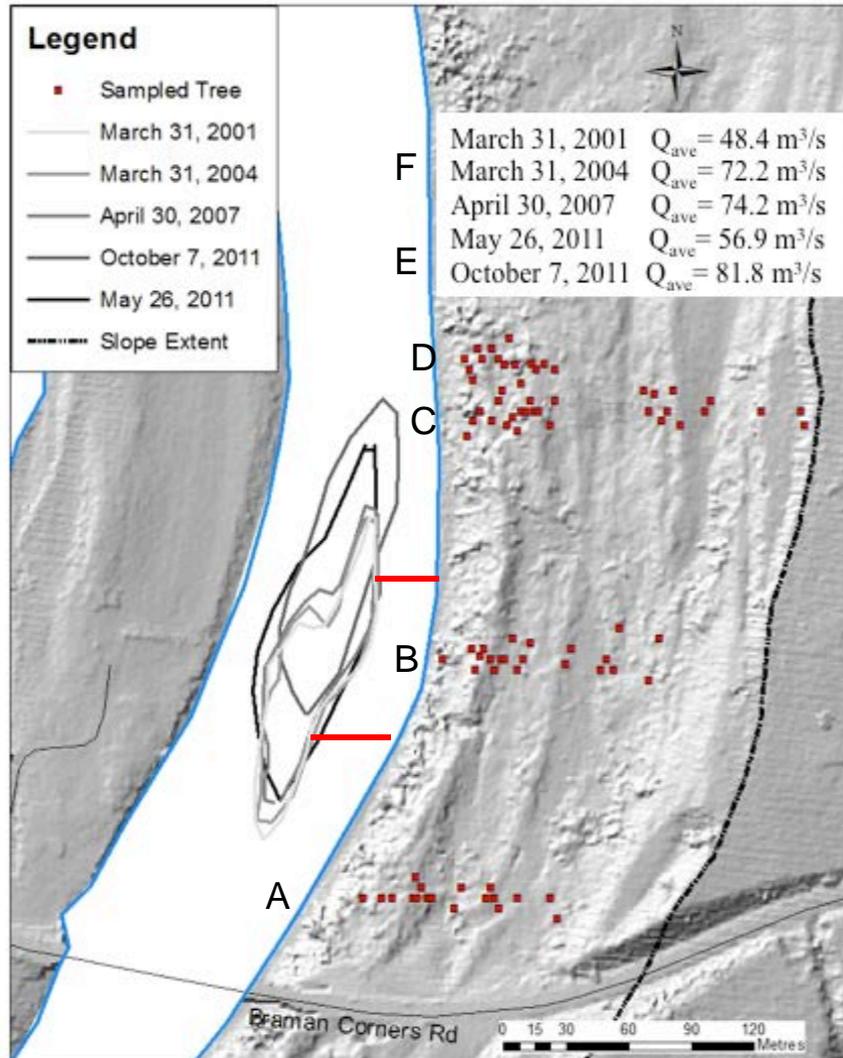
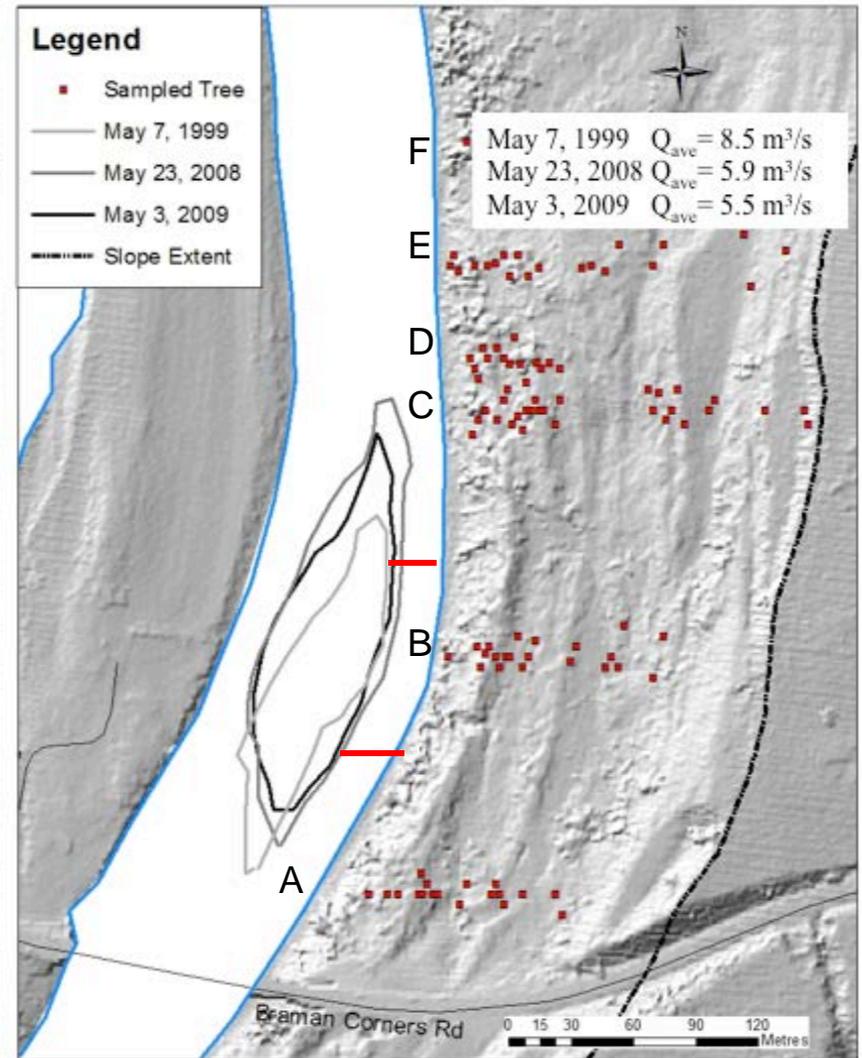
# Medial Bar Mapping

High Flow Conditions

Low Flow Conditions
