2018 Natural Channels
Conference – Guelph, ON

Lorenzo Brignoli
W.K. Annable

Field Based Correction
of Environmental Flow
Estimates Affected by
Aquatic Vegetation
Growth at Gauged
Sites

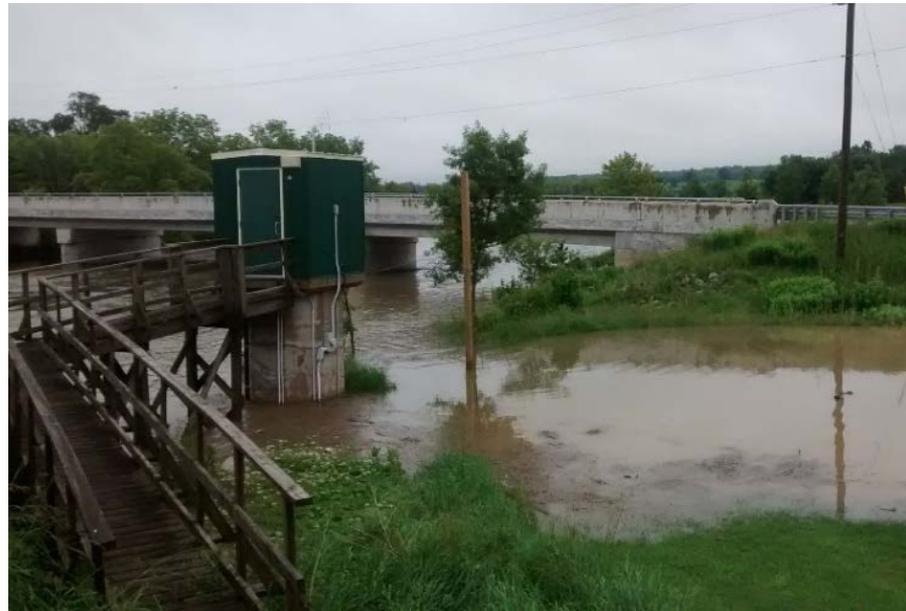
- Only “direct” source of flow data
- Multiple uses (and end-users)
- Measure water levels at gauging stations
- Obtain flow from a rating curve

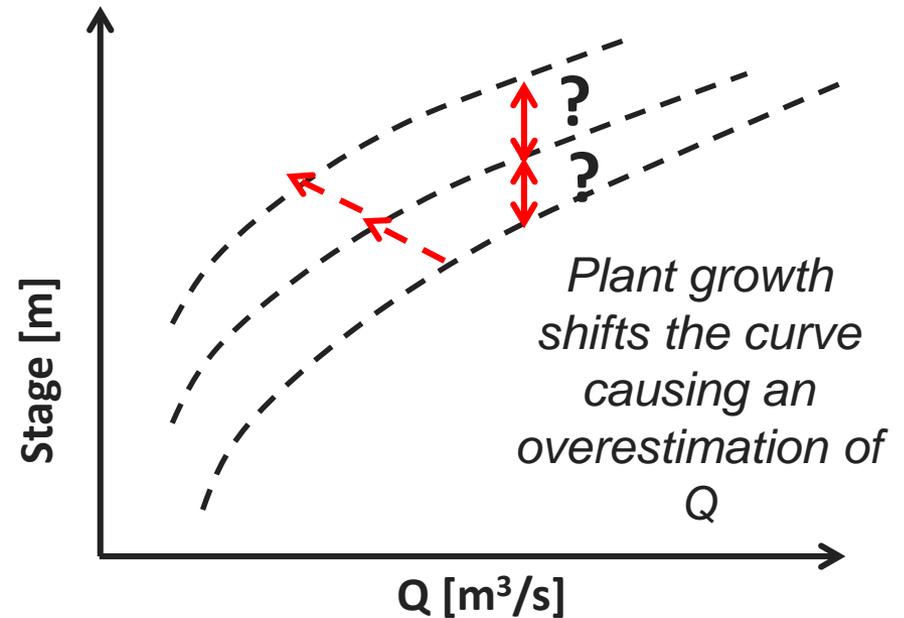
- Vegetation increases flow resistance
- Increases water level for the same Q
- Q estimated through a conventional rating curve will be overestimated
- Errors are generally higher at low flow

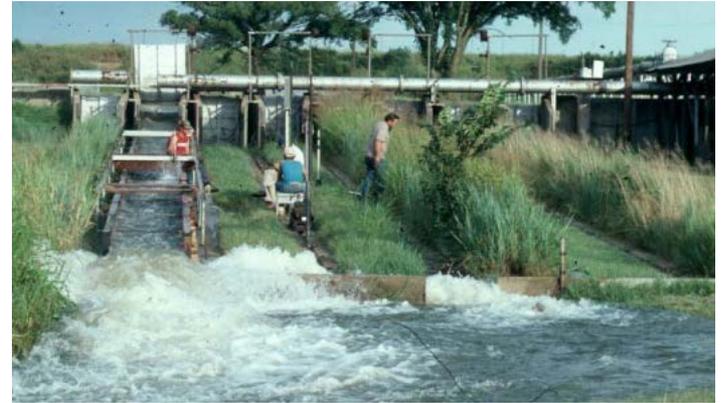
Experiments in Stillwater, OK (ca. 1985) photo by N. Kouwen

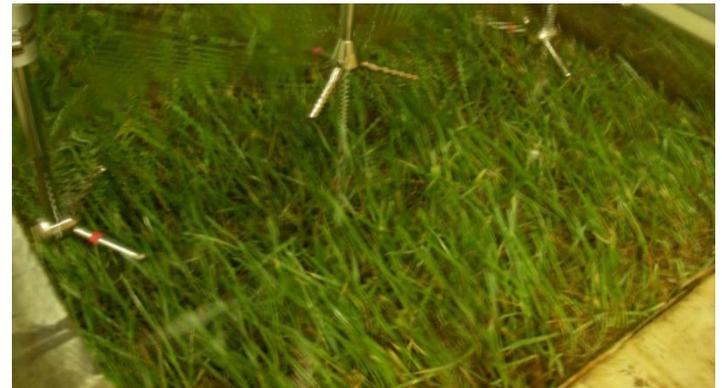
Lab experiments at UWaterloo (2011)

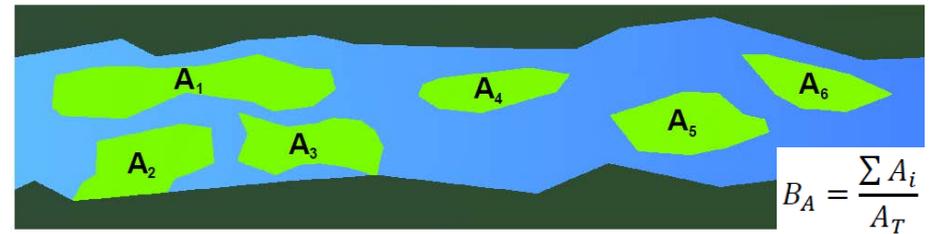
Longitudinal+Lateral=Aerial cover (B_A)

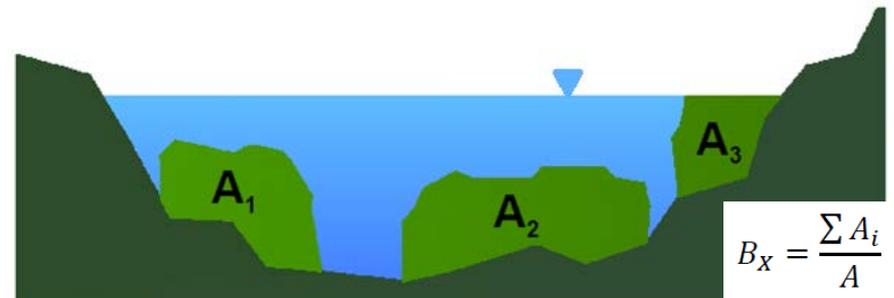
Vertical+Lateral=Blockage factor (B_X)

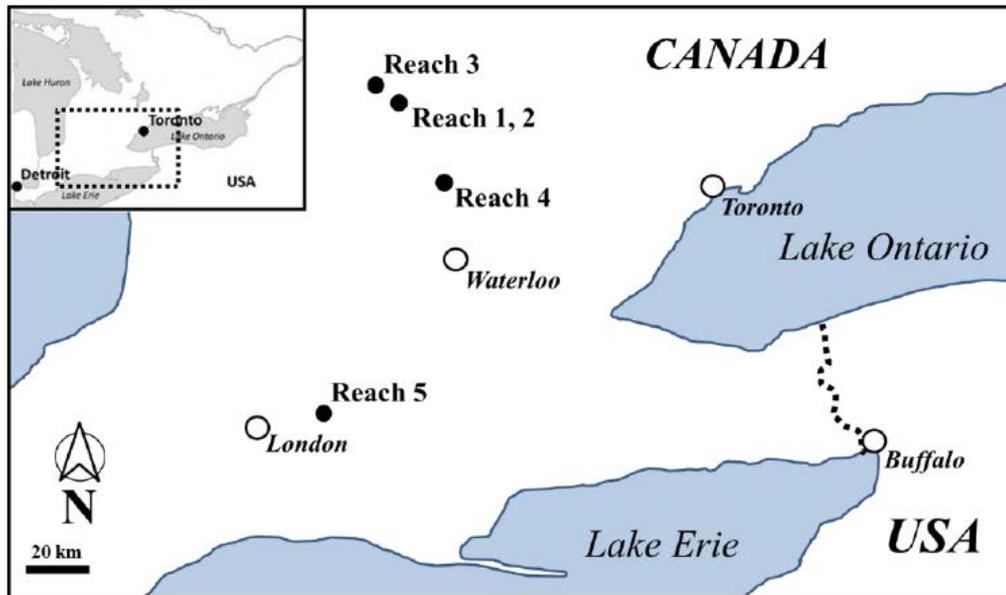
- Five reaches in Southern Ontario
- Avg Width ~ 7 – 12 m
- Length ~ 106 – 149 m
- Drainage Area ~ 46 – 145 km²
- Both submergent and emergent species

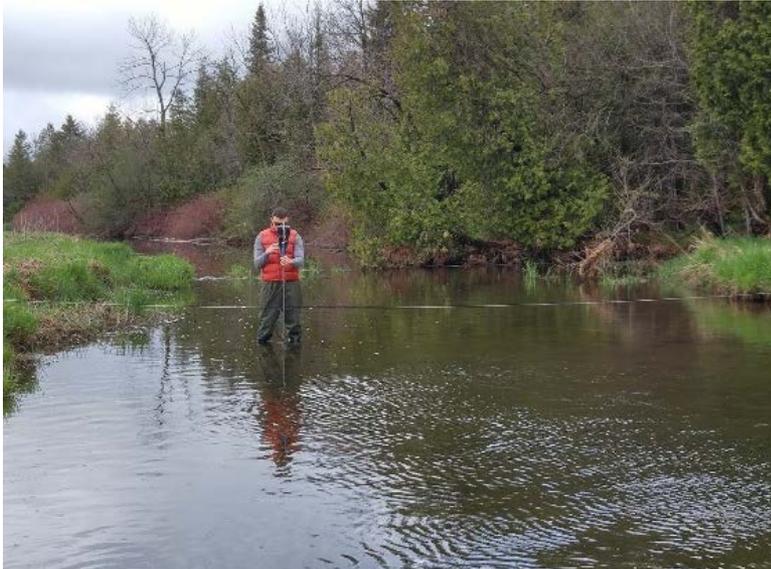
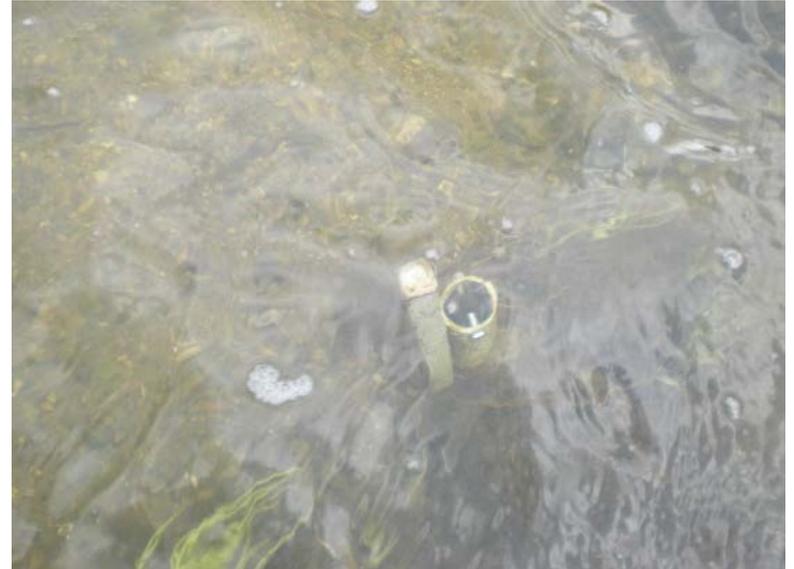
- Flow measurements
 - To develop a rating curve
- Continuous depth measurements
 - At vegetated locations
 - At non-vegetated locations

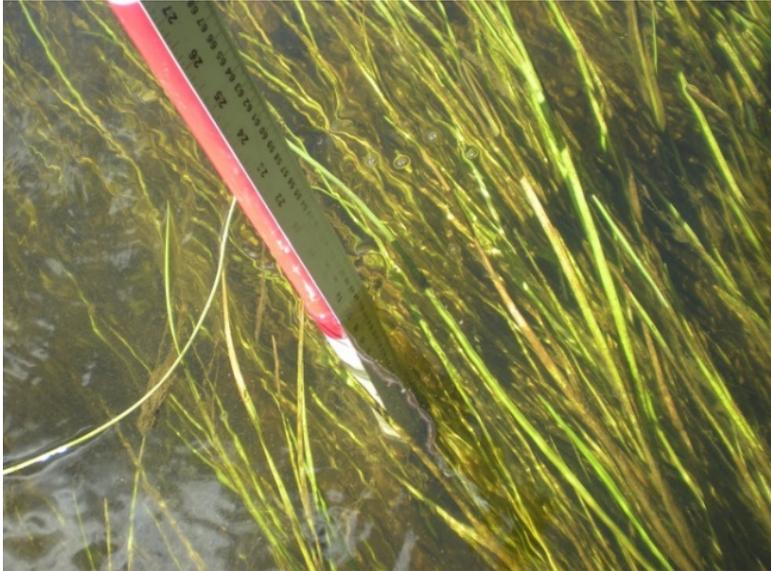
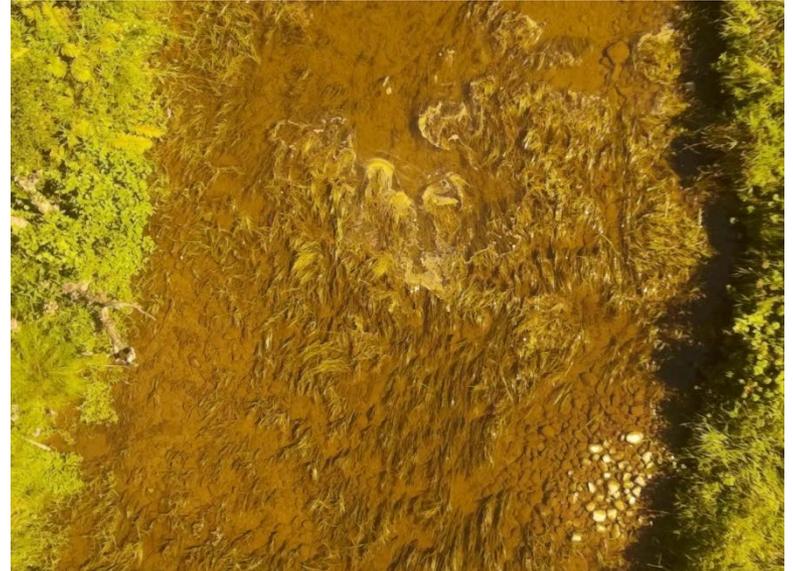
- Vegetation surveys
 - To map aquatic vegetation
 - Discrete (in channel); Repeated 7-10 times per year
 - Aerial – with drone

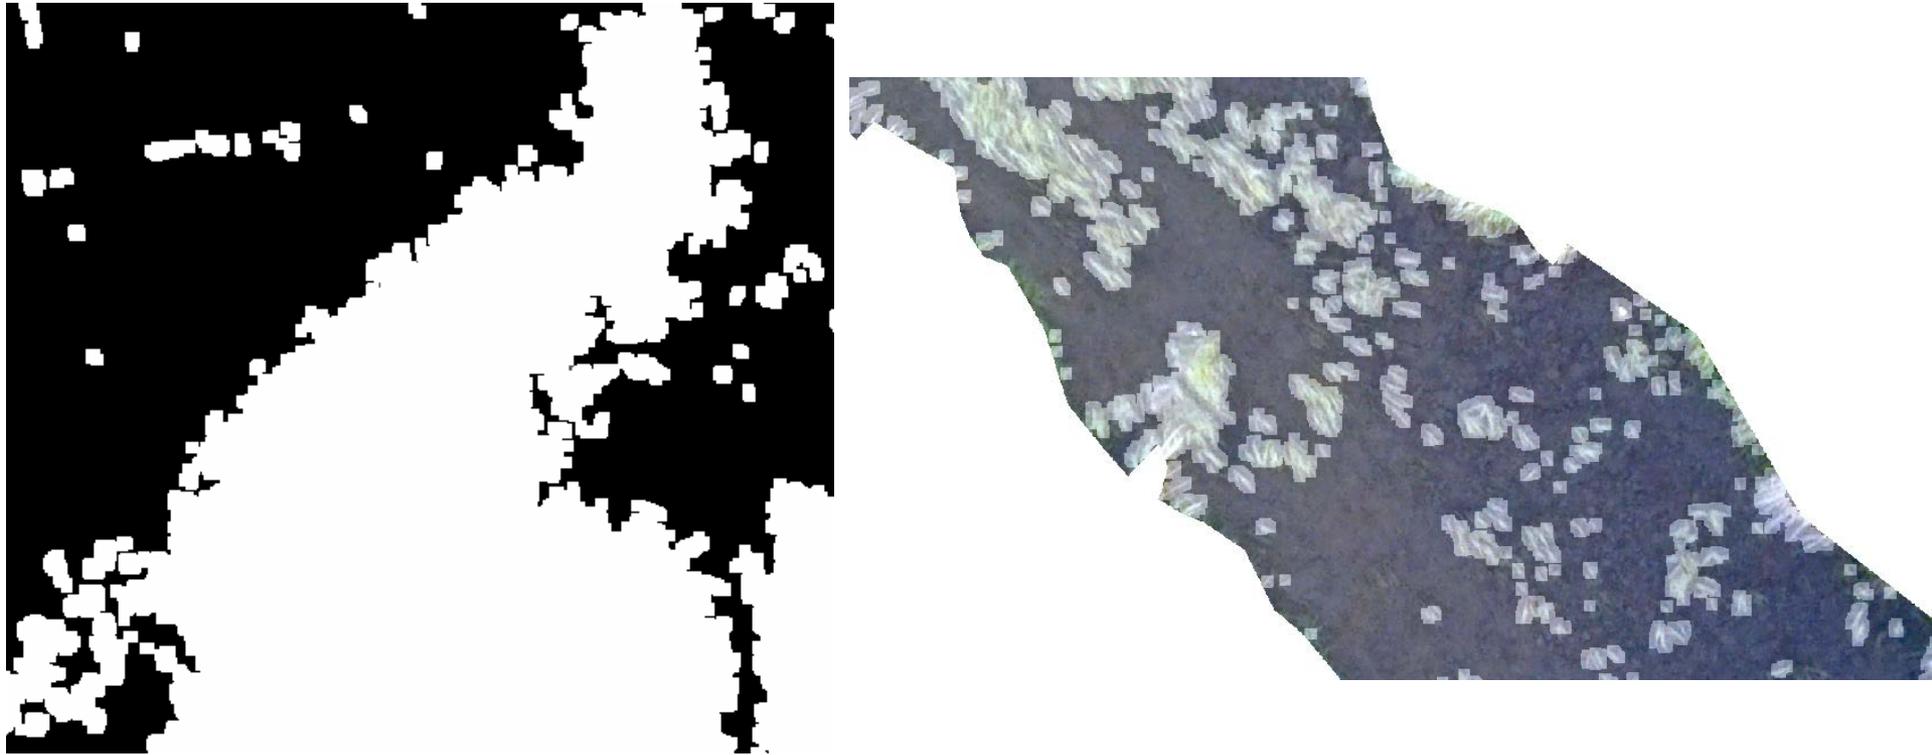
Post-processing UAV photos with MATLAB®

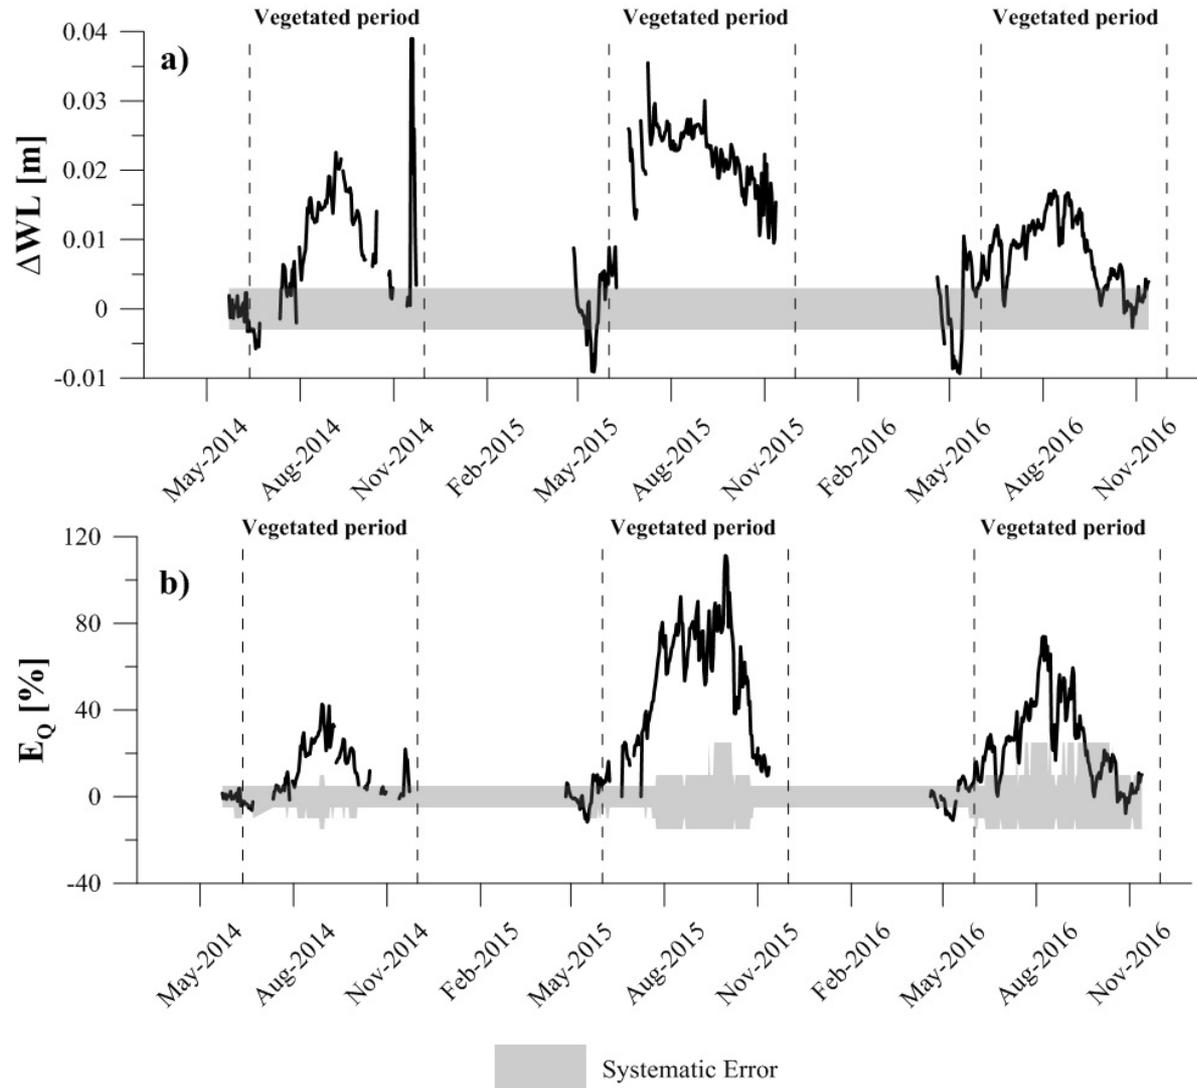
Increase in water level
(for a constant Q)

Increase in Discharge
Error

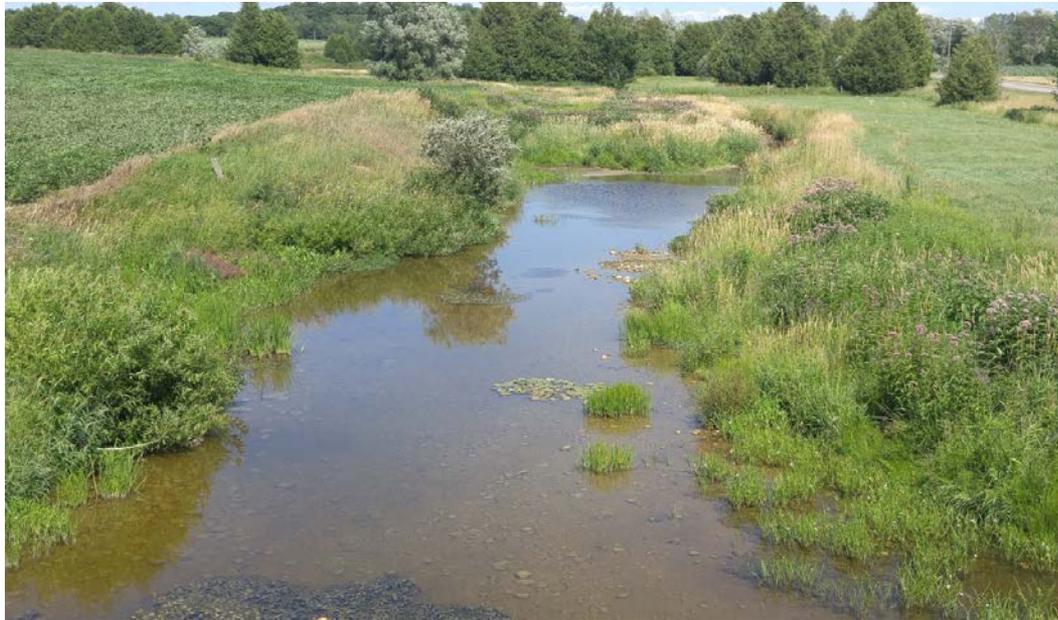
It is not the average distribution of plants that causes flow resistance to increase.

Rather, it's where vegetation is the most dense that affects flow resistance.

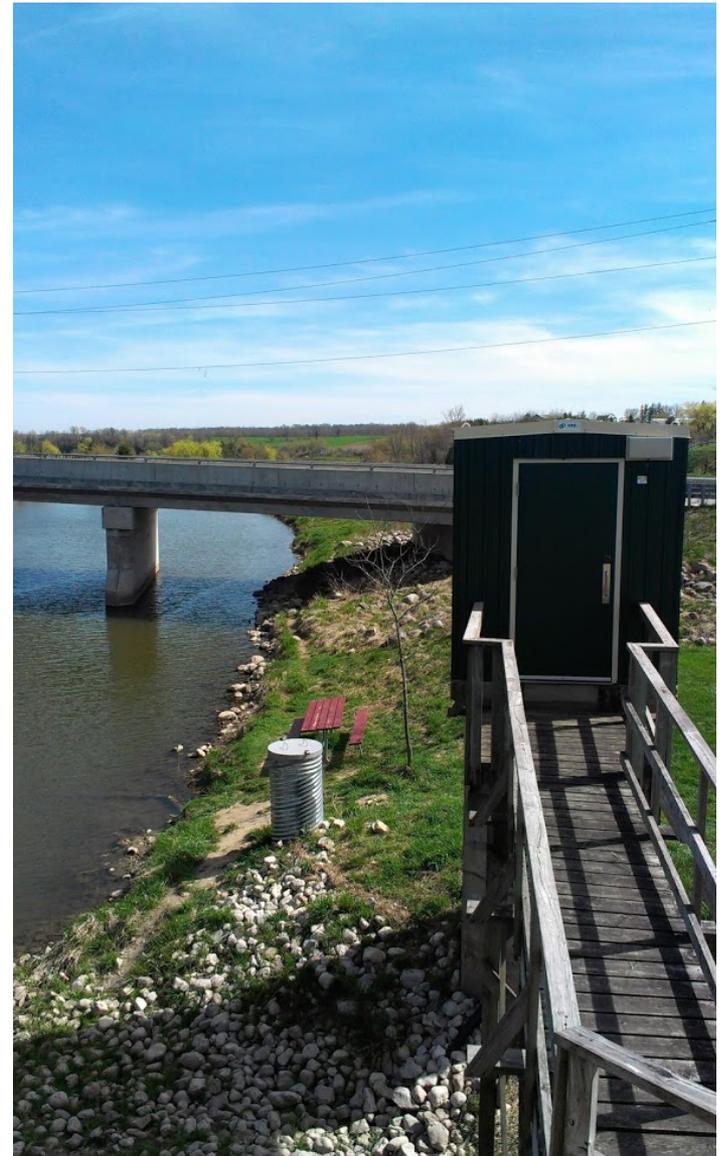
- Before correction
 - ~1,550 m³/day overestimated (on average)
- After correction
 - ~37 m³/day overestimation (98% reduction)
- One survey per month is enough to capture growth
 - Comparable to frequency used by streamgauging agencies
