# The Time-limited Resilience of River Morphology to Alteration: Examples from Across Canada

Robin McKillop and Dan McParland  
6<sup>th</sup> Conference on Natural Channel Systems  
May 24, 2018

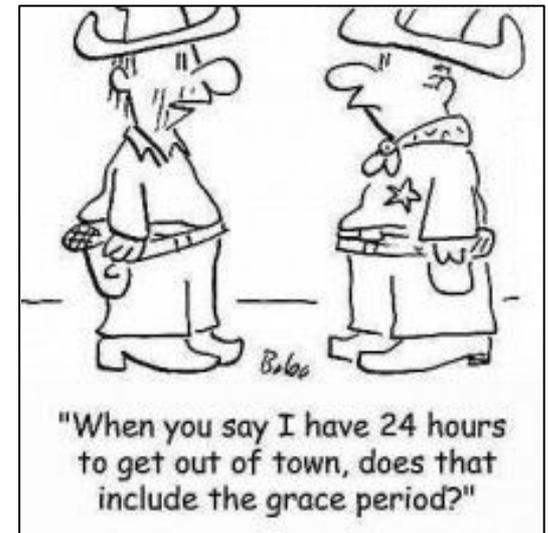
# Response to perturbations

- Change in one (or more) geomorphic control affects balance
- Geomorphic response may not manifest immediately – *time lag*?
- ‘Grace period’ – period following disturbance during which channel morphology remains largely unchanged
  - A ‘test’ of a river’s resilience

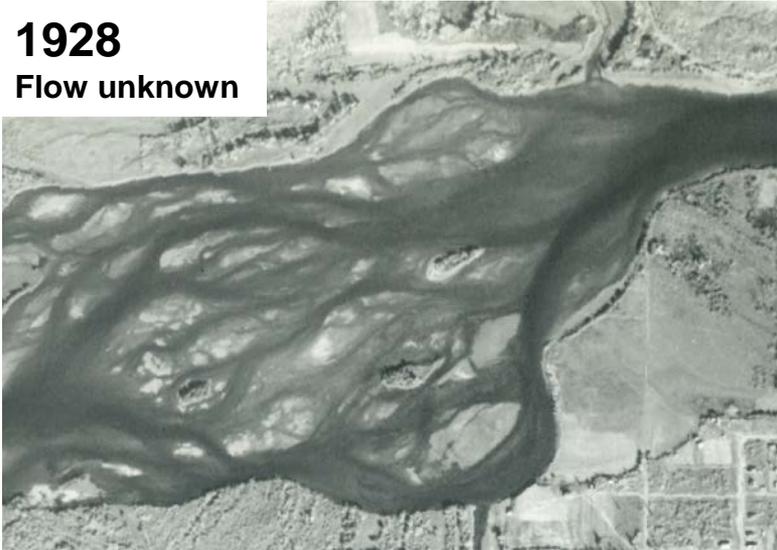
**1928**

Flow unknown

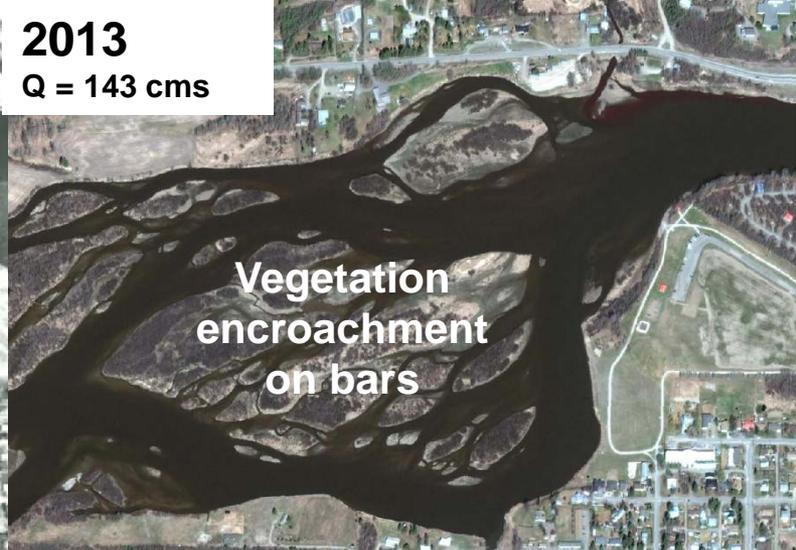
**2013**

Q = 143 cms

- Reduction in erosion rates post-regulation
- Vegetation encroachment on banks and bars took decades following regulation
- Fine 'sediment slug' associated with two dam-related avulsions ~150 km upstream reached Vanderhoof between 1966 and 1973
  - Coincides with White Sturgeon recruitment failure

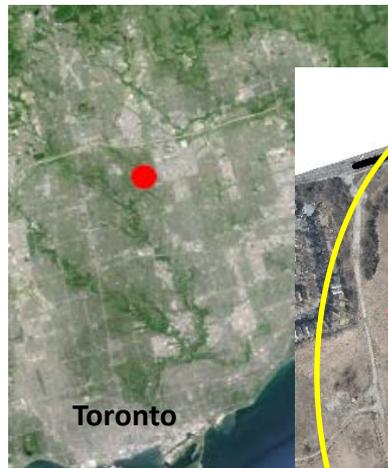
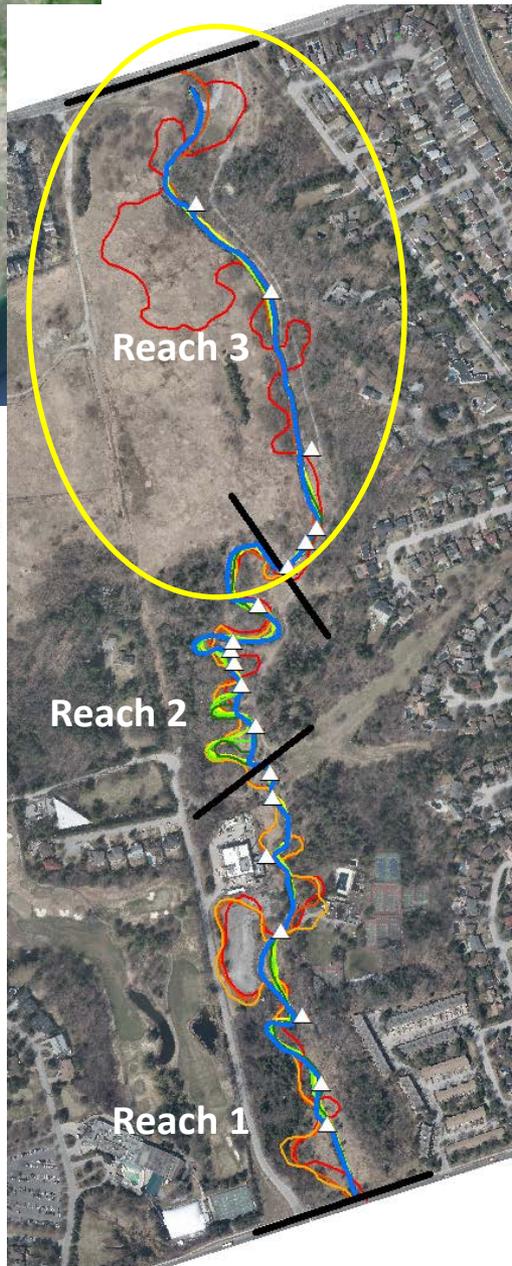
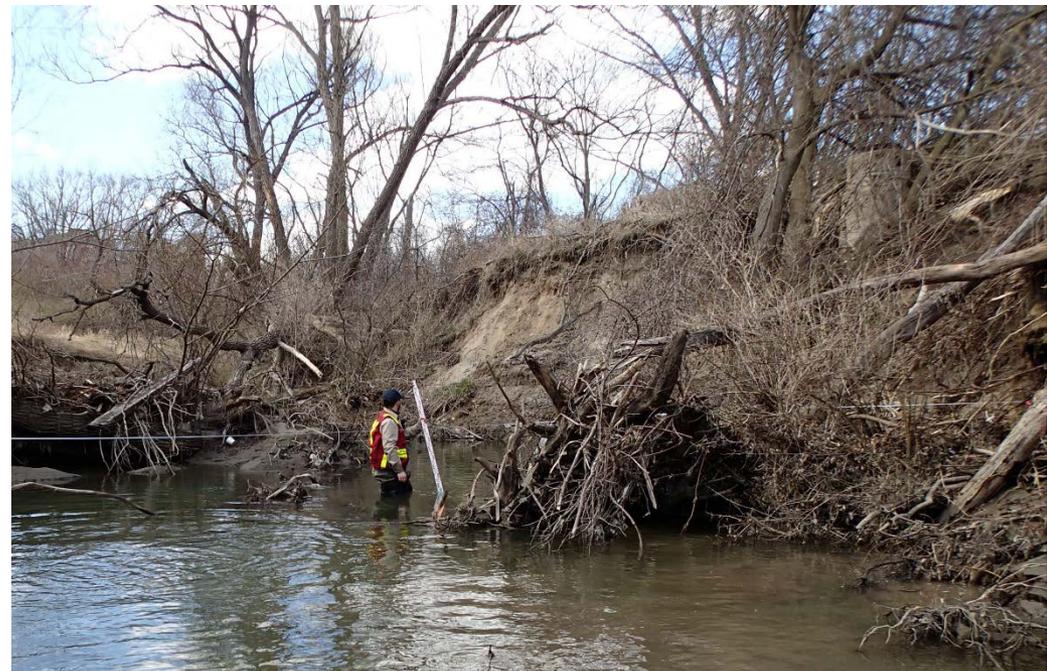
- Numerous at-risk crossings and encroachments of sanitary sewer
- History of alteration
