Review of Redside Dace Habitat Corridor Realignment: Morphology, Sedimentology and Habitat Suitability within Aged Natural Corridor Designs

5th International Conference on Natural Channel Systems

September 26-27, 2016, Niagara Falls, Ontario

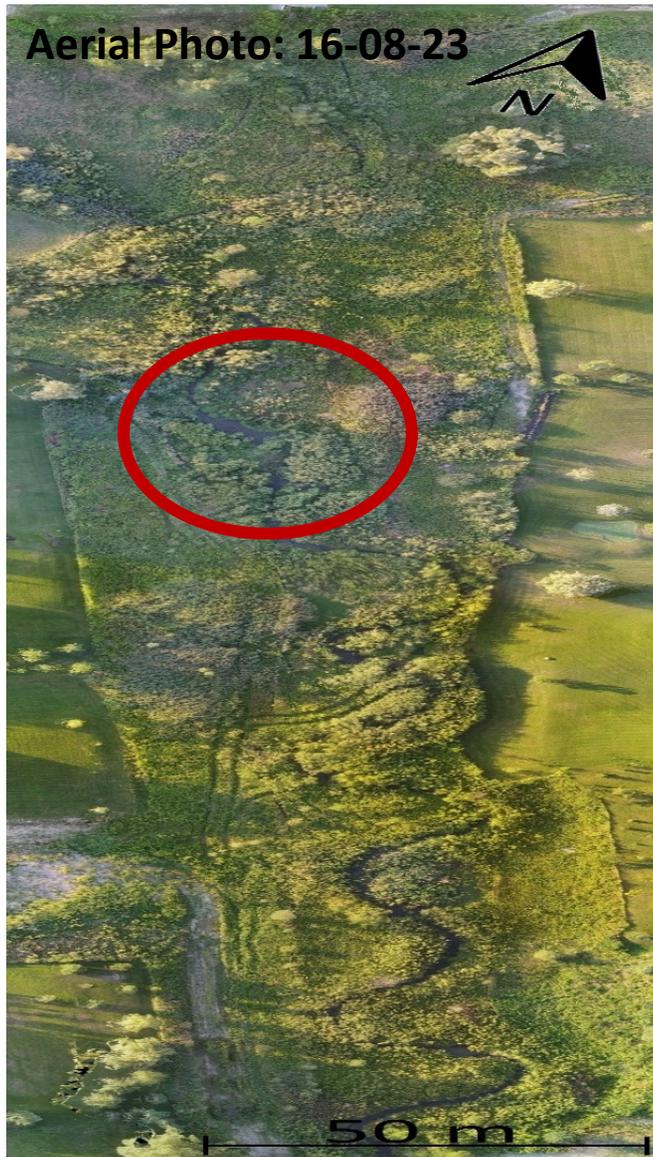
Carruther's Creek, Pickering

Range of Water Depths	0.42m-1m
Range of Velocities	Pool -0.009 m/s - 0.007 m/s
Undercutting	0.08m - 0.40m
Habitat Features	Rooted emergent
Riffle Substrate	Clay/silt, gravel, cobble, rootlets
Pool Substrate	Clay/silt, sand, rootlets
Bank Substrate	Clay/silt, rootlets
Riparian Vegetation	Major localized gaps, Canopy coverage: 60-79% shading
Large obstructions	6 beaver dams (1 breached)

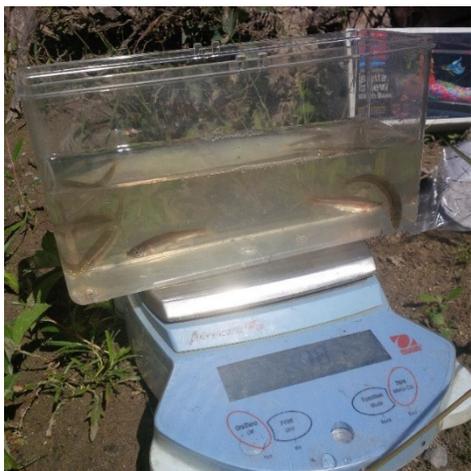
Carruther's Creek, Pickering

- Electrofishing survey completed on September 15, 2016
- Base flow at approximately 2 lpm at time of survey
- Channel maturing with moderate riparian cover
- No riffles, very shallow slope and deep pools present
- Channel dominated with muck and submergent vegetation
- Riffle/pool sequence upstream of Highway 7
- Watercress present in pools
- Seven species of fish collected
- Seven Redside Dace captured during survey reach

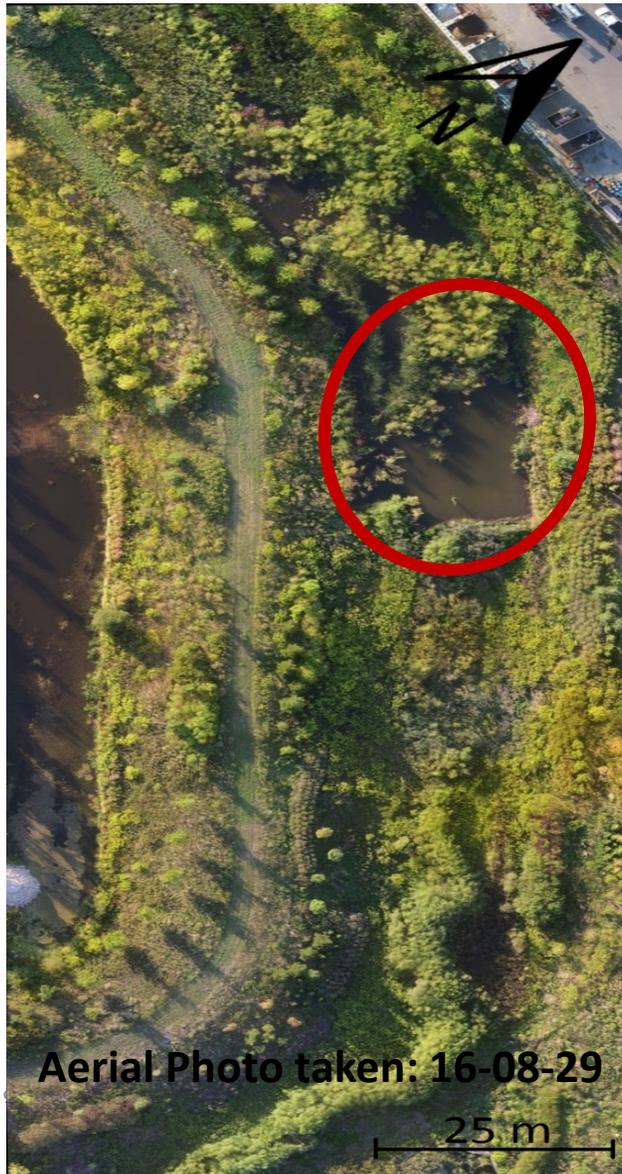
Churchville Creek: Timberbank

Range of Water depth	0.34m - 1.5m
Range of Velocities	Pool
	-0.006 m/s 0.044 m/s
Undercutting	0.15 m
Habitat Features	Rooted emergent/ submergent
Riffle Substrate	Clay/silt, gravel, cobble, rootlets
Pool Substrate	Clay/silt, sand, rootlets
Bank Substrate	Clay/silt, rootlets
Riparian Vegetation	Major localized gaps, Canopy coverage: >80 % shading
Large obstructions	2 Beaver dams (1 was 15m across)
Notes	Large amounts of flooding due to beaver dams

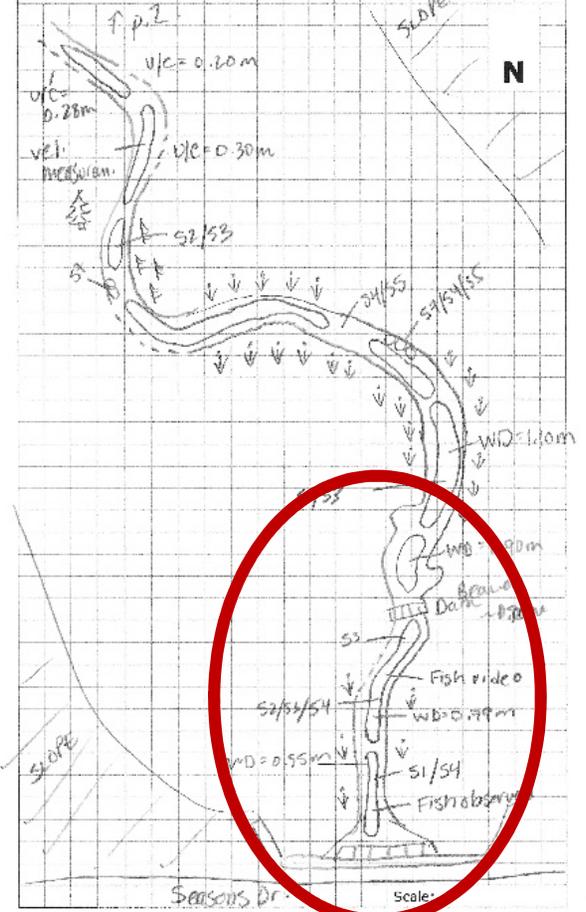
Morningside Creek, Scarborough

Range of Water depth	0.55m- 1.10m
Range of Velocities	Riffle -0.009 m/s - 0.385 m/s
Undercutting	0.05m- 0.30m
Habitat Features	Rooted submergent
Riffle Substrate	Gravel, Cobble
Pool Substrate	Sand, gravel, parent
Bank Substrate	Clay/silt
Riparian Vegetation	Major localized gaps, Canopy coverage: <50 % shading
Large obstructions	Large amounts of flooding due to 5 Beaver dams
Notes	Flooded since 2013, fish observed

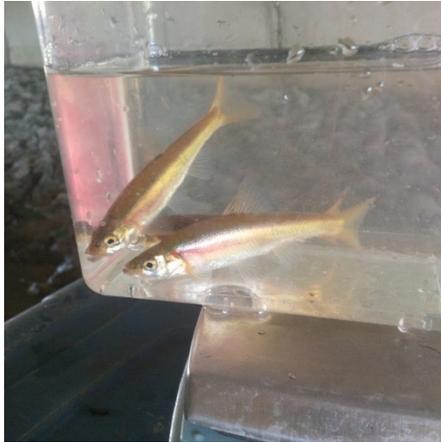
Morningside Tributary, Rouge River

- Electrofishing survey completed on September 15, 2016
- Base flow at approximately 20 lpm at time of survey
- Channel maturing with moderate riparian cover
- Riffles composed of cobbles and gravel
- Beaver present with constructed dams
- Nine species of fish collected
- Four Redside Dace captured during survey

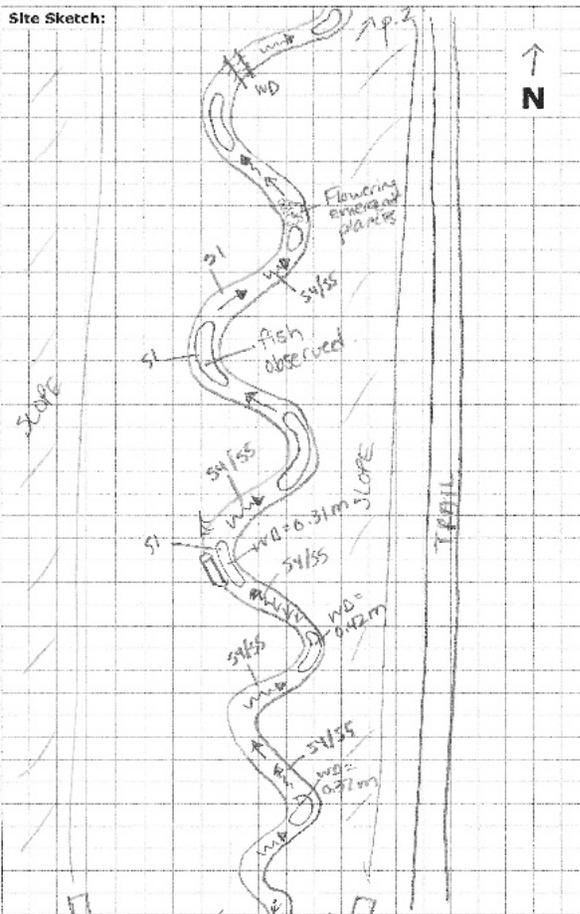
Fletcher's Creek, Brampton

Range of Water depth	0.55m- 1.10m
Range of Velocities	Pool -0.006 m/s - 0.044 m/s
Undercutting	0
Habitat Features	Rooted emergent
Riffle Substrate	Cobble
Pool Substrate	Clay/silt
Bank Substrate	Clay/silt
Riparian Vegetation	Major localized gaps, Canopy coverage: <50 % shading
Large obstructions	No beaver dams
Notes	Standing water, no flow

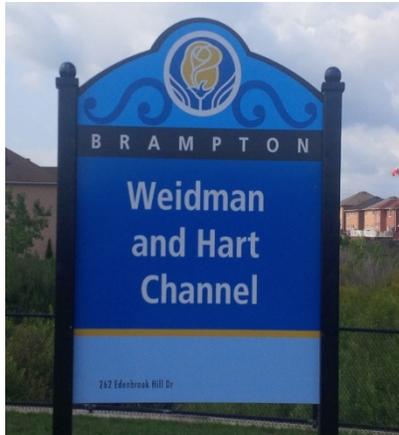
Fletcher's Creek, Credit River

- Electrofishing survey completed on August 25, 2016
- Base flow at approximately 40 lpm at time of survey
- Channel maturing with dense riparian cover with some large woody cover in pools
- Riffles composed of cobbles
- Channel dominated with muck
- Beaver present with constructed dams
- Six species of fish collected
- YOY Redside Dace captured in same survey reach in 2011 by Credit Valley Conservation
